# Evaluation of the 24th Street Bridge

**Final Report**  
**November 2010**

**IOWA STATE UNIVERSITY**  
**Institute for Transportation**

**Sponsored by**  
Federal Highway Administration  
Iowa Department of Transportation

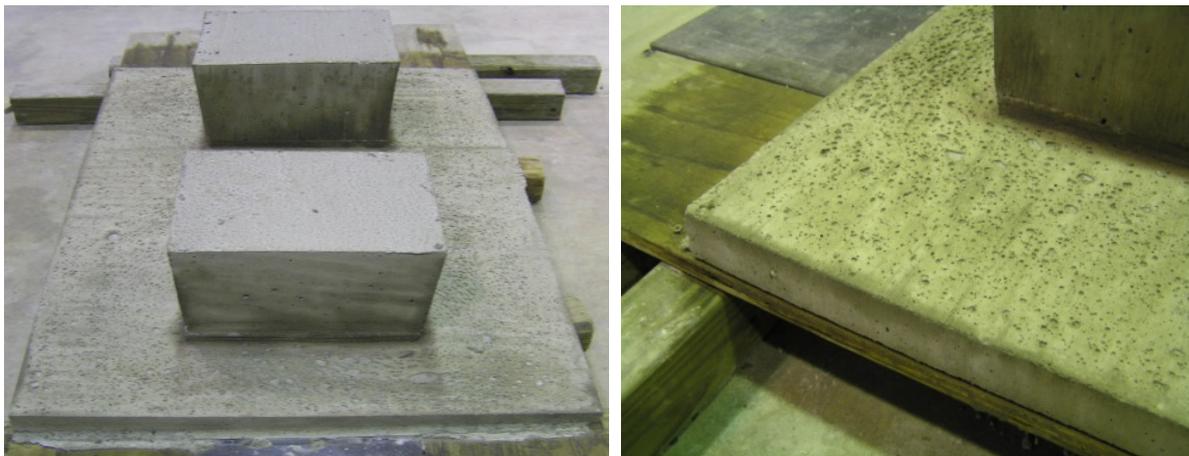
**a. Grout filled pockets and haunch**

No difficulty was found in bending the four studs in the corners of the stud pocket. Bending of the center two studs was more arduous but still possible. The grout was then placed into the two stud pockets in the mockup and agitated with an electric vibrator. Figure 3.1 shows the mockup after removal of the forms, clearly indicating that grout can sufficiently flow through the stud pockets and into the haunch area in the specified dimensions. The grout, however, did have small air pockets/voids that formed on the surface as seen in Figure 3.1b. It is uncertain how the air pocket would affect the long term performance of the haunch grout.

During construction of the panels the precaster had difficulty finding an economical blackout form during casting of the panel. The tapered edges of the pocket as seen in Figure 3.1 were eliminated and the sides of the blackout were redesigned to be vertical in order to provide cost savings to the project.

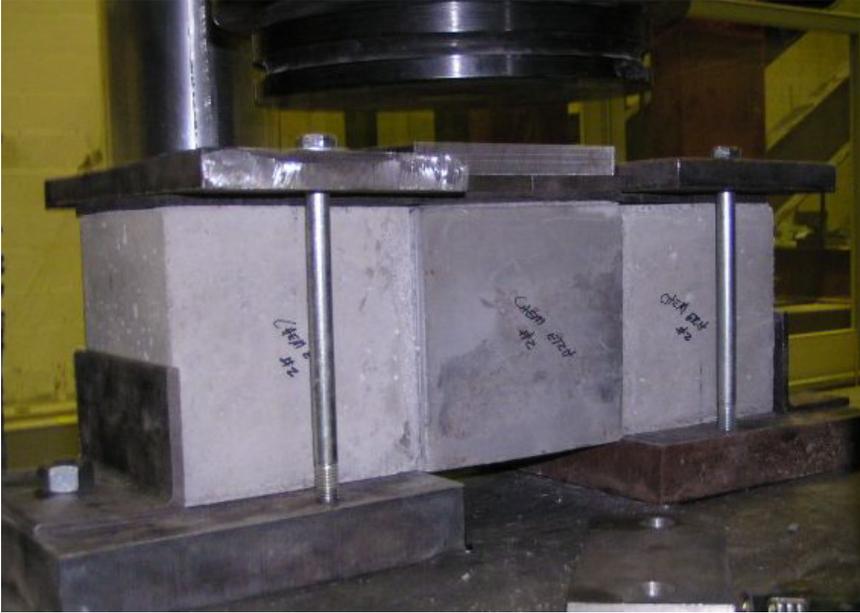
**Figure 3.3. Push-out tests for transverse joint surface treatment**

The following four surface “roughening” alternatives were tested and evaluated: Control (i.e. no roughening), Diamond Plate forms, Chemical Etching, and Sandblasting. For each alternative, three specimens were tested, each specimen consisting of a 6 in. x 6 in. x 6 in. grout cube sandwiched between two concrete cubes of similar dimensions. Push-out tests were performed on each of the specimen as shown in Figure 3.3. Figure 3.4 illustrates a typical deflection vs. load curve for the sandblasted specimen. A progression in higher shear bond strength is evident as one move from the Control specimens, to Diamond Plate specimens, to Chemically Etched specimens, to Sandblasted specimens. Sandblasting appears to be the most effective surface treatment for resistance to pure shear.

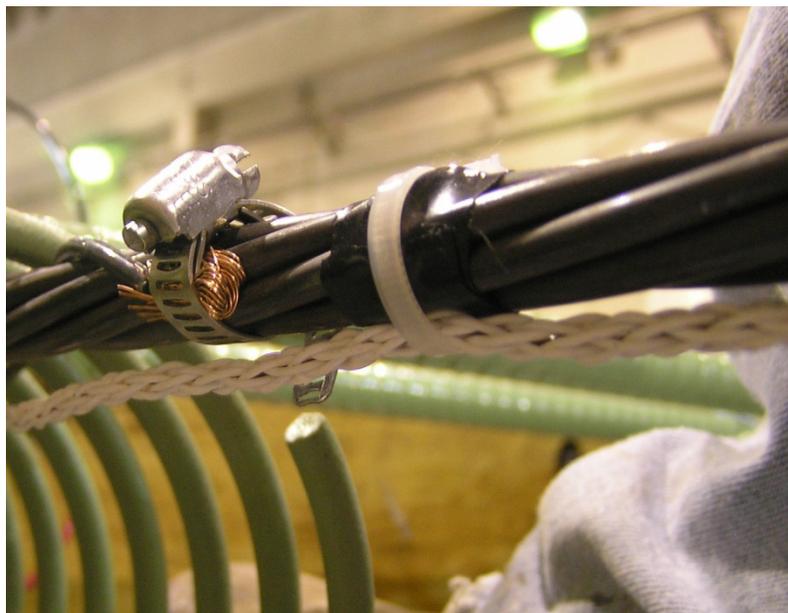
**Figure 4.1. Corrosion electrode tied to strand**

Both the prestress and post-tensioning strands that were selected for monitoring were instrumented their full length. Electrode readings for the prestress strands were taken during the placement of the deck in 2008. The sacrificial post-tensioning strands were read after their placement in 2008. Both strands were again read in 2009. The results of the electrode readings are shown in Table 4.2. All electrode readings are within Range 1, indicating that no corrosion is taking place in the strands.

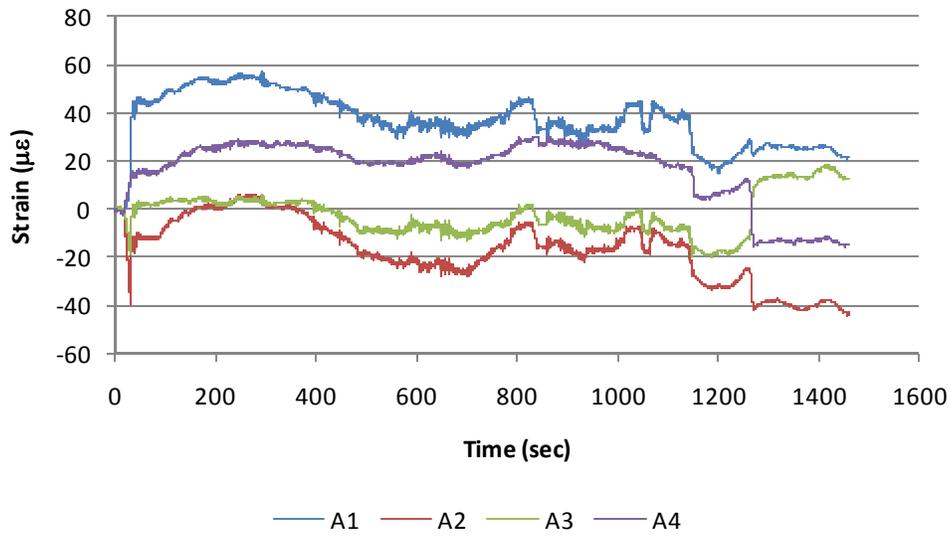
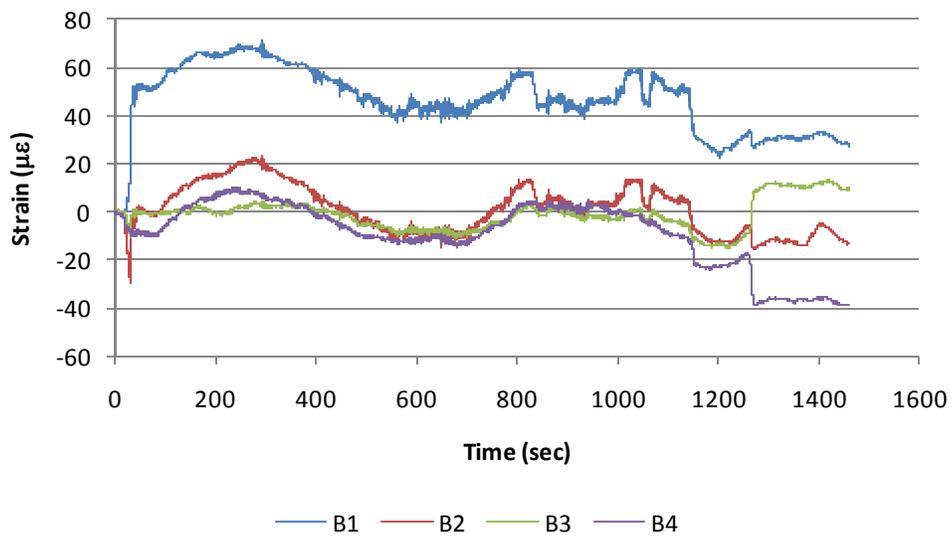
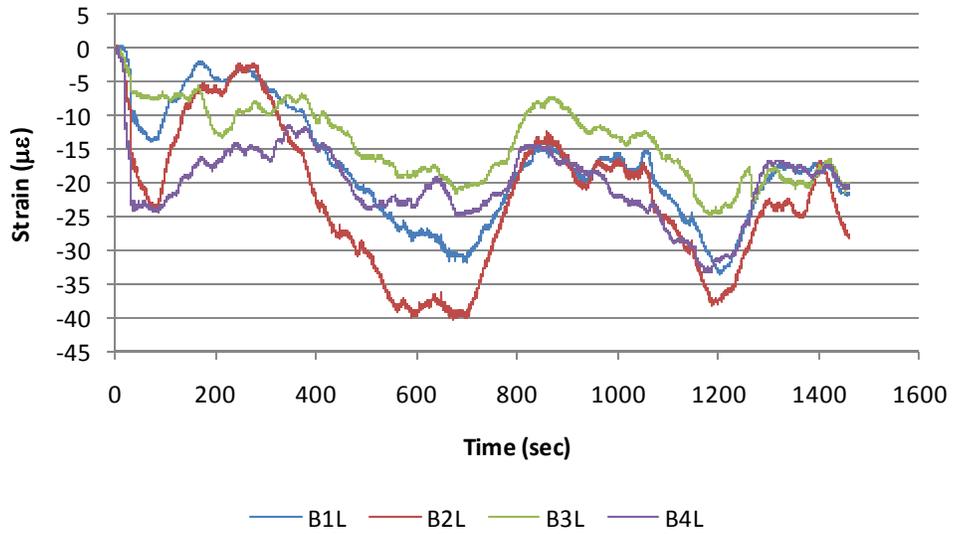
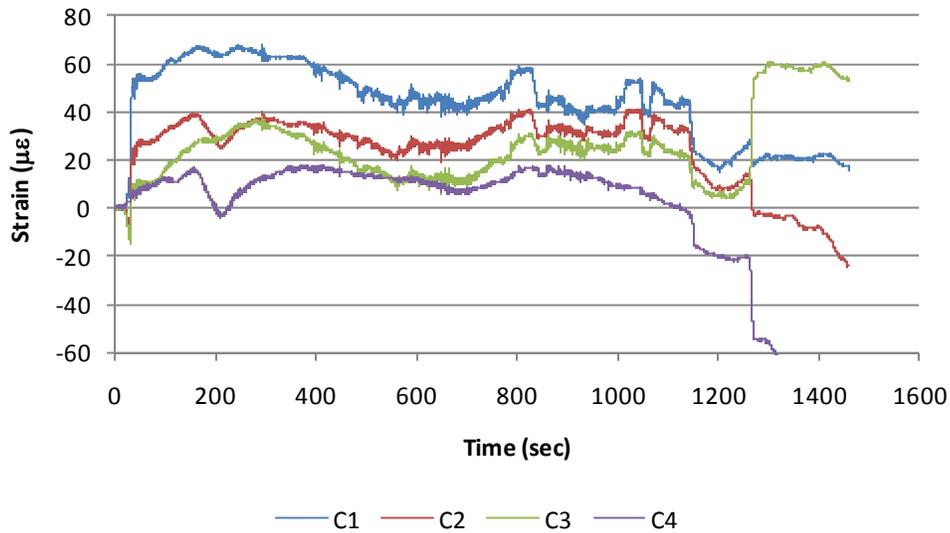
**Figure 4.8. Panel No. 1 strain readings during panel placement**

The strain results for Panel No 1 are shown in Figure 4.8. As shown by the strain, the panel was fully lifted after 40 secs., representing the spike in the strain reading. Then, as the crane lifted and swung the panel over to the bridge, the strain peaked ( $68 \mu\epsilon$ ) at about 240 secs. At approximately 550 secs. to 1250 secs., the construction workers were aligning the panel to the proper location on the girders. At some points during this time the panel had points of contact with the girders.

After 1250 secs., the panel was in place and had its leveling bolts resting completely on the girders. The transverse strain along grid line 1, which is the center line of the panel, showed the highest strain readings. The strain on grid line 1 varied from  $55 \mu\epsilon$  to  $68 \mu\epsilon$  all in tension. The longitudinal gauges located along gridline B varied between  $3 \mu\epsilon$  to  $40 \mu\epsilon$  all in compression during the placement of the panel.

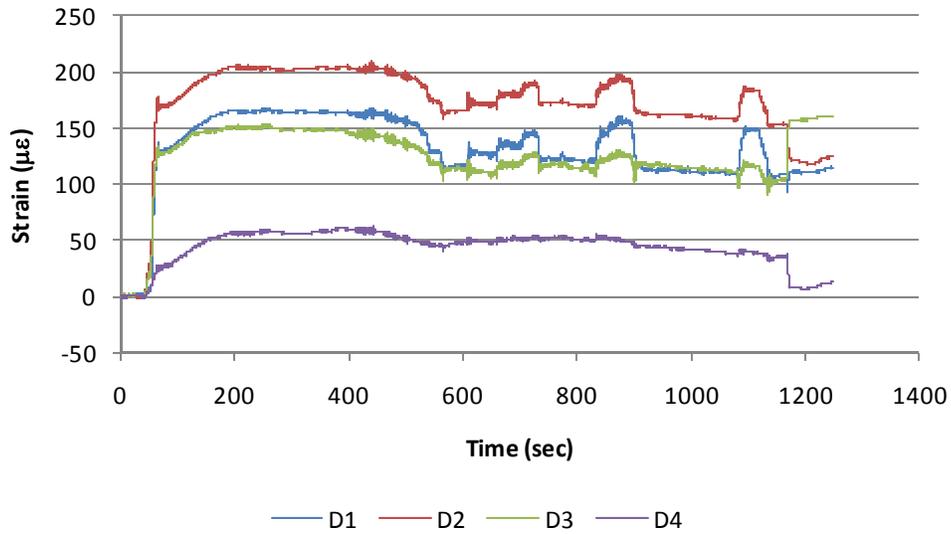
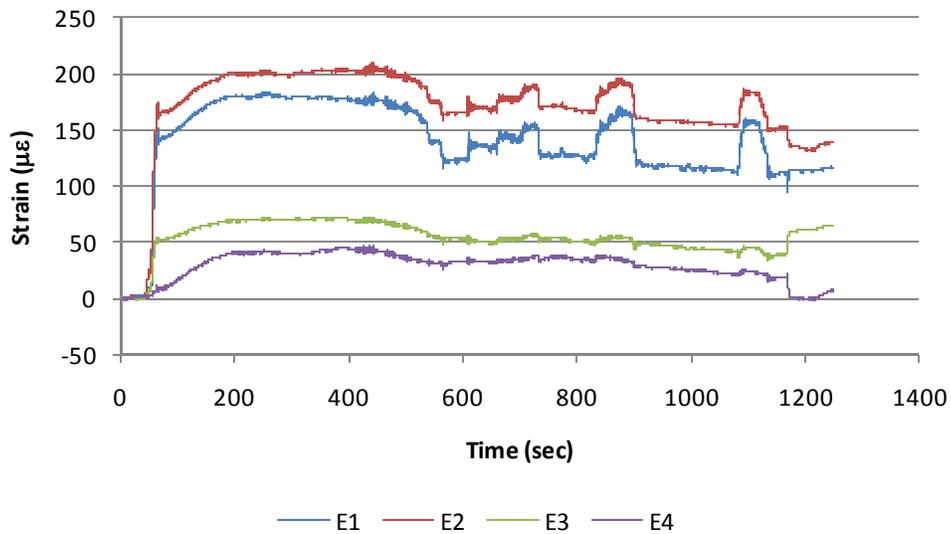
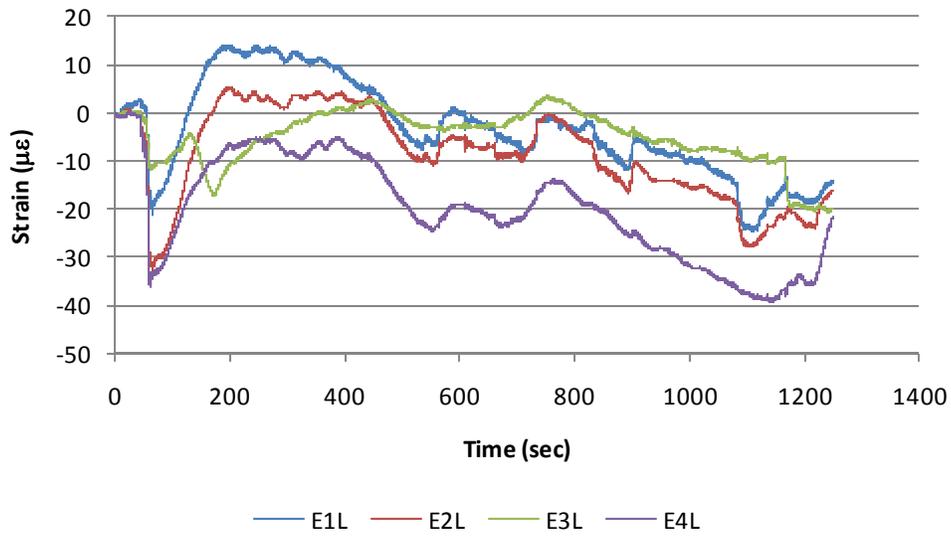
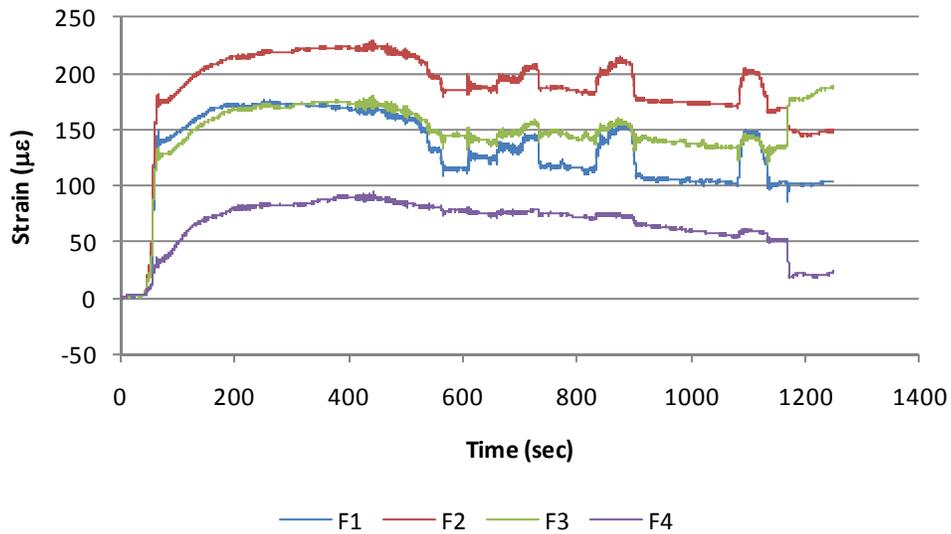
**Figure 4.10. Panel No. 2 strain readings during placement**

The strain readings for Panel No. 2 are shown in Figure 4.10. As seen at approximately 63 secs. the panel is fully picked up. The panel was then lifted and swung over the girders. At approximately 560 secs., the panel was being maneuvered by the construction workers into placement. Then, at approximately 1150 secs., the panel's leveling bolts were fully resting on the girders. Panel No. 2 reached a maximum strain of approximately 230  $\mu\epsilon$ . The maximum strain occurred at location F2. At the time of maximum strain the strain in all the gauges varied from 48  $\mu\epsilon$  to 230  $\mu\epsilon$ . The lowest strain consistently occurred along gridline 4.

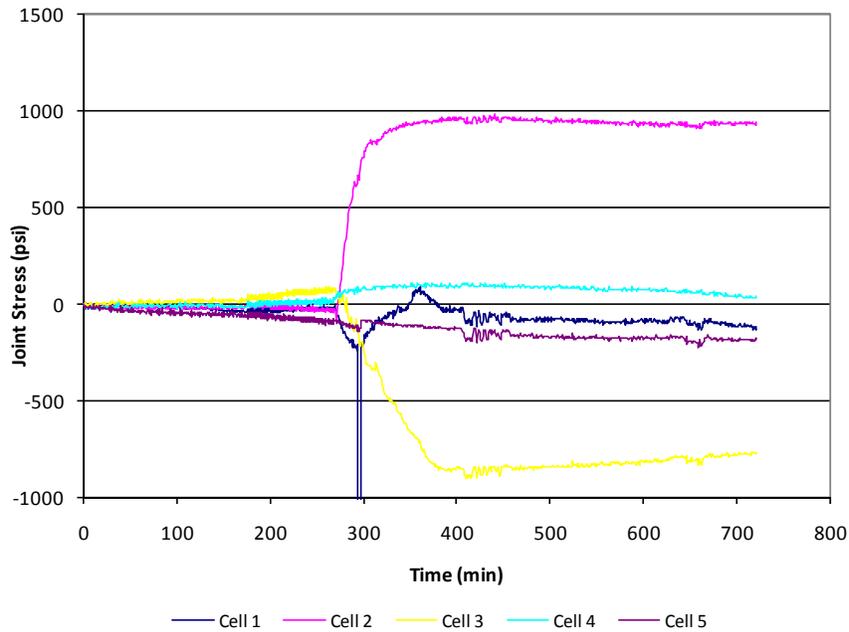
**Figure 4.14. Deck panel load during strand stressing**

As the deck was post-tensioned from both the south and the north ends, load cell readings were taken continuously. The post-tensioning process took approximately 12 hours total and each strand was elongated approximately 21 to 22 in. The stress at each load cell during the 12 hours of recording is shown in Figure 4.14. The maximum stress obtained from the load cells was from Cell 2, which had a maximum stress of approximately 950 psi. Due to the negative pressure readings and non-uniform stress from load cell to load cell, it is uncertain if all the load cells were working properly during post-tensioning. Load Cell 6 did not record data during the post-tensioning.

3. Joint stress of 950 psi was observed in one of the load cells during the post-tensioning of the deck strands. It is uncertain, however, if the load cells were working properly.

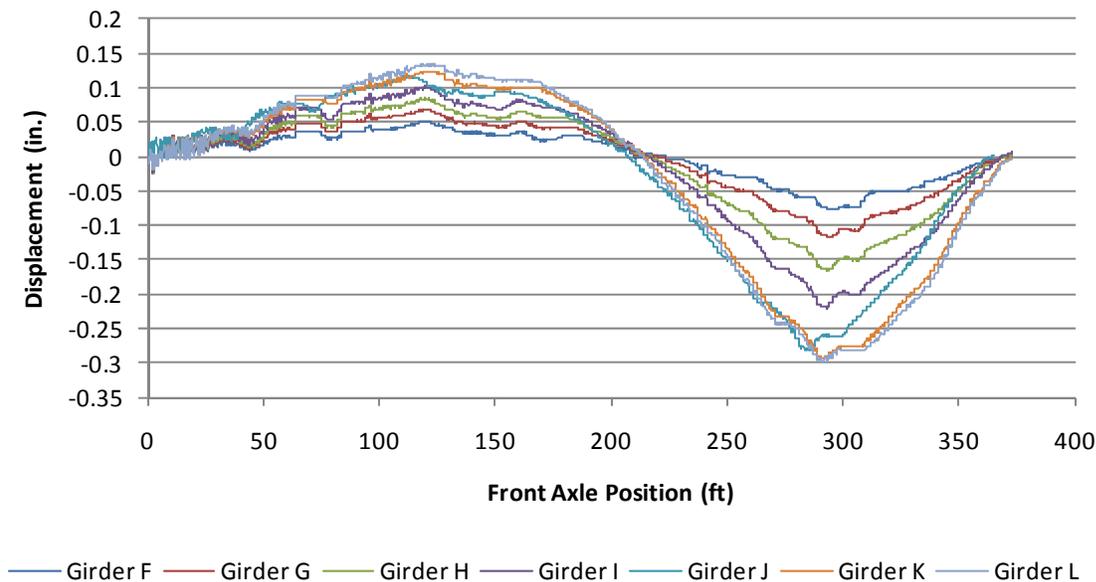
**Figure 4.19. Representative time history deflections for Load Case 2**

Deflection transducers were installed on the bottom flange of the seven east girders. Representative time-history deflections for load case 2 at the north span mid-span with respect to front axle position are shown in Figure 4.19. The load truck was located in the center of the east driving lane for load case 2. In general all load cases produced the same deflection shape for the bridge with positive deflection when the truck was on the south span and negative deflection when the truck was on the north span. For all the load cases a deflection range of -0.32 in. to +0.21 in. was seen when the truck was on the south span and a range of -0.41 in. to +0.23 in. when the truck was on the north span for the seven girders. The maximum north span deflection of -0.41 in. corresponds to a span to deflection ratio of  $L/5120$ .
