1. Report No. IHRB Project TR-577	2. Government Accession No.	3. Recipient's Catalog No.	
4. Title and Subtitle Evaluation of Rumble Stripes on Low-Volume Rural Roads in Iowa—Phase I		5. Report Date July 2009

EVALUATION OF RUMBLE STRIPES ON LOW-VOLUME RURAL ROADS IN IOWA—PHASE I

**Final Report
July 2009**

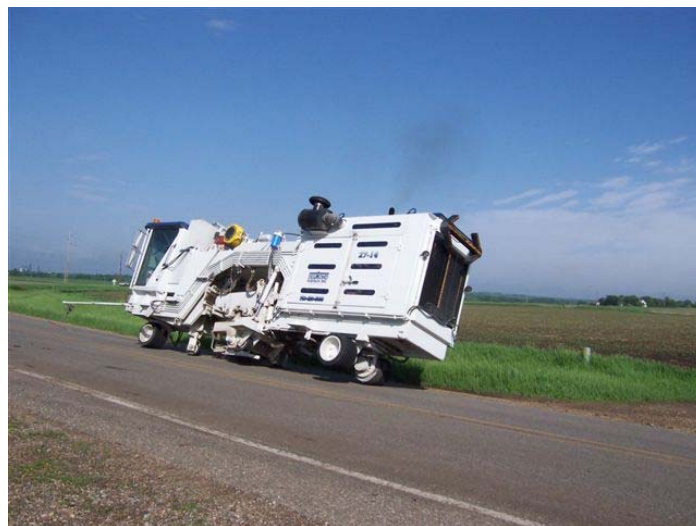
Figure 3-11. Machine tipping on inside curve

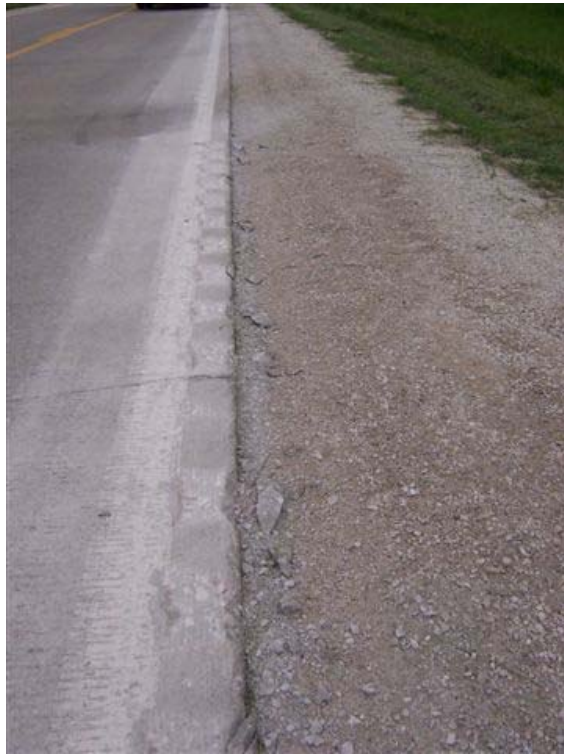
Milling in the rumble strips also resulted in some breakup of the pavement surface, as shown in Figure 3-12. In one county, milling was suspended around mailboxes to avoid damage, as shown in Figure 3-13.

Figure 3-12. Edge spalling along edge of PPC pavement

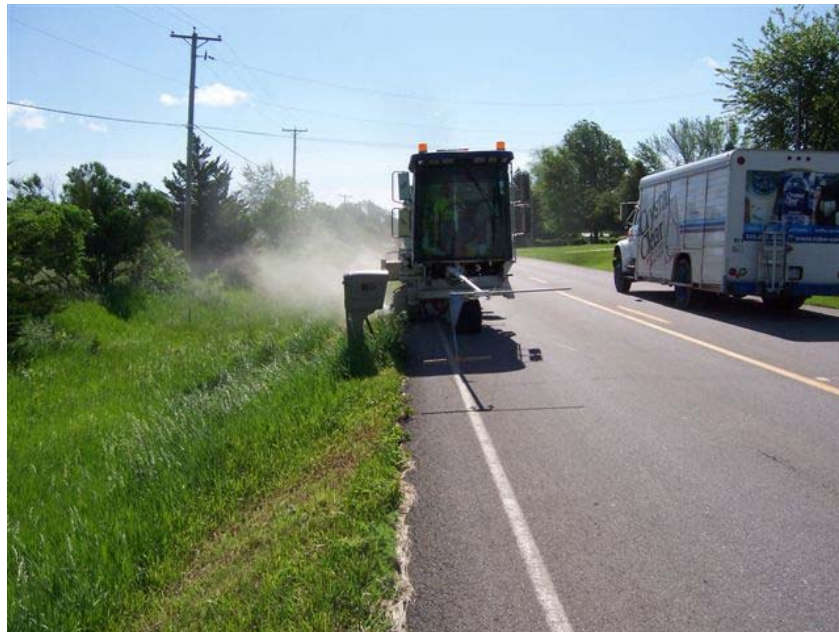
Figure 3-13. Milling operation omitting short areas around mailboxes in Polk County

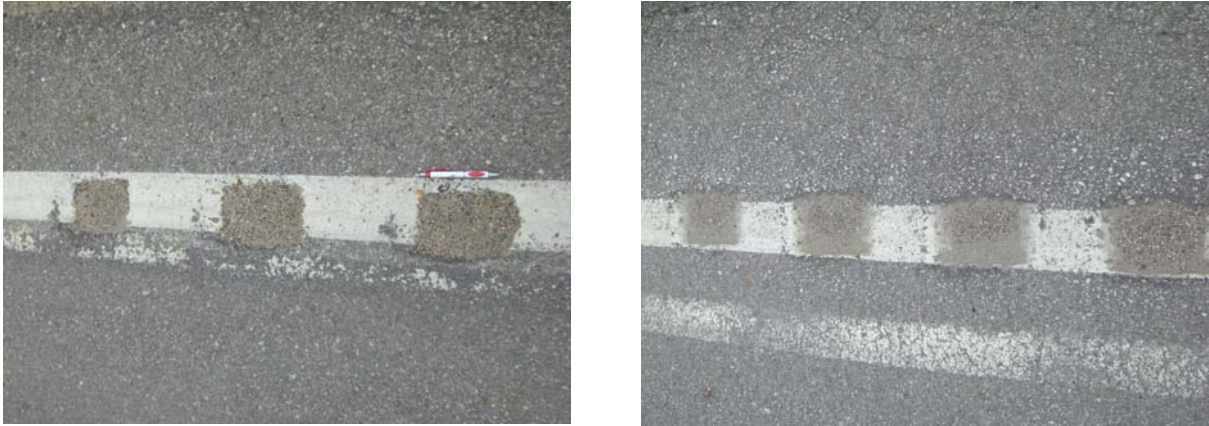
Although the appearance of the stripes seemed the same for the initial and most of the fall collections, county maintenance crews had pulled up the gravel shoulders on the Poweshiek project, filling the stripes with loose granular material. This rendered them ineffective until the paint contractor blew out the material with compressed air. Also, the spring collection period revealed that the many of the stripes had been filled or partially filled with loose gravel material,

even on the Polk County roads with paved shoulders. See Figure 5-2. This may be attributed to winter maintenance using sand (sometimes mixed with salt) on slick roads. The amount of filling seemed to be much heavier on the asphalt pavements than on the PCC pavements.

Figure 5-2. Rumble stripes filled with sand

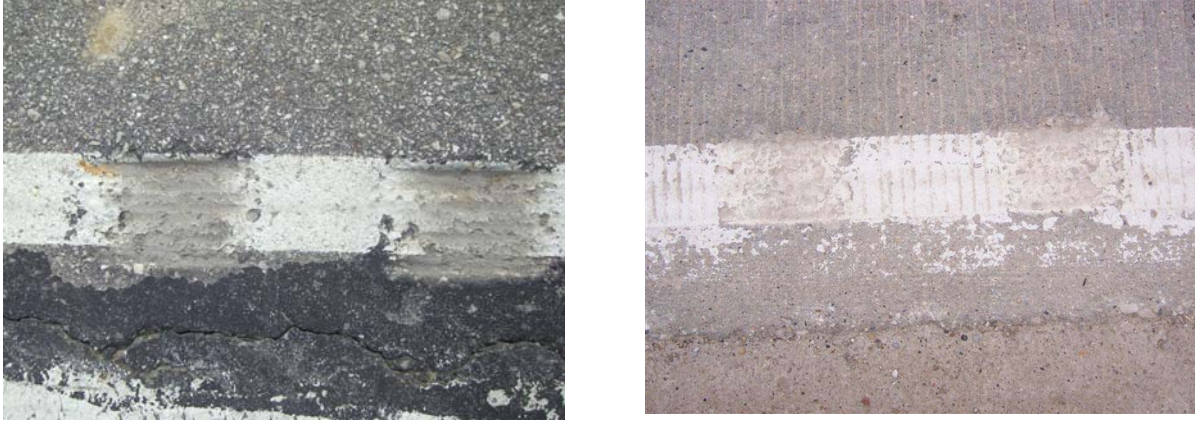
Stripes that were caked and only partially filled showed better retroreflectivity readings than those that were completely filled. Although the authors did not wish to introduce a possible maintenance activity for using these stripes, they did consider that the performance might be better if the loose (or caked) material was broomed from the stripe. See Figure 5-4. Therefore, they did broom (by hand) several stripes of each type and shot them for performance. In all cases, the retroreflectivity of the swept stripes measured lower than the untouched ones. The authors believe that this may have occurred due to dust created by the brooming covering most of the reflective beads and/or due to the brooming action itself removing much of the beading from the paint surface. Using a stiff or soft bristle hand broom seemed to make no difference.

Figure 5-4. Swept stripe areas on asphalt and PCC pavements

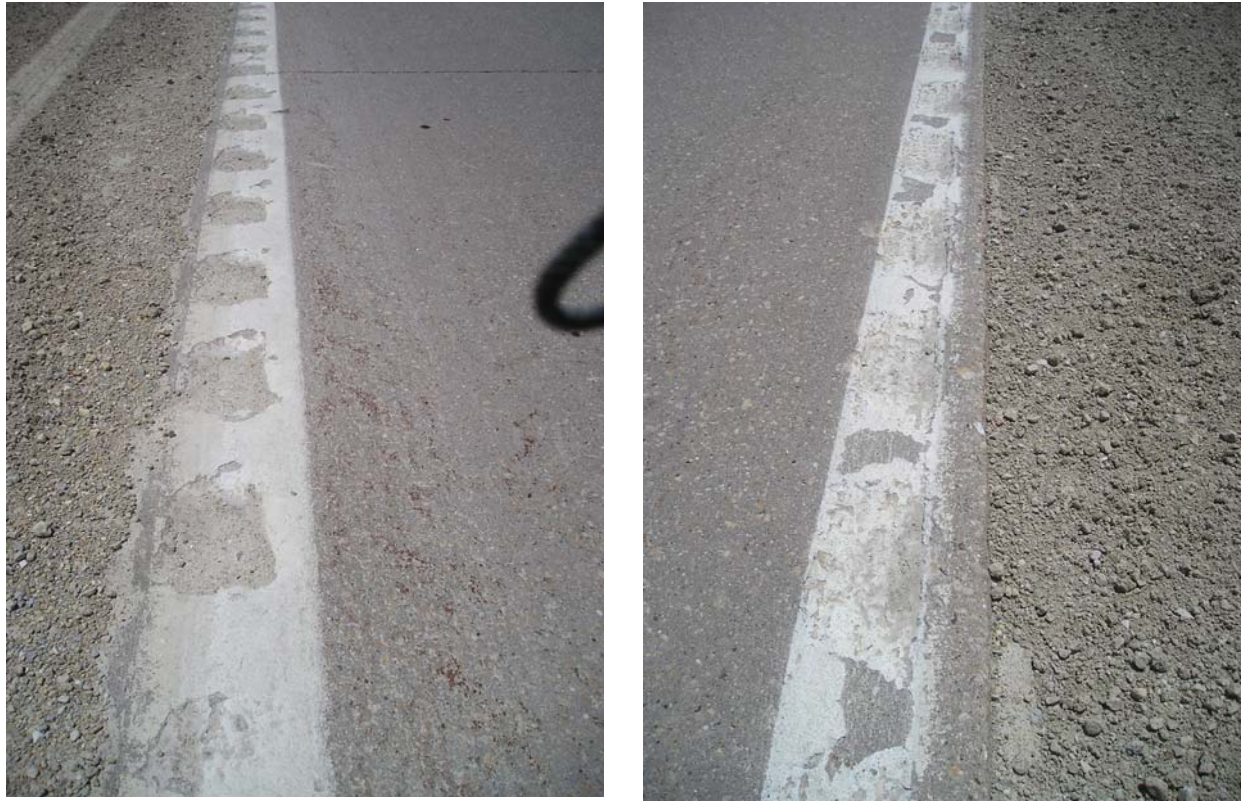
Wear on pavement markings was also compared by visual inspection. Figure 5-13 shows a section of the rumble stripes in Buchanan County taken in May 2009. Notice how, in general, the markings have worn considerably, but the area within the groove appears to have experienced even greater wearing. The pavement in this section is PCC.

Figure 5-13. W-13 pavement markings in spring and after wear over winter, showing more wear in the groove than in the flat section

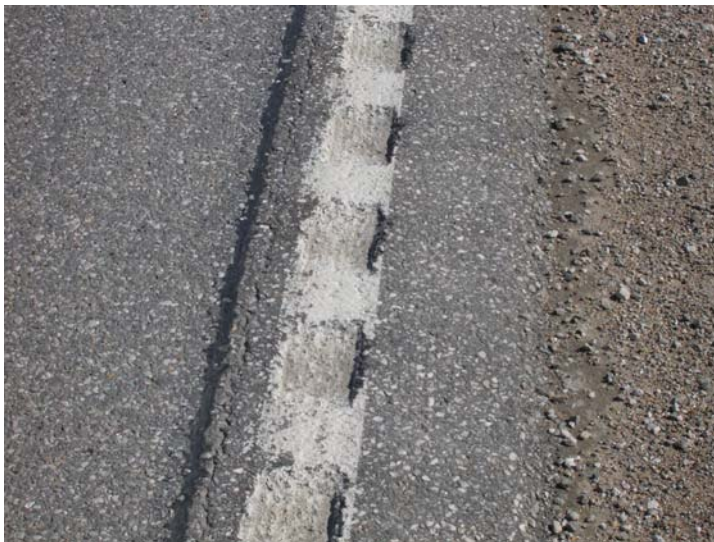
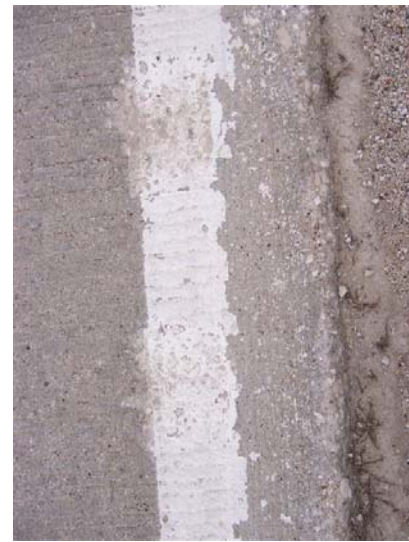
In other areas, the paint seemed to be holding up well in both the rumble stripes and flat sections. Figure 5-15 shows a portion of F-29 taken in spring 2009. Figure 5-16 shows a portion of E-18 taken in spring 2009.

Figure 5-15. Similar wear for rumble stripe and flat section (taken spring 2009). F-29 is on the left and P-53 is on the right.

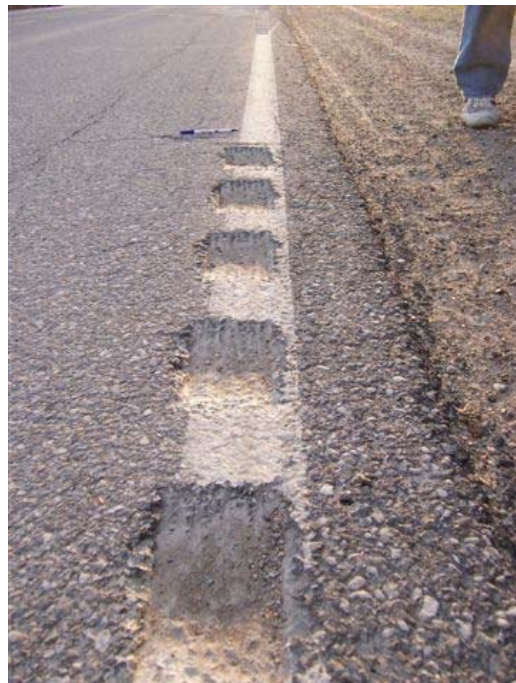
In other areas, the paint in the rumble stripe appeared to weather better and show less wear than the pavement markings on the flat portion of the roadway. Figure 5-17 shows a portion of F-29 that shows less wear in the groove than in the flat areas. Figure 5-18 shows a similar scenario for P-53.

Figure 5-17. Another portion of F-29 showing less wear in the rumble stripe than in the flat area (taken spring 2009)
