Minnesota Route 4—HMA Overlay—June 2008

RESEARCH PROJECT TITLE

Accelerated Implementation of Intelligent Compaction Technology for Embankment Subgrade Soils, Aggregate Base, and Asphalt Pavement Materials (FHWA DTFH61-07-C-R0032)

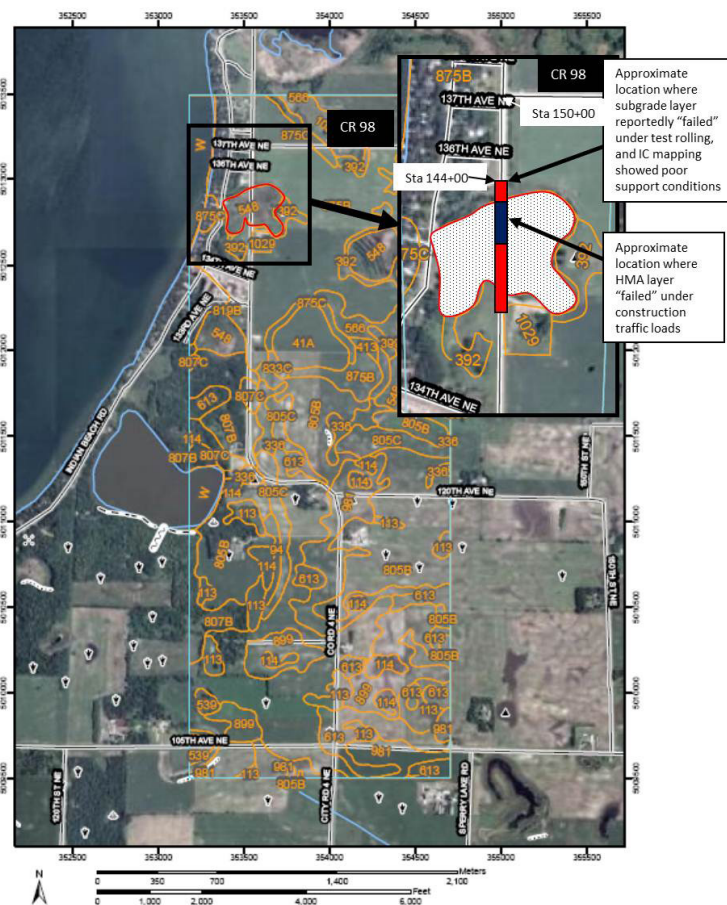
The approximate location of the area that “failed” under test rolling is highlighted on the soil survey map presented in Figure 2. The natural soils in this area consist of Palms muck soil series with sandy substratum which contained muck to a depth of about 0.7 m (27 in.) underlain by clay loam and sandy soils to a depth of about 1.5 m (60 in.), below natural grade. A review of project drawings indicates that approximately 1 m to 2 m (3 ft to 6 ft) of new subgrade fill was placed over the previous grade in this region.

Figure 2. Aerial image with soil survey information of the project area (modified from NRCS 2008)

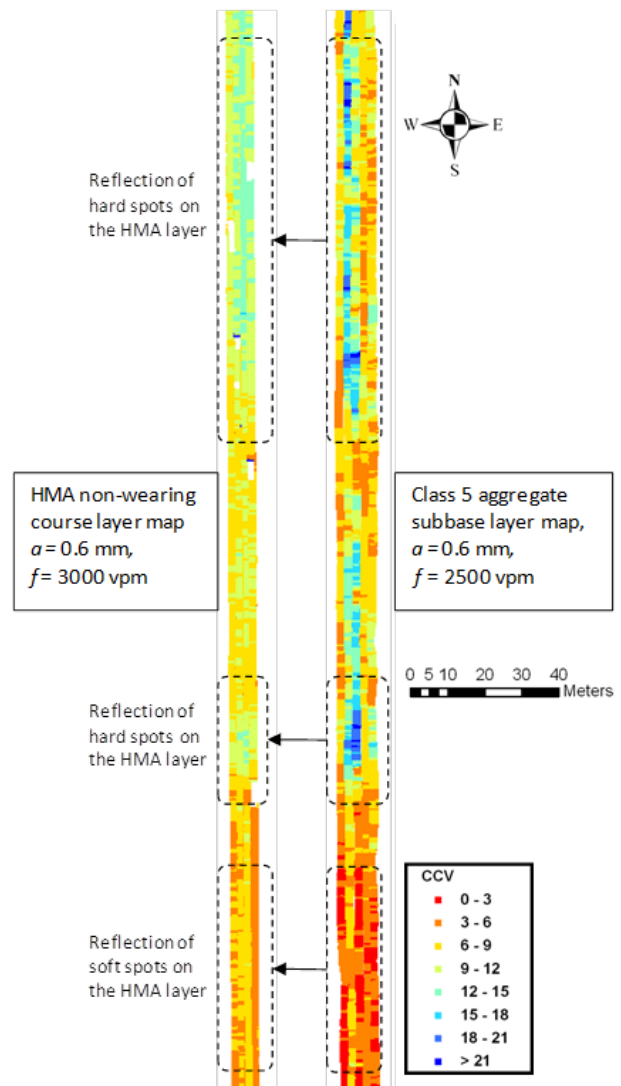
Figure 3 shows CCV maps of the HMA non-wearing course layer and the underlying subbase layer for a 210 m (700 ft) long section with heterogeneous subbase. Figure 3 also shows locations of high CCV and low CCV areas on the subbase layer reflecting on CCV measurements on the HMA layer. Regression relationships in Figure 4 indicate a statistically strong relationship between CCV measurements obtained on the HMA non-wearing course layer and subbase layer at $a = 0.6$ mm setting with R^2 -value of about 0.7. CCV measurements obtained on the subbase layer at $a = 0.3$ mm showed relatively poor correlation to CCV measurements on the HMA layer.

Figure 3. Comparison of HMA non-wearing course layer and subbase layer map showing the influence of underlying layer heterogeneity (from White and Vennapusa 2008)

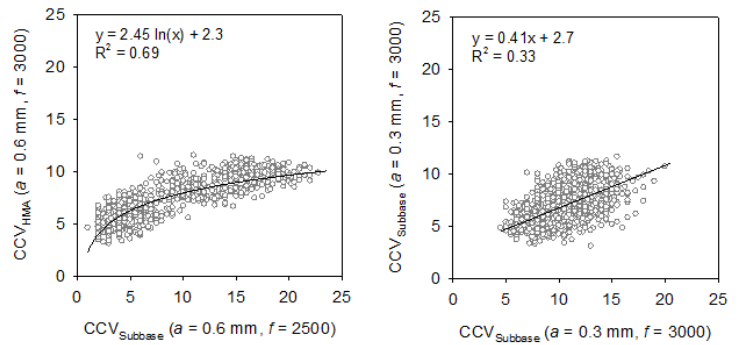
Figure 4. Simple regression relationships between CCV measurements on subbase and HMA non-wearing course layer (from White and Vennapusa 2008)

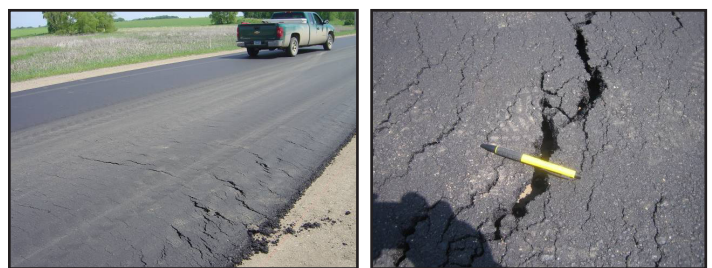
Following compaction operations on the HMA non-wearing course layer on the SB lane, premature “failure” cracks were observed over a 200-ft long section on the HMA layer under construction traffic (Figure 5). To further evaluate the condition, the CCV measurements on the HMA wearing course layer and the subbase layer in this area were compared as shown in Figure 6. The data in Figure 6 show average CCV = 2.5 for the subbase layer, which is considerably lower than the project average CCV = 7.5. Average CCV on the HMA wearing course in the same area was about 5.2, which was also lower than the project average of about 6.9. This area is located within the area where the subgrade layer reportedly “failed” under test rolling in summer 2007. Again, the underlying natural soils in this section were identified in the soil survey as consisting of peat/muck soil deposits (see Figure 2).

- Following compaction and mapping of the HMA non-wearing course layer on the SB lane, premature “failure” cracks were observed over a 200-ft long section on the HMA layer. This area was located within the area where the subgrade layer reportedly “failed” under test rolling in summer 2007 and is an area underlain by peat/muck soils.

Figure 5. Premature failure observed in the HMA non-wearing course layer between Sta. 140+12 and Sta. 142+61 (from White and Vennapusa 2008)

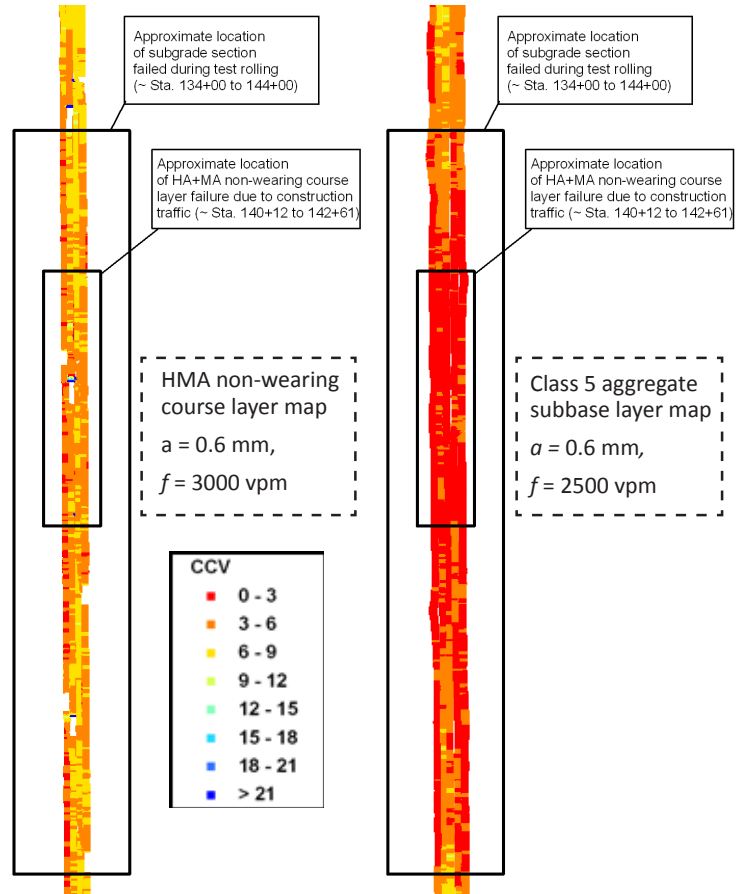
Figure 6. Comparison of HMA non-wearing course layer and subbase layer maps (from White and Vennapusa 2008)
