Instrumentation and Monitoring of Precast Bridge Approach Tied to an Integral Abutment Bridge in Bremer County

**Final Report
April 2010**

Sponsored by
Federal Highway Administration
Iowa Department of Transportation
(InTrans Project 08-335)

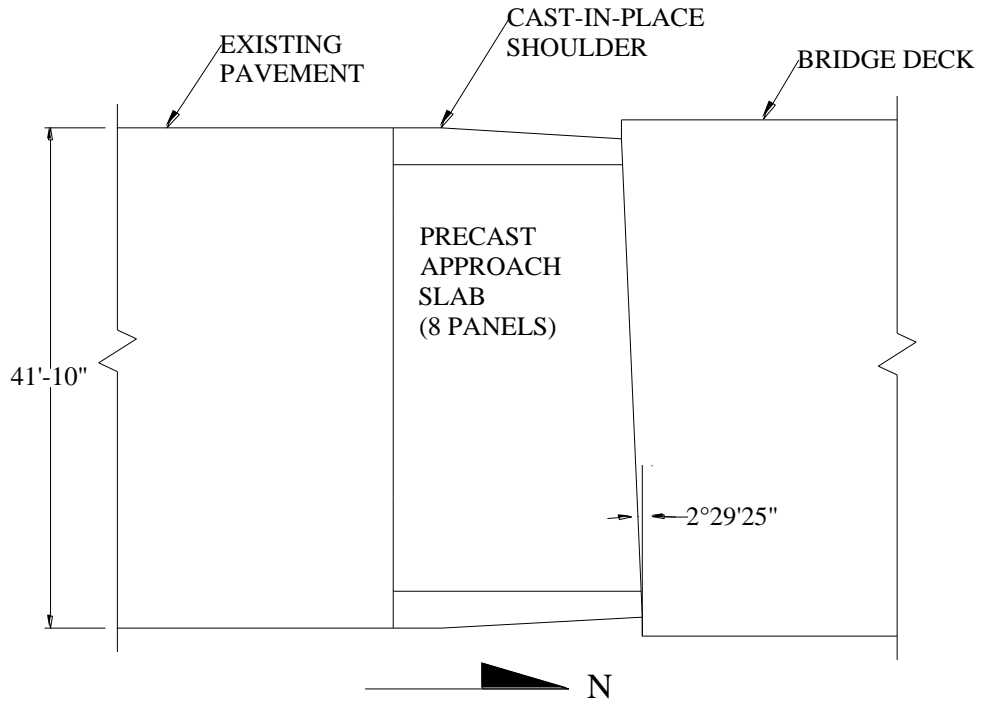
Figure 3.1. Plan view of precast approach slab with bridge and existing pavement (see Figure 3.2 for slab panel dimensions)

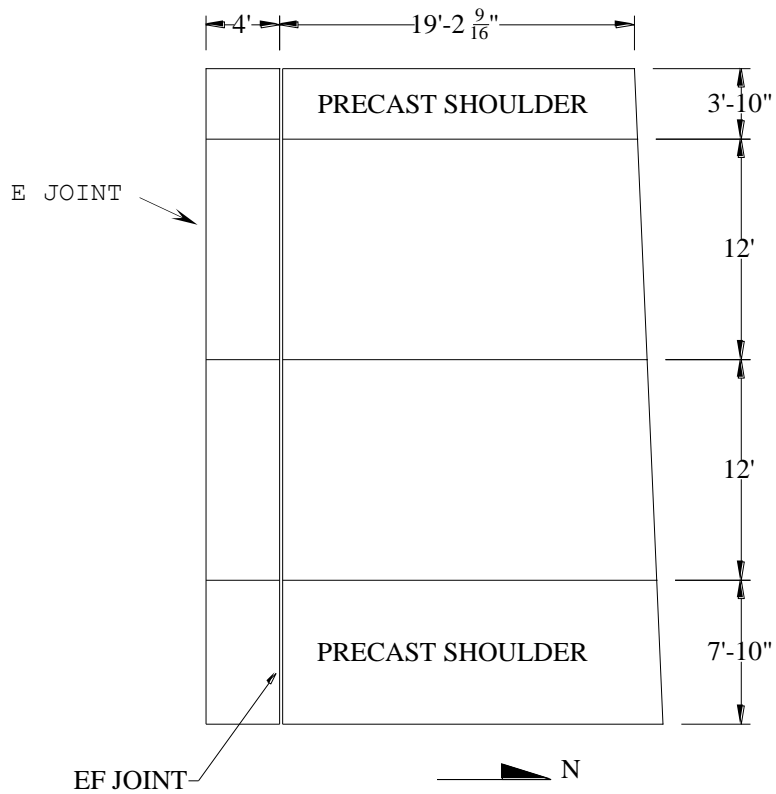
Figure 3.2. Plan view of precast approach slab

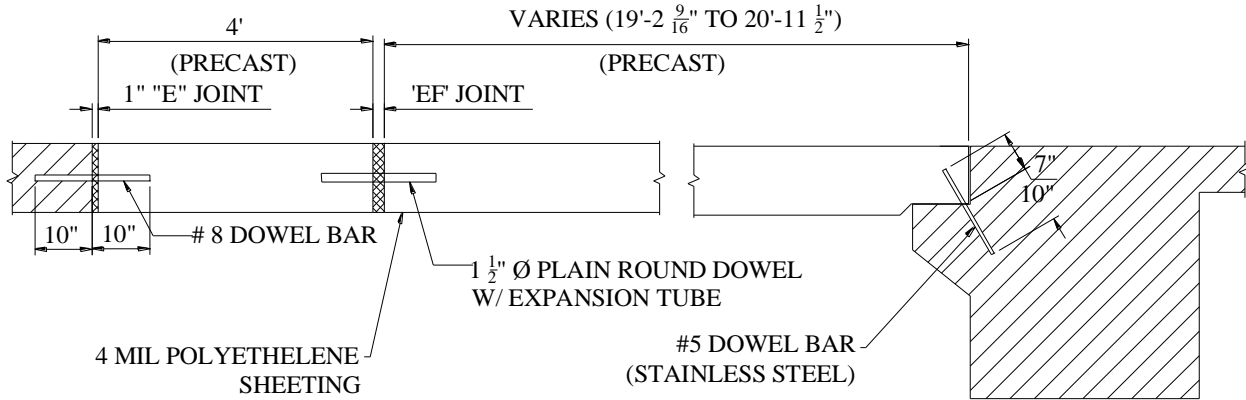
Figure 3.3. Elevation view of precast approach slab

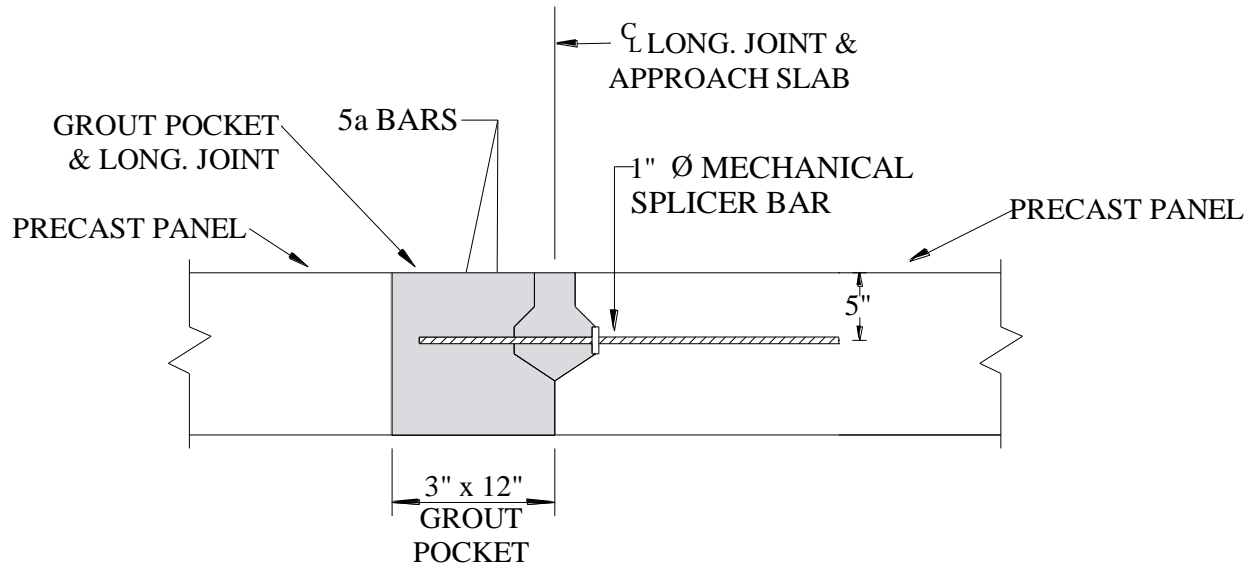
Figure 3.4. Longitudinal joint at centerline of approach slab at location of mechanical splicer bar (Bierwagen 2009)

An open joint and a keyway joint were used to connect the longitudinal joints at the centerline and shoulders, respectively (Bierwagen 2009). The centerline joint included threaded mechanical bars with 3 in. x 12 in. full depth grouted pockets spaced at 12 in. (see Figure 3.4). A 5/8 in. stainless steel dowel, drilled and grouted into the existing abutment paving notch, was used to connect the approach slab to the abutment. For more construction details, refer to Bierwagen (2009).

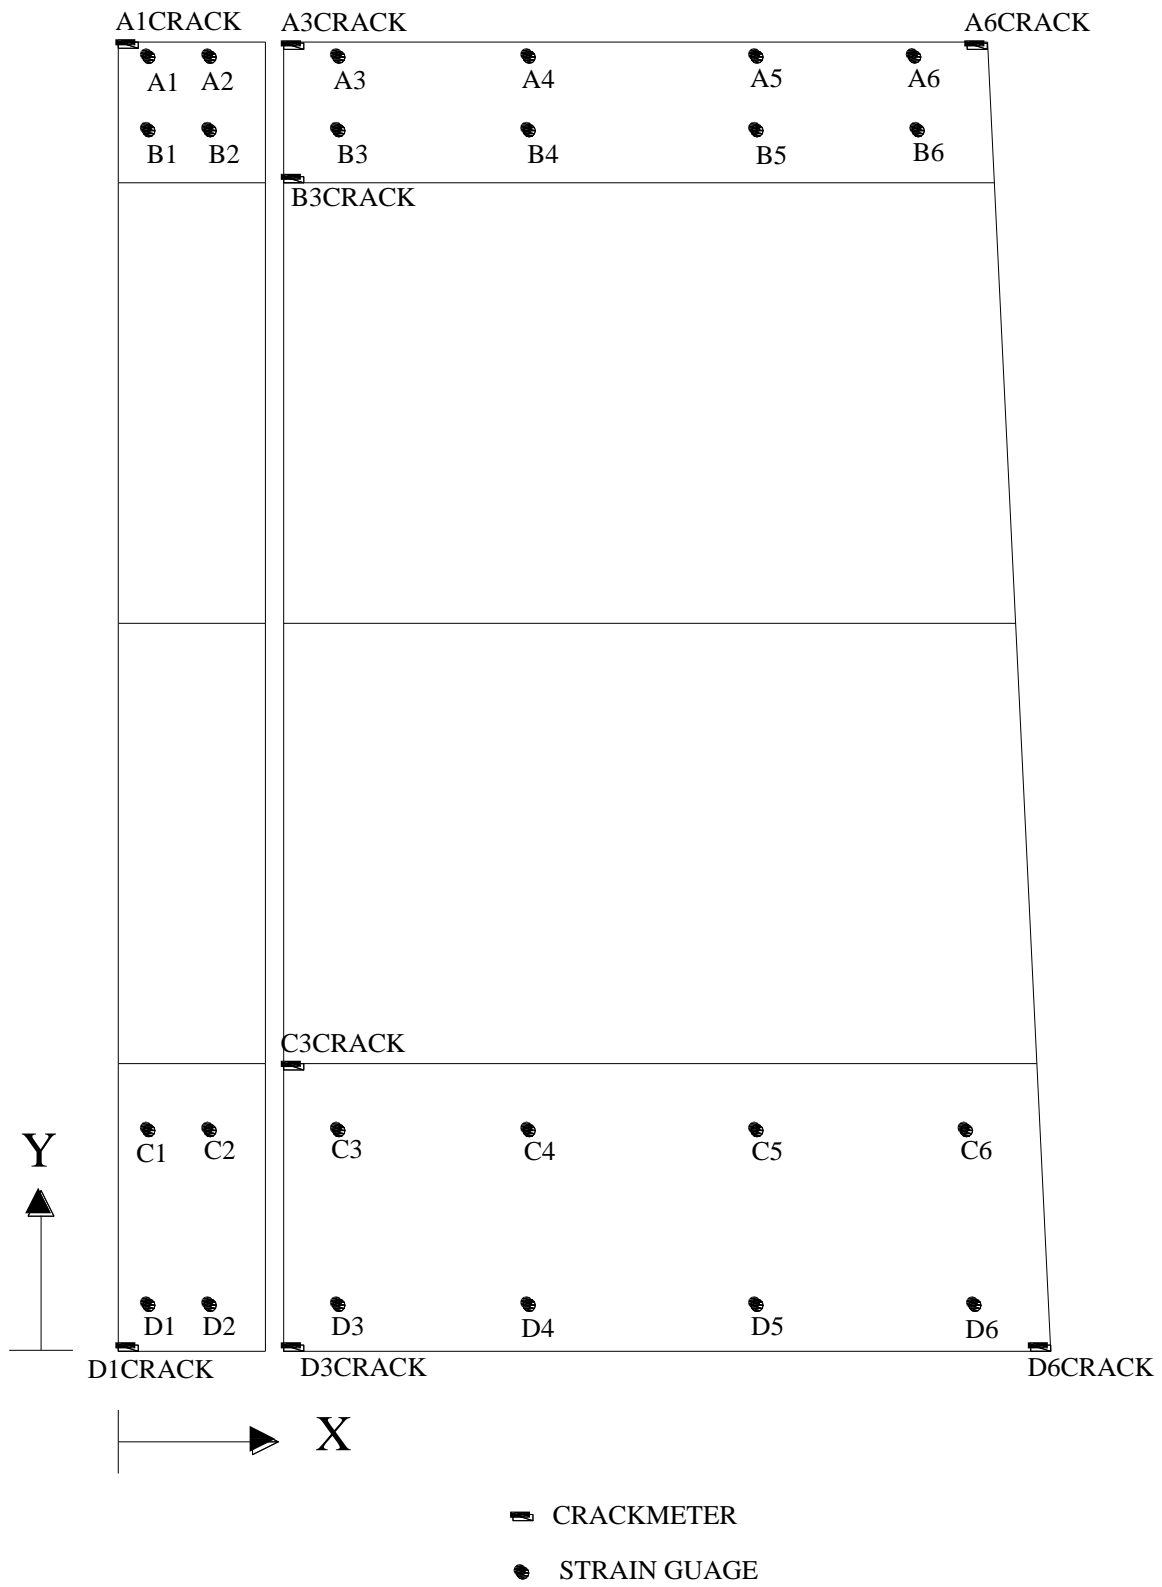
Figure 3.5. Instrumentation layout

A total of 32 sensors were installed on the approach slab (24 strain gauges and 8 crackmeters). The strain gauges were intended to measure the strain in the approach slab and the crackmeters were intended to measure the relative movement at the approach slab joints. The instrumentation layout can be seen in Figure 3.5.

The approach slab was instrumented with 24 vibrating wire strain gauges as described Section 3.3 and shown in Figure 3.5. The temperature information obtained from the thermistor was used to correct the strain gauge readout and to determine the load strain (strain caused by an applied load or a restraining force) using Equation 4.3.

The approach slab joints were equipped with eight crackmeters (see Figure 3.5), two at the abutment joint, four at the expansion joints and two at the pavement joint, to monitor joint opening and closing over time. The opening at the crackmeters is related to the change in readings by Equation 4.8.

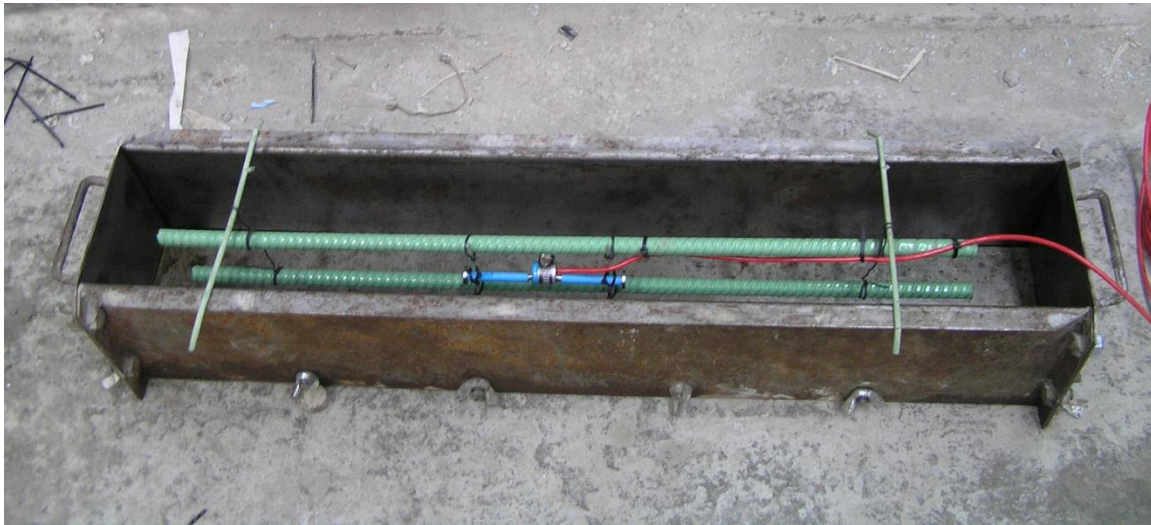
Figure 3.6. Installed embedded strain gauge in the temperature compensation beam form

A temperature compensation concrete beam was instrumented in the same manner as the approach slab in order to determine the coefficient of thermal expansion of the concrete. The beam measured 6 in. x 6 in. x 36 in. and was unconfined. The beam was placed under the bridge beside the south abutment. Figure 3.6 is a photograph of the installed strain gauge in the beam form prior to concrete placement.

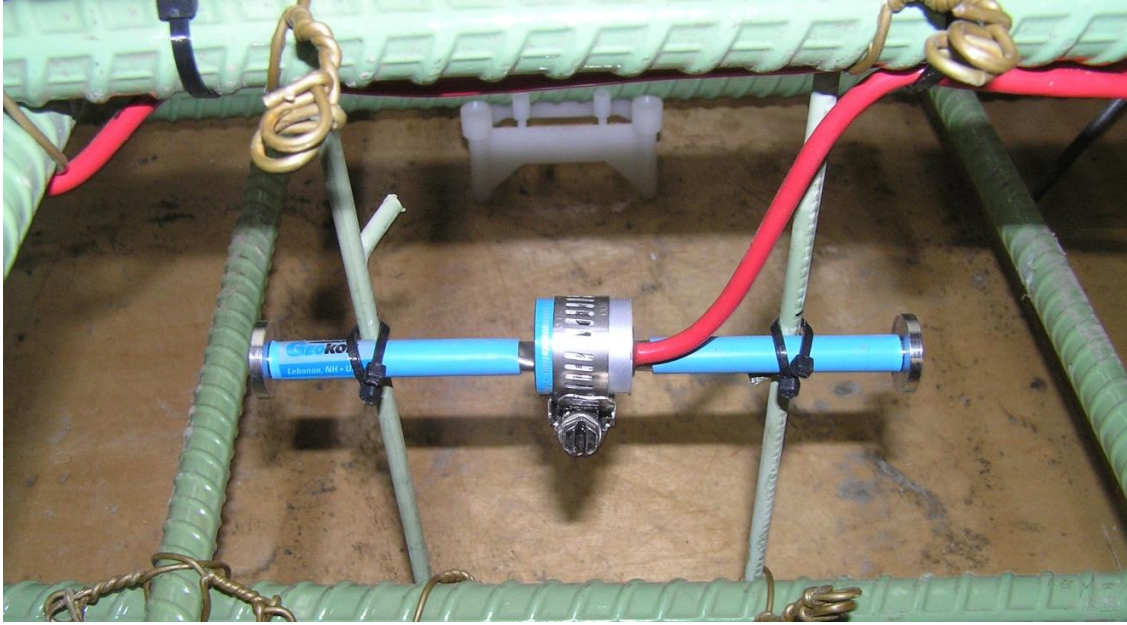
Figure 3.7. Installed embedded strain gauge in the approach slab form

Geokon VCE-4200 Vibrating Wire Strain Gauges were embedded in the approach slab. Twelve strain gauges were placed in each of the precast shoulders of the approach slab (see Figure 3.5). Gauges A1 to A6 and B1 to B6 were cast in the west precast shoulder. Gauges C1 to C6 and D1 to D6 were cast in the east precast shoulder. In all cases the strain sensors were placed at mid-depth. The sensors were installed between two longitudinal reinforcing bars with wire tying them together. Figure 3.7 is a photograph of a typical installed embedded strain gauge prior to concrete placement.

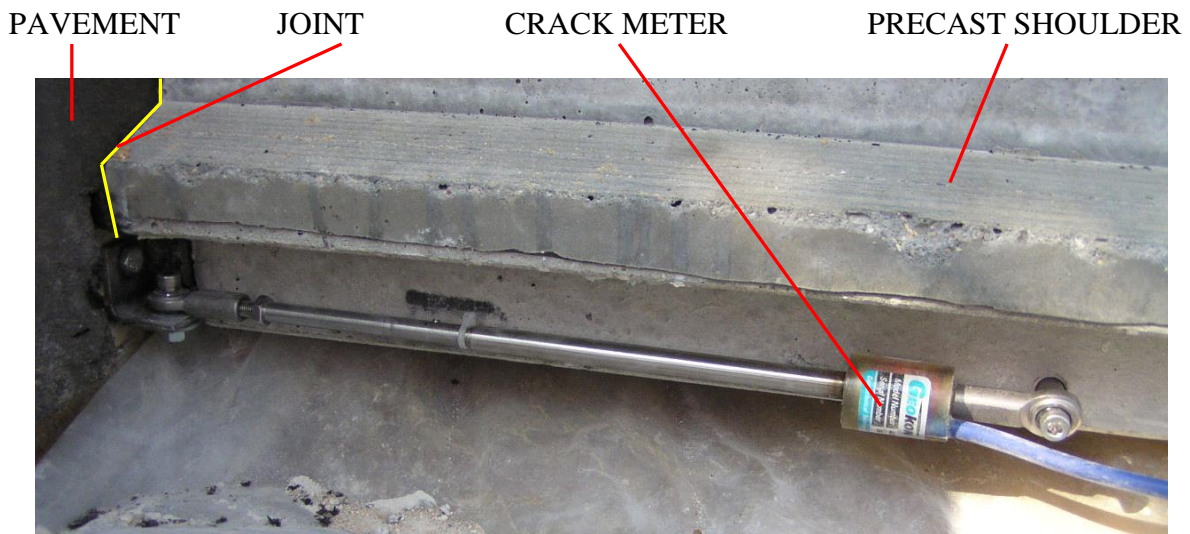
Figure 3.8. Installed crackmeter (D1CRACK)

The approach slab was instrumented with eight Geokon Model 4420 Vibrating Wire Crackmeters. Two of the crackmeters were placed across the bridge to approach slab joint (A6CRACK and D6CRACK), two were placed across the approach slab to existing pavement joint (A1CRACK and D1CRACK), and four were placed across the EF joint (A3CRACK, B3CRACK, C3CRACK, D3CRACK). Special block-outs were cast into the approach slabs at each joint to accommodate the sensors. Figure 3.8 is a photograph of a typical crackmeter, D1CRACK. The relative movement at the crackmeter location is recorded as the joint opens and closes.

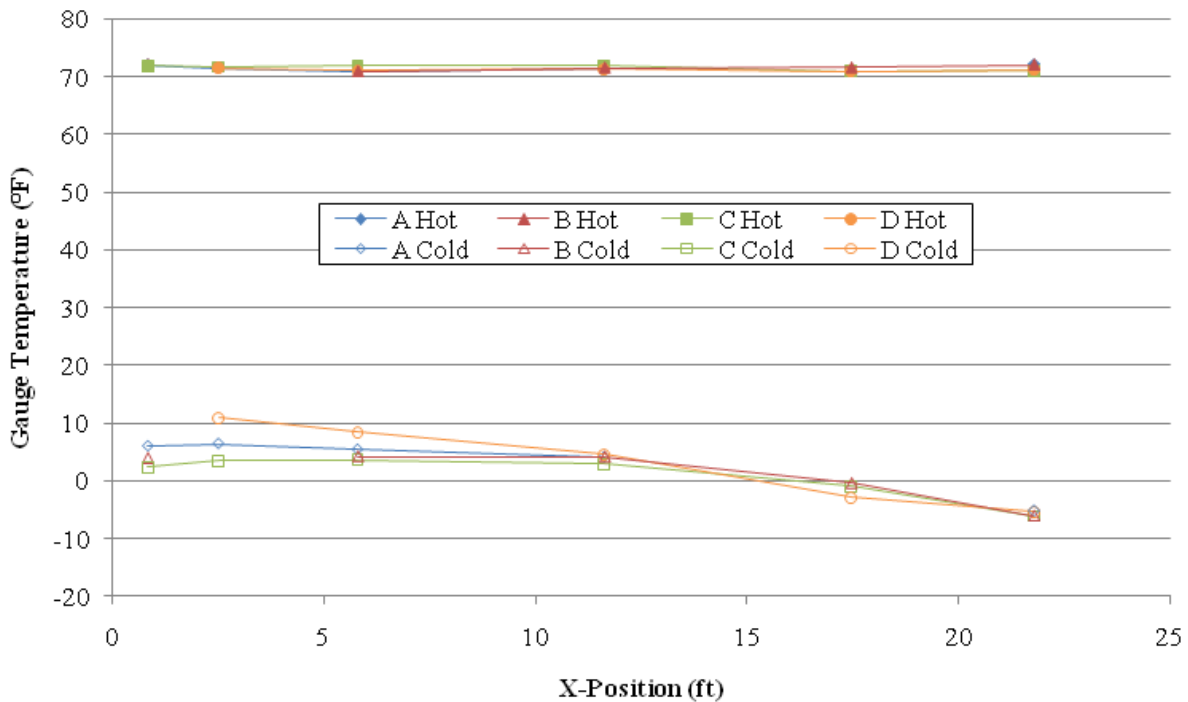
Figure 4.1. Temperature variation in approach slab (see Figure 3.5 for X-location)

A typical plot of temperature with respect to position of the gauges along the precast approach slab is shown in Figure 4.1. The hot temperature data occurred on July 21, 2009 at 12:00 p.m. (noon) and the cold temperature data occurred on January 5, 2010 at 12:00 p.m. (noon). Figure 4.1 shows that the temperatures across and along the slab were relatively uniform, varying somewhat more on cold days than hot days.

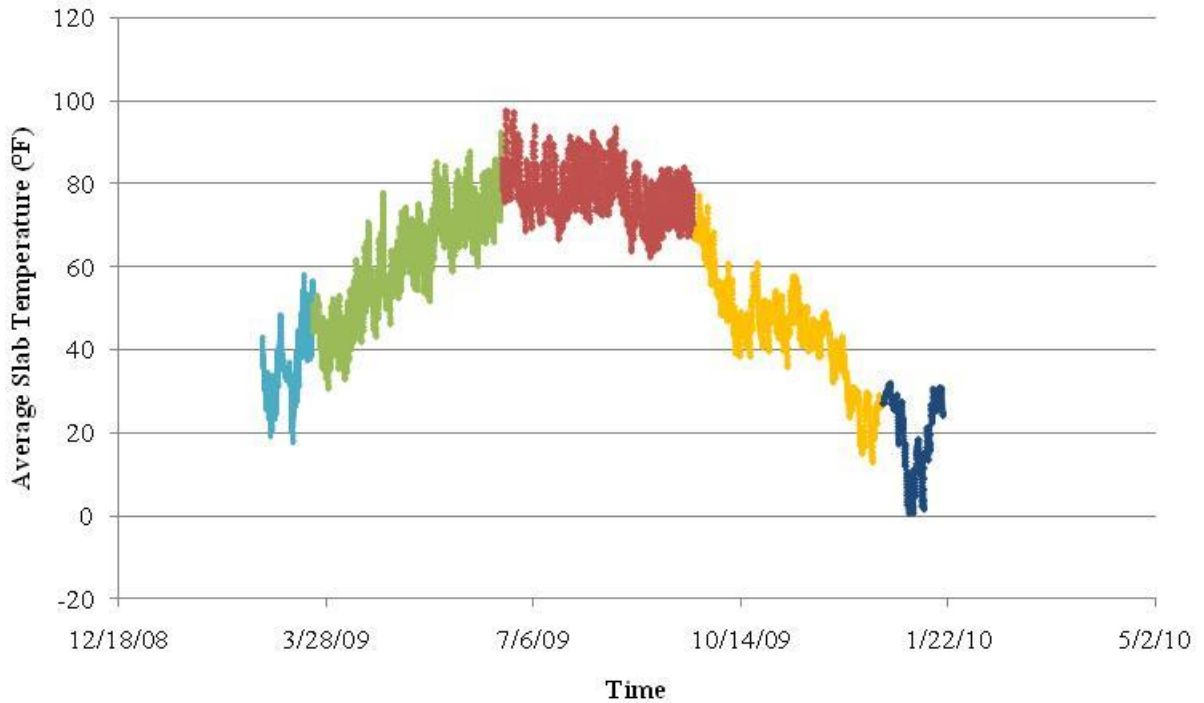
Figure 4.2. Average approach slab temperature over time

The temperature data from all 24 gauges were averaged together and are shown in Figure 4.2. The average extreme low slab temperature was 0.5° F and occurred on January 3, 2010 at 10:00 a.m. The average extreme high slab temperature was 97.5° F and occurred on June 22, 2009 at 7:00 p.m.

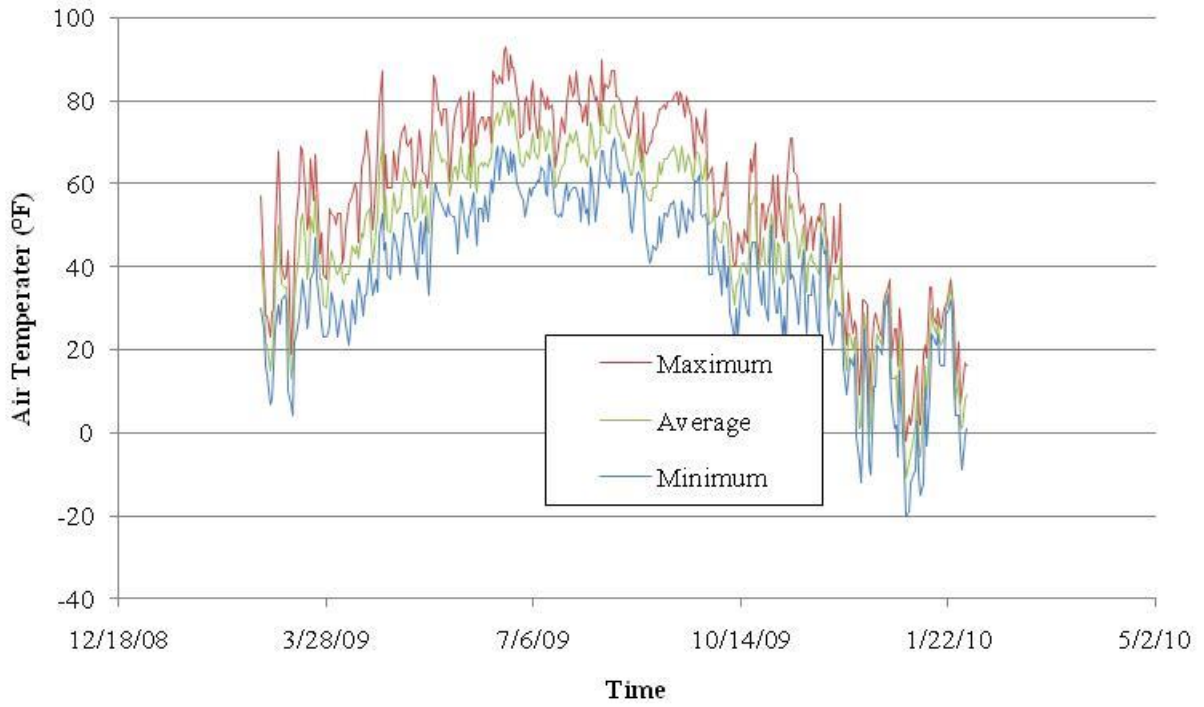
Figure 4.3. Air temperature over time

Figure 4.4 compares the average approach slab temperatures (Figure 4.2) and the daily high and low air temperatures in Waterloo, Iowa (Figure 4.3).

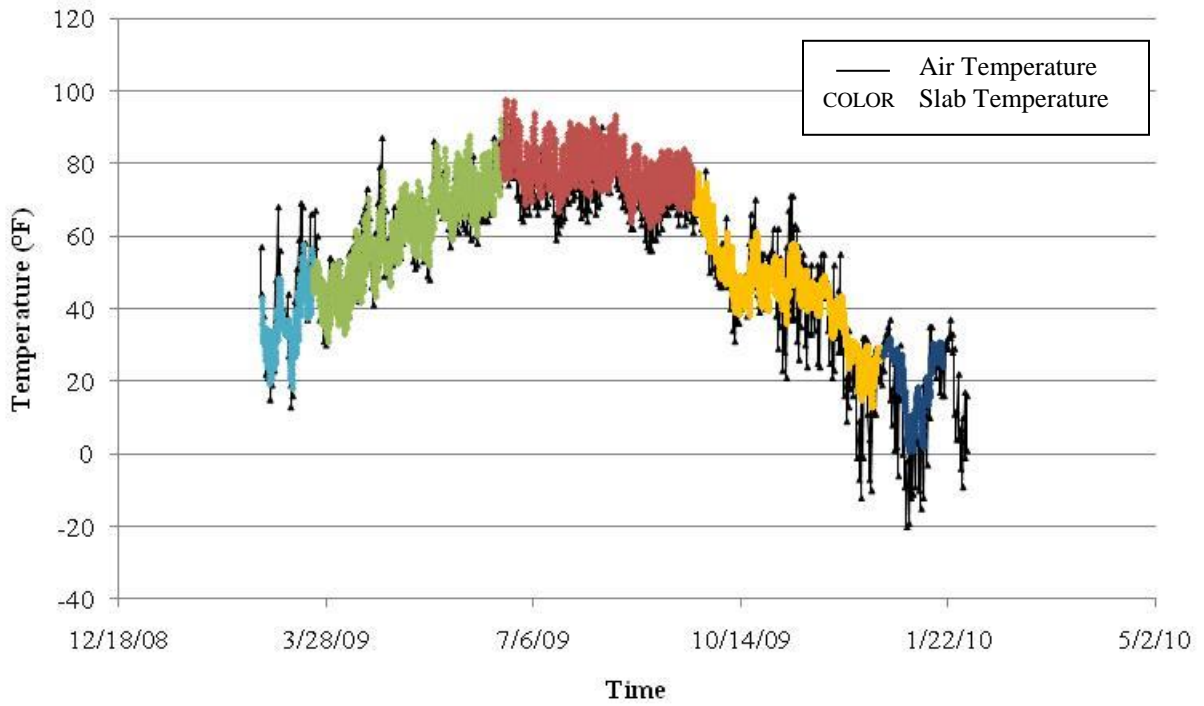
Figure 4.4. Average approach slab temperature and Waterloo, Iowa air temperature over time

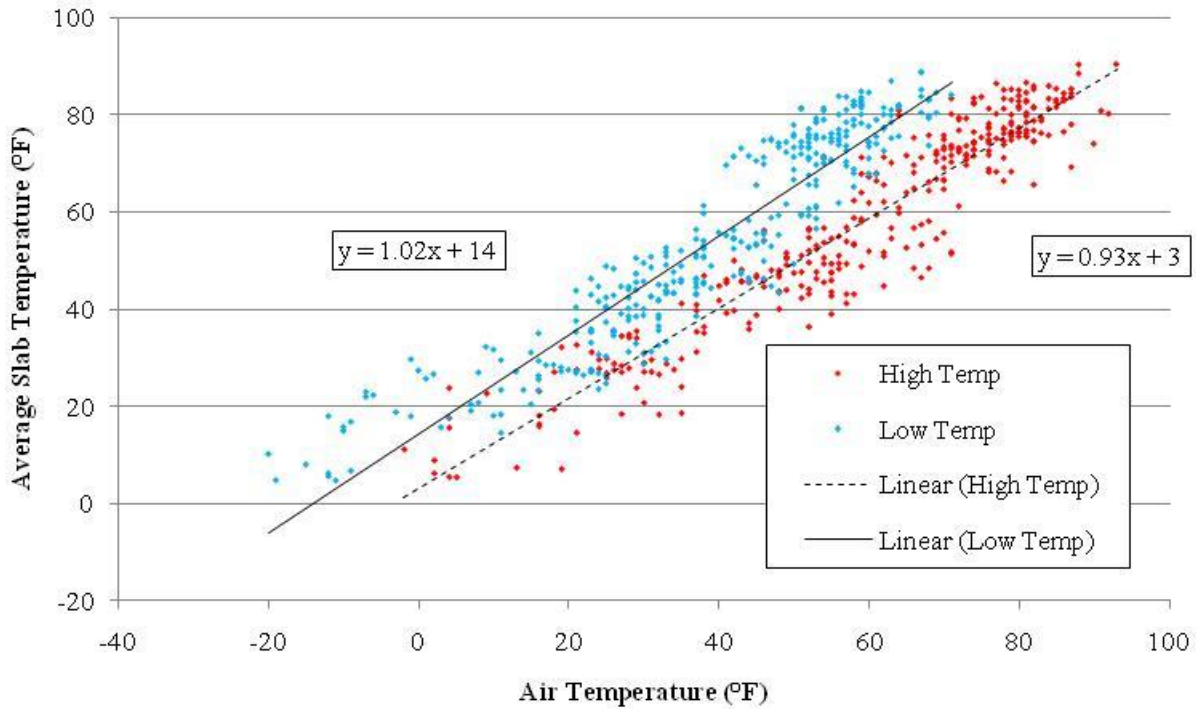
Figure 4.5. Correlation of daily high and low Waterloo, Iowa air temperatures with daily high and low average approach slab temperatures

Correlations of the daily high and low air and slab temperatures are shown in Figure 4.5 with linear regression straight line fits. As expected, the thermal mass of the approach slab moderates the air temperature, i.e., the slab highs are lower than the air highs and the slab lows are higher than the air lows.

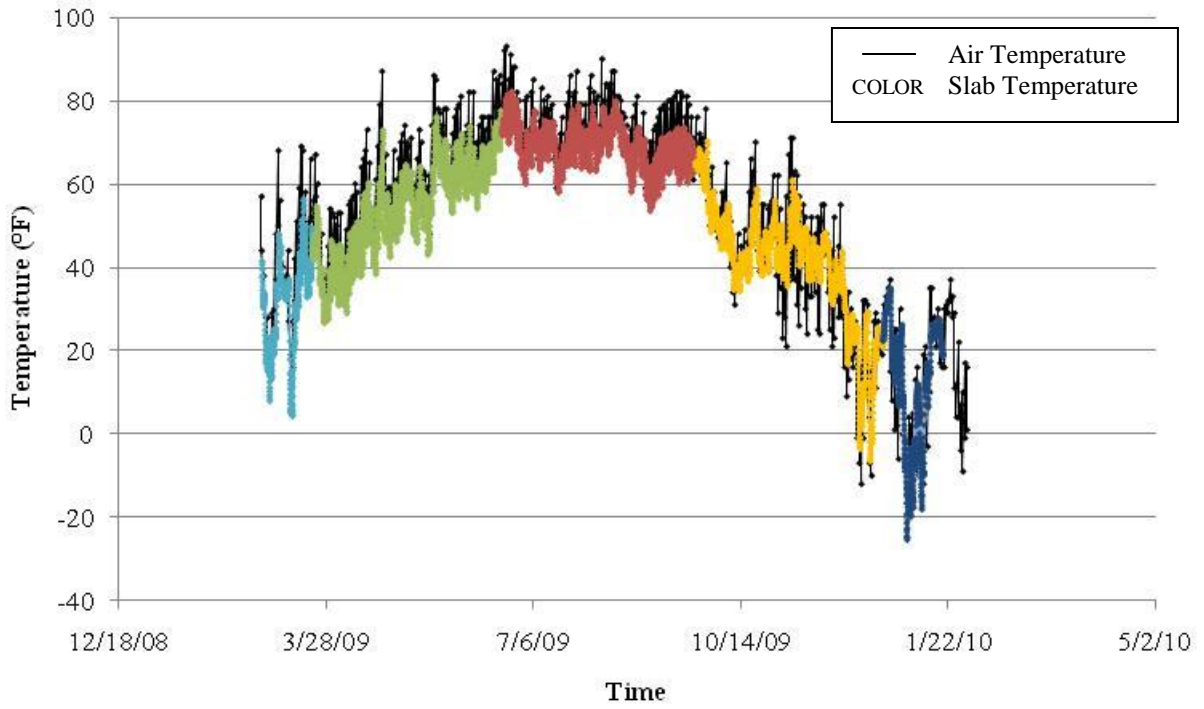
Figure 4.6. Temperature compensation beam temperatures and Waterloo, Iowa air temperatures over time

The gauge temperatures in the temperature compensation concrete beam were compared to the daily high and low air temperatures of Waterloo, Iowa, as shown in Figure 4.6. Shown in Figure 4.7 are the correlation of the temperature compensation gauge and the daily high and low air temperatures with linear regression fits.

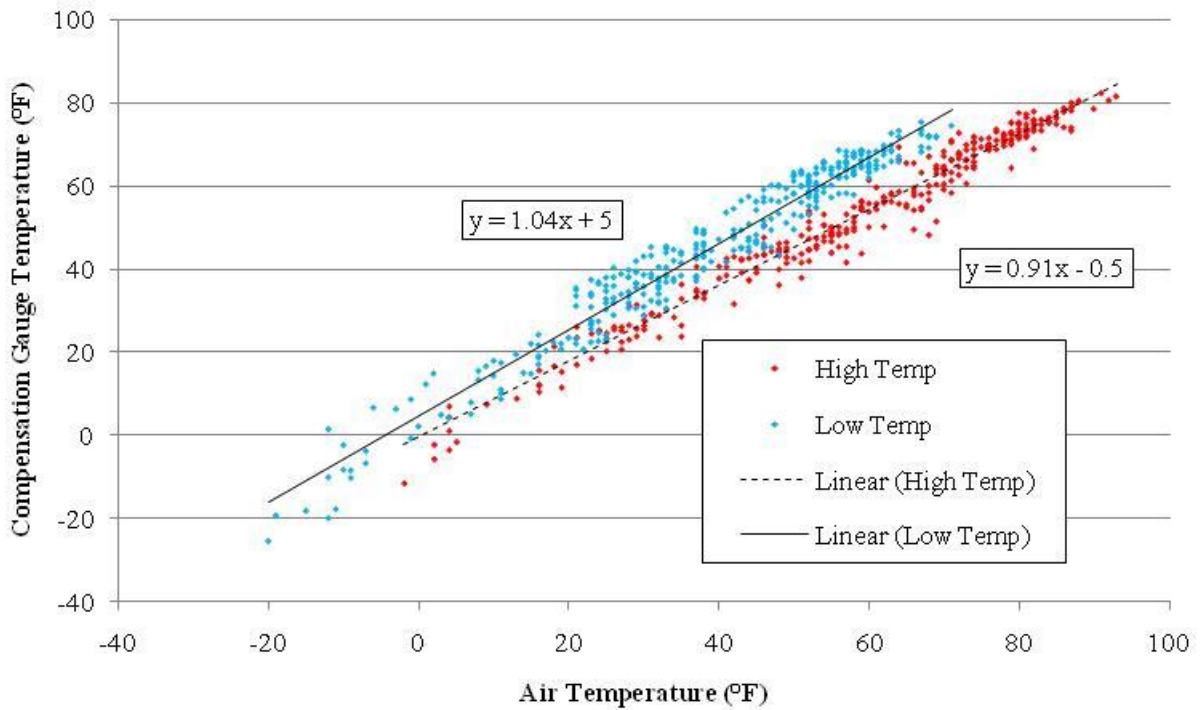
Figure 4.7. Correlation of average air temperatures and compensation beam temperatures

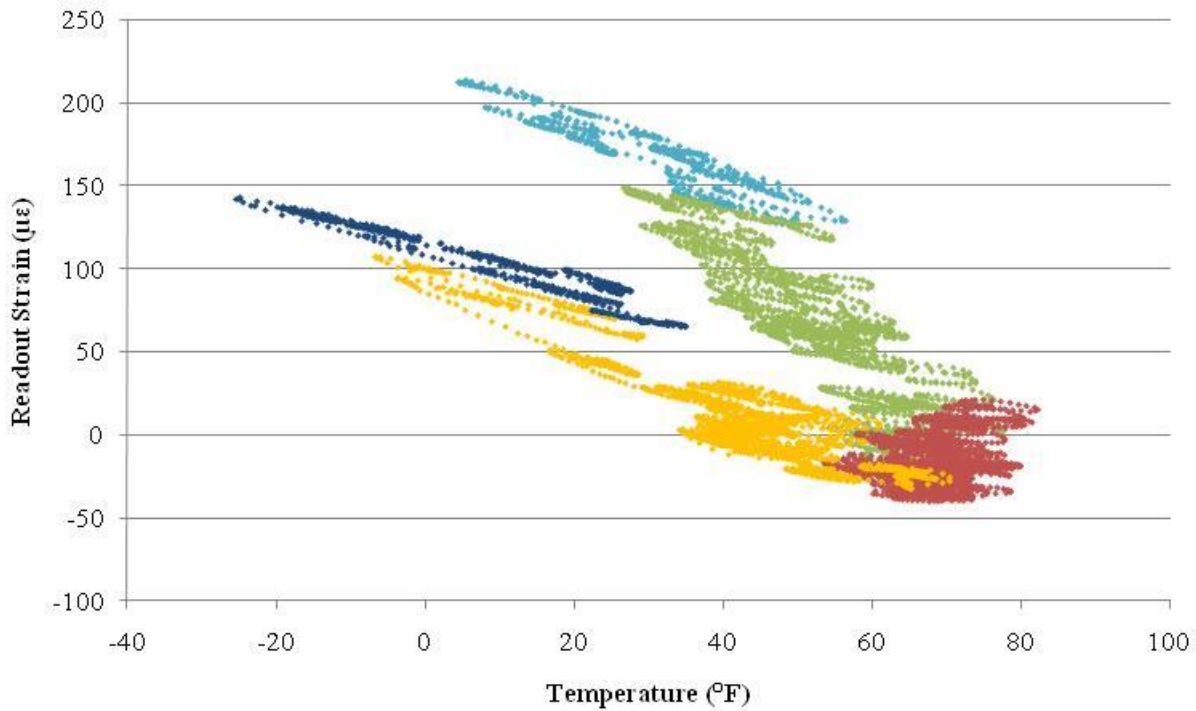
Figure 4.8. Correlation of readout strain and temperature in compensation beam

Figure 4.8 is a plot of readout strain ΔRB with temperature. The slope of the linear regression line ($\Delta RB/\Delta T$) in Figure 4.8 is $-1.7 \mu\varepsilon/^\circ F$. Using Equation 4.5, with $6.78 \mu\varepsilon/^\circ F$ as the manufacturer-furnished coefficient of thermal expansion of the gauge, the value of the coefficient of thermal expansion of the concrete is $5.1 \mu\varepsilon/^\circ F$. This coefficient of thermal expansion will be used to appropriately adjust the output strain readings.

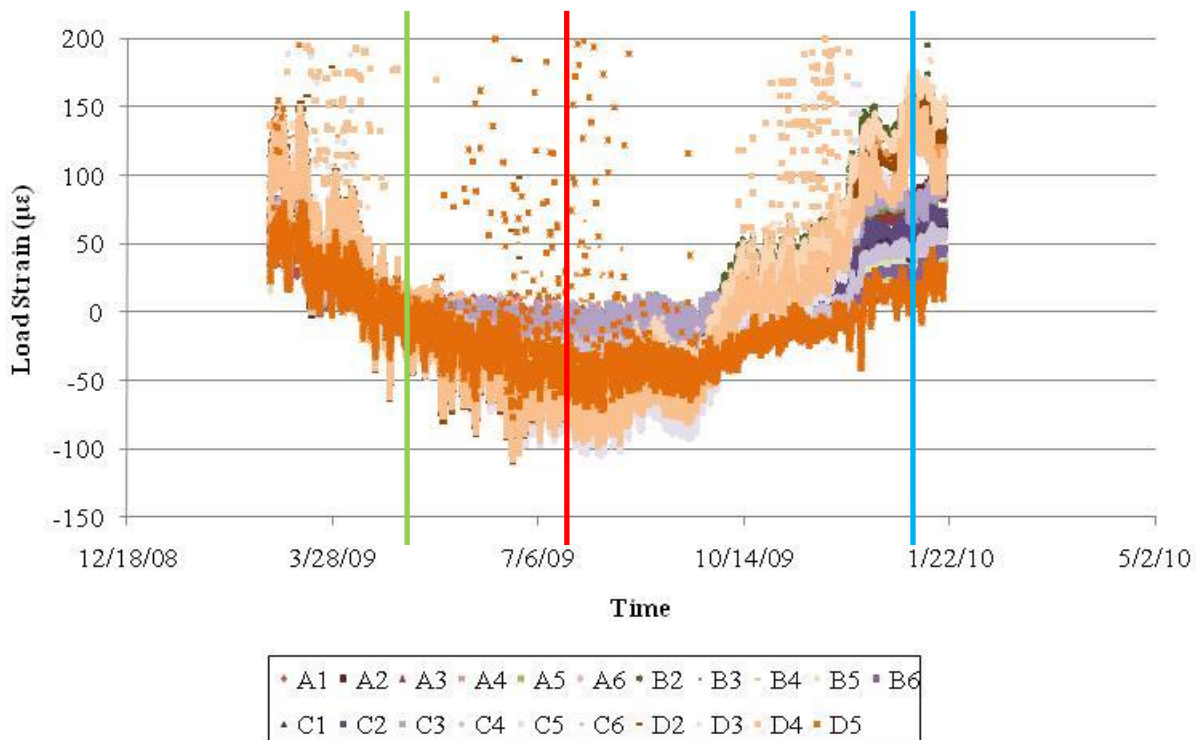
Figure 4.9. Load strain in approach slab over time (February 2009-February 2010, relative to “average” day)

The load strain time history, for all functioning gauges after February 25, 2009, is shown in Figure 4.9. In general, as the temperature decreases the load strain within the slab increases (i.e., the load strain moves toward tension in winter months and toward compression in summer months). The strain data shown in Figure 4.9 are relative to the “average” day listed in Table 4.2 (i.e., the data were zeroed on the “average” day). The three vertical lines represent the cold, hot and average days (see Table 4.2).

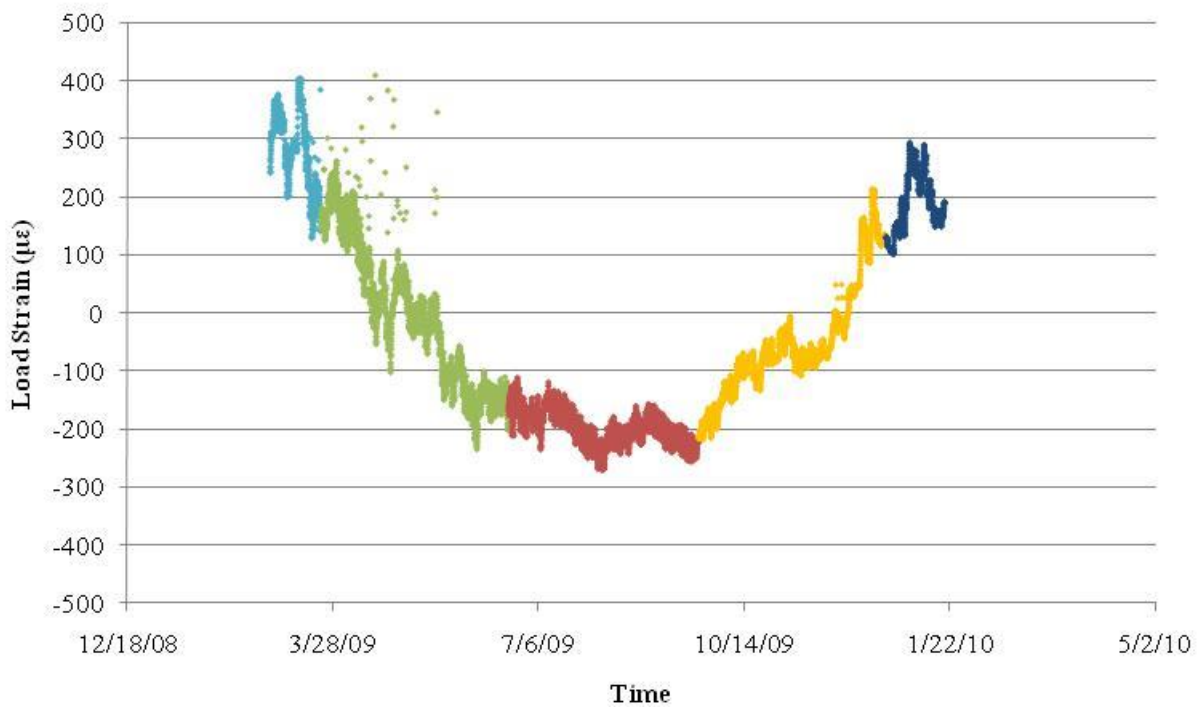
Figure 4.10. Load strain in approach slab over time for gauge D6

Data from strain gauges B1, D1 and D6 were not used in the calculation of load strain due to malfunctioning gauges or questionable data. There were no data from gauges B1 and D1. Gauge D6 gave data 2 to 3 times larger than other gauges as is shown in Figure 4.10.

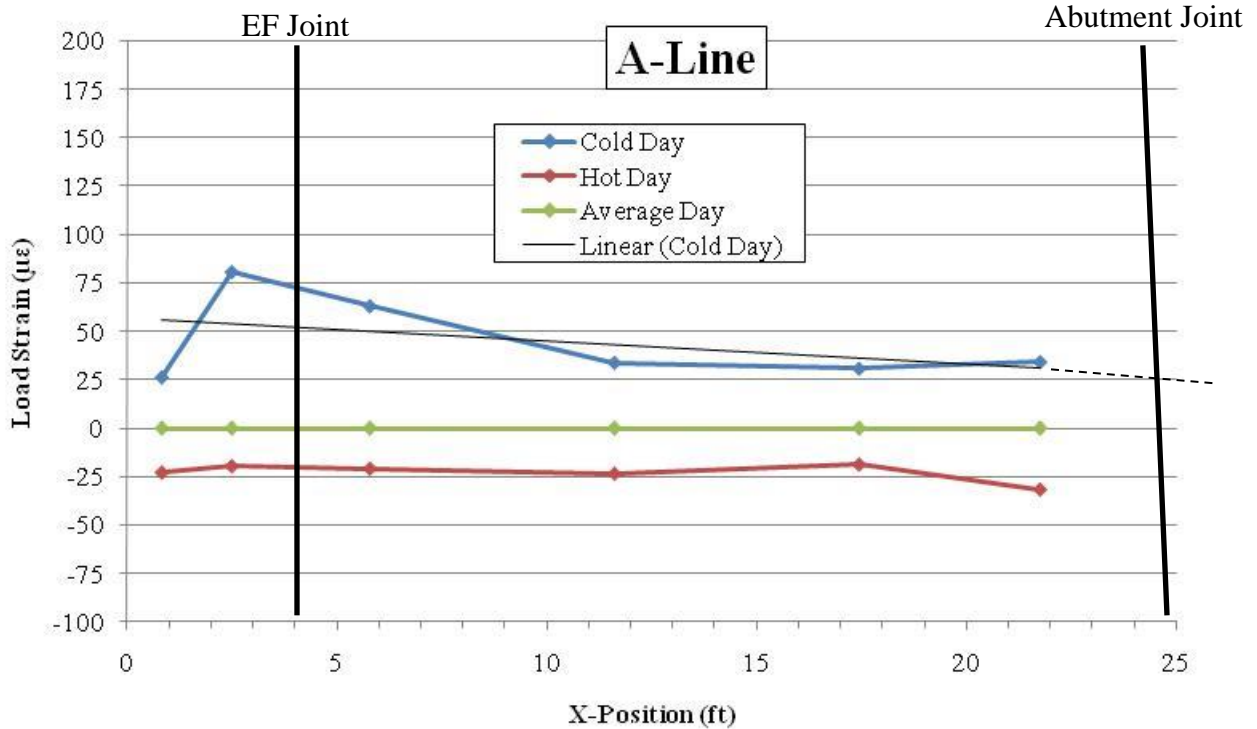
Figure 4.11. Load strain along A-line of approach slab

Figures 4.11 through 4.14 show how the load strain varies longitudinally on the cold, hot, and average days along the A, B, C, and D lines of gauges. Each of these figures shows the locations of the EF joint and the abutment joint. These figures also show the linear regression line on the cold day (when strain varies the most) with the linear regression line extrapolated to the abutment joint. The linear regression lines on the cold day for gauge lines A, B, and D have slopes of differing magnitudes but in the same direction (i.e., the load strain is decreasing longitudinally toward the abutment). The linear regression line on the cold day for gauge line C slopes in the opposite direction (i.e., the load strain is increasing toward the the abutment).

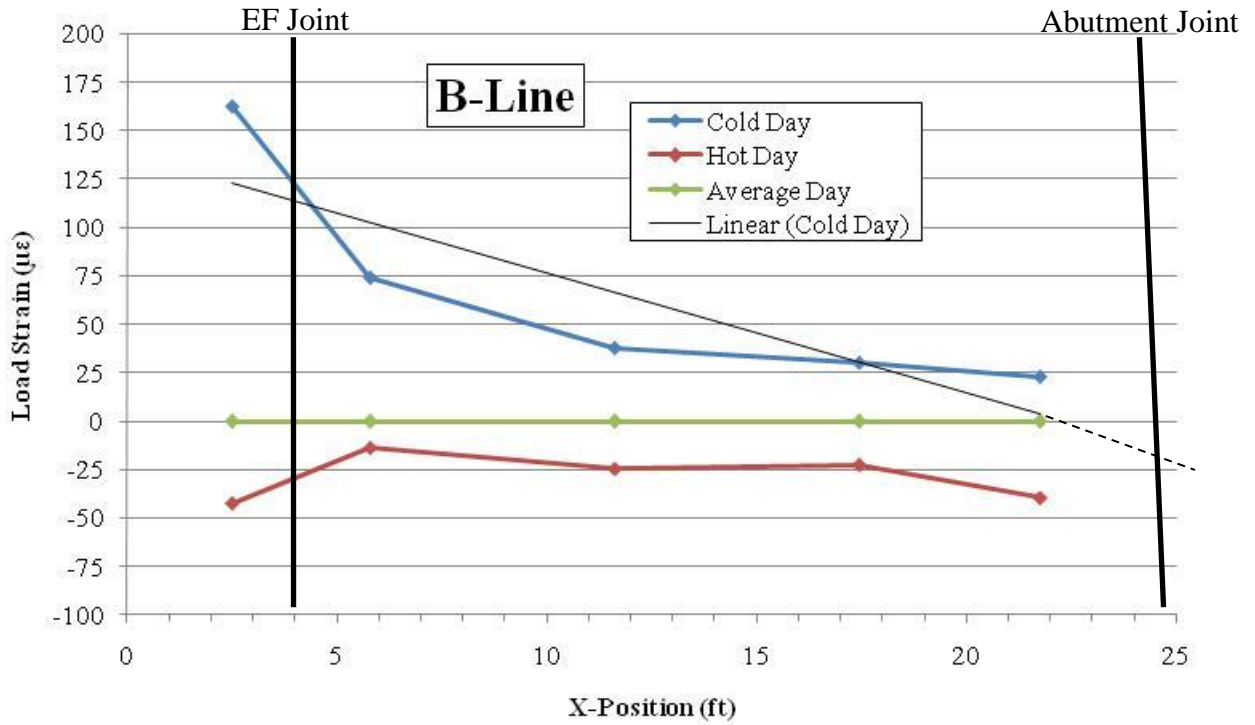
Figure 4.12. Load strain along B-line of approach slab

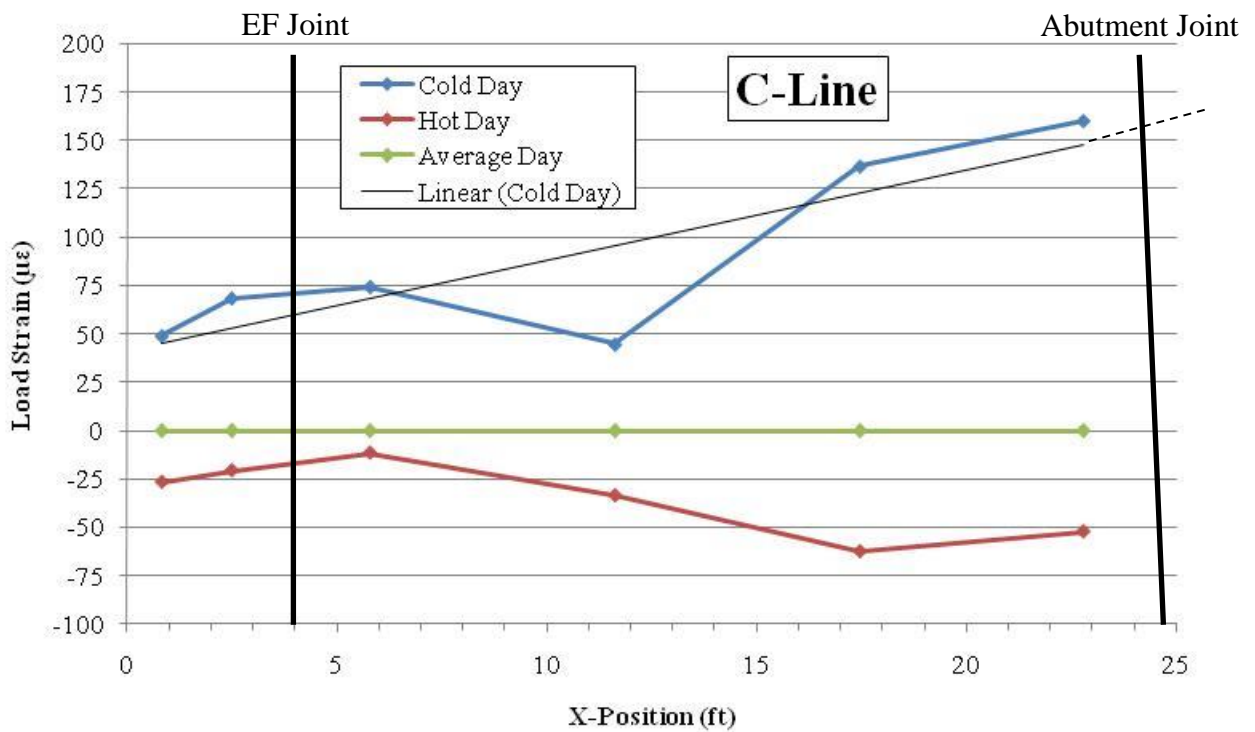
Figure 4.13. Load strain along C-line of approach slab

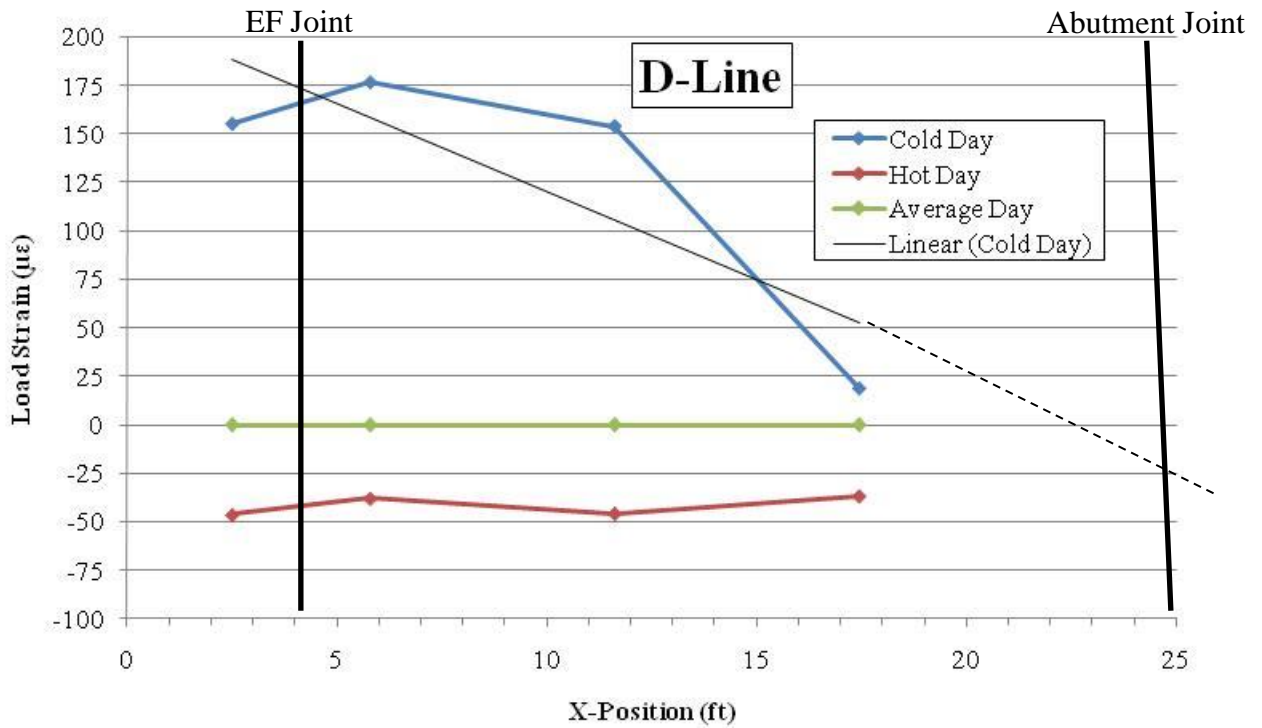
Figure 4.14. Load strain along D-line of approach slab

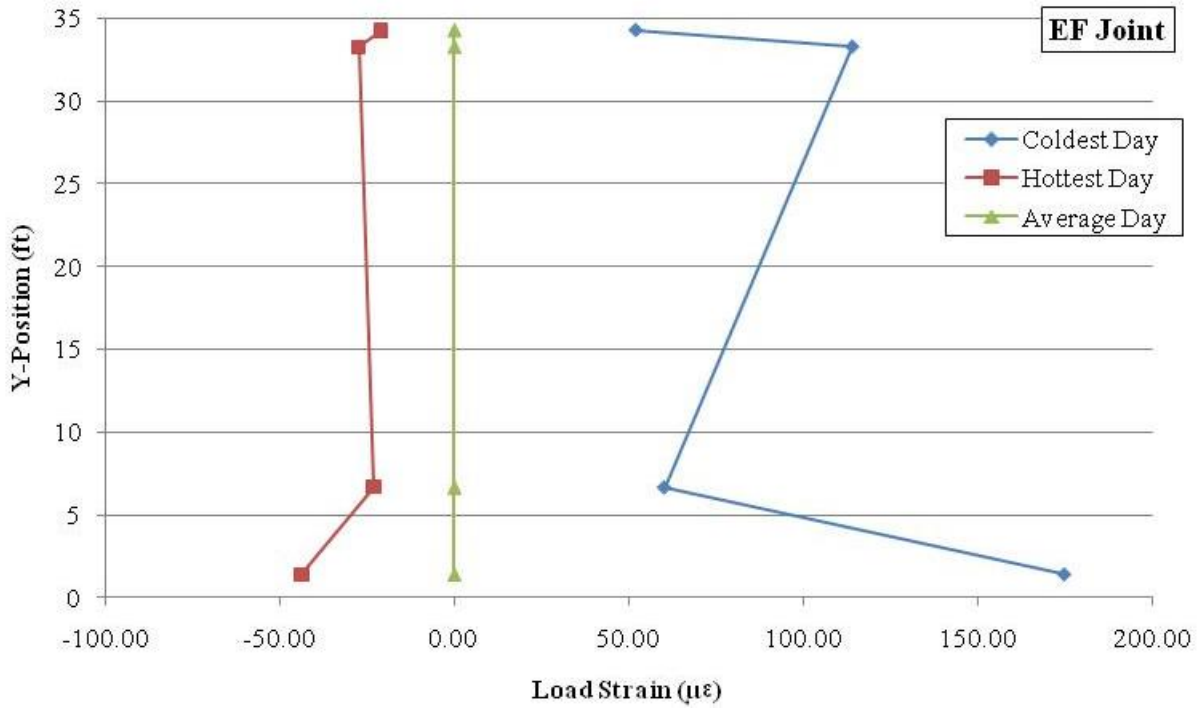
Figure 4.15. Load strain across the EF joint of the approach slab for the cold, hot, and average days

The transverse variation in load strain along the EF joint and abutment joint is shown in Figures 4.15 and 4.16, respectively. Figures 4.11 through 4.16 show the load strain varies more on cold days than on hot days across and along the slab.

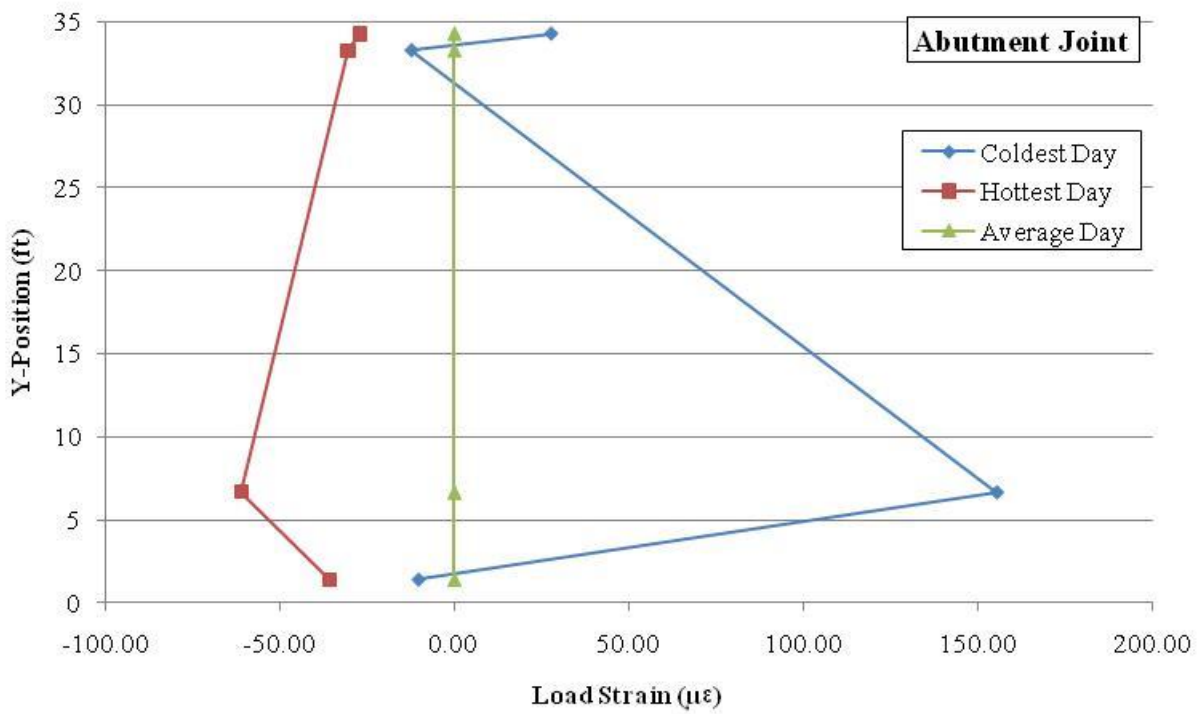
Figure 4.16. Load strain across the abutment joint of the approach slab for the cold, hot, and average days
