Instrumentation and Monitoring of Precast Bridge Approach Tied to an Integral Abutment Bridge in Bremer County

**Final Report
April 2010**

Sponsored by
Federal Highway Administration
Iowa Department of Transportation
(InTrans Project 08-335)

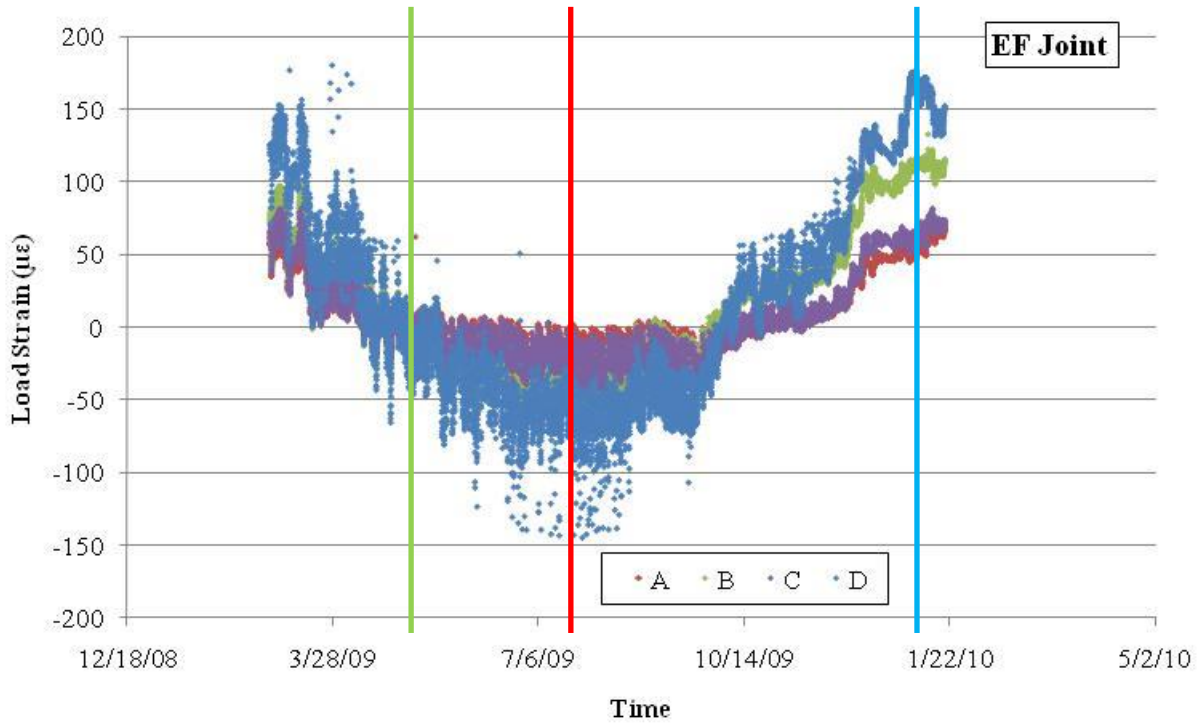
Figure 4.17. Load strain at EF joint

The load strains at the EF joint and abutment joint, from the A, B, C, and D lines in Figures 4.11 through 4.14, are shown in Figures 4.17 and 4.18, respectively. Figure 4.19 shows the average of the A, B, C, and D loads strains at the EF and abutment joints. The connection of the precast panels to the cast in place shoulders may have an impact on the strains in the precast panels.

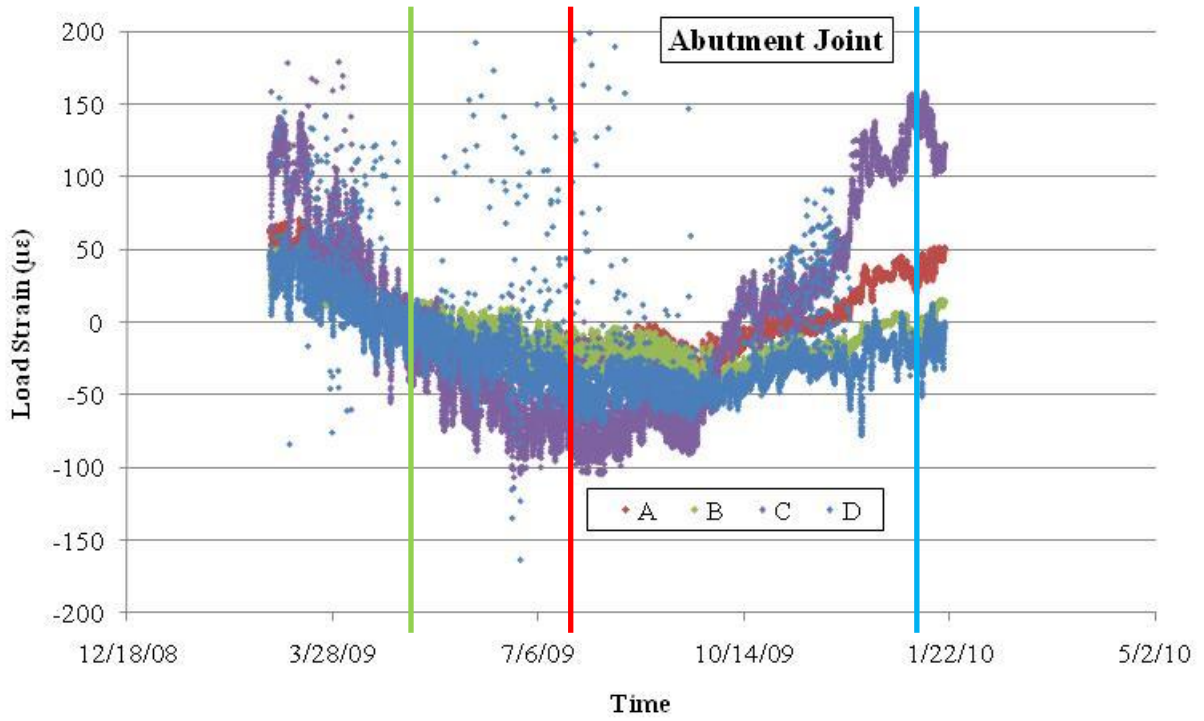
Figure 4.18. Load strain at abutment joint

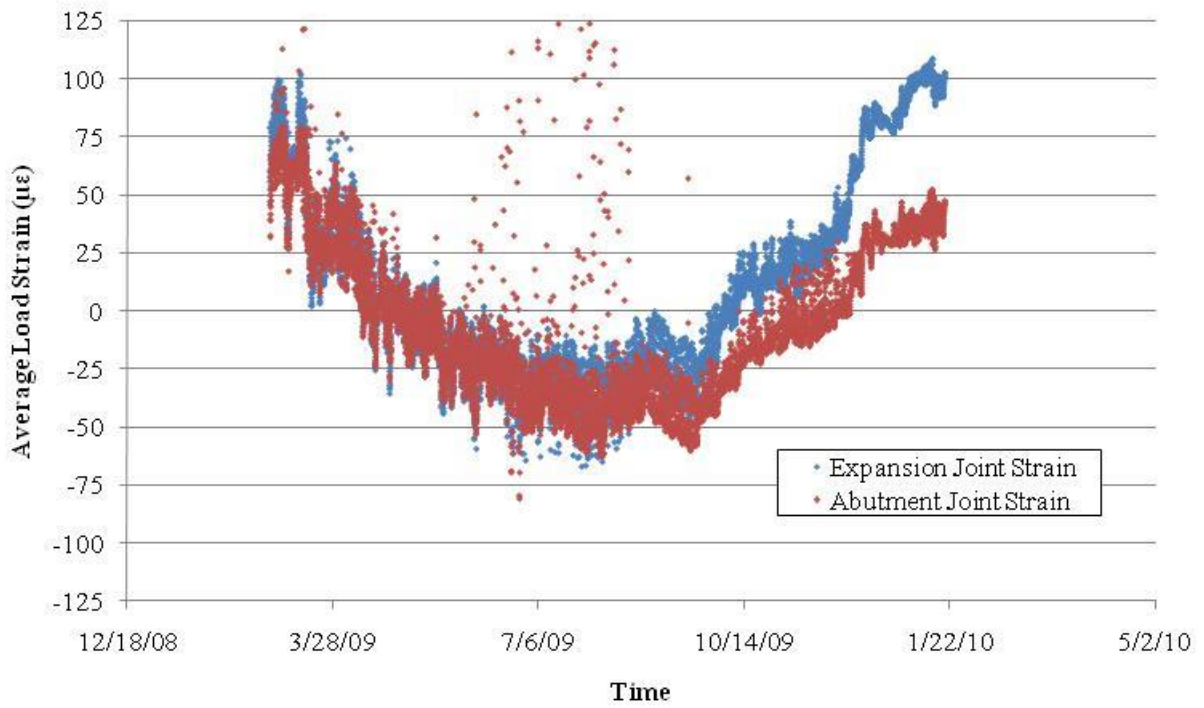
Figure 4.19. Average load strain at EF joint and abutment joint

Figure 4.22 shows the average of the slab force at the EF and abutment joints and is analogous to Figure 4.19 showing load strain. During the summer, the slab forces at the EF and the abutment joints are somewhat similar, indicating moderate frictional forces under the slab. However, in the fall/winter seasons there is a growing difference. Similar to load strain in Figure 4.19, the slab force varies more across and along the slab on cold days than hot days, which may be attributable to the connection of the cast in place shoulder to the bridge wing wall.

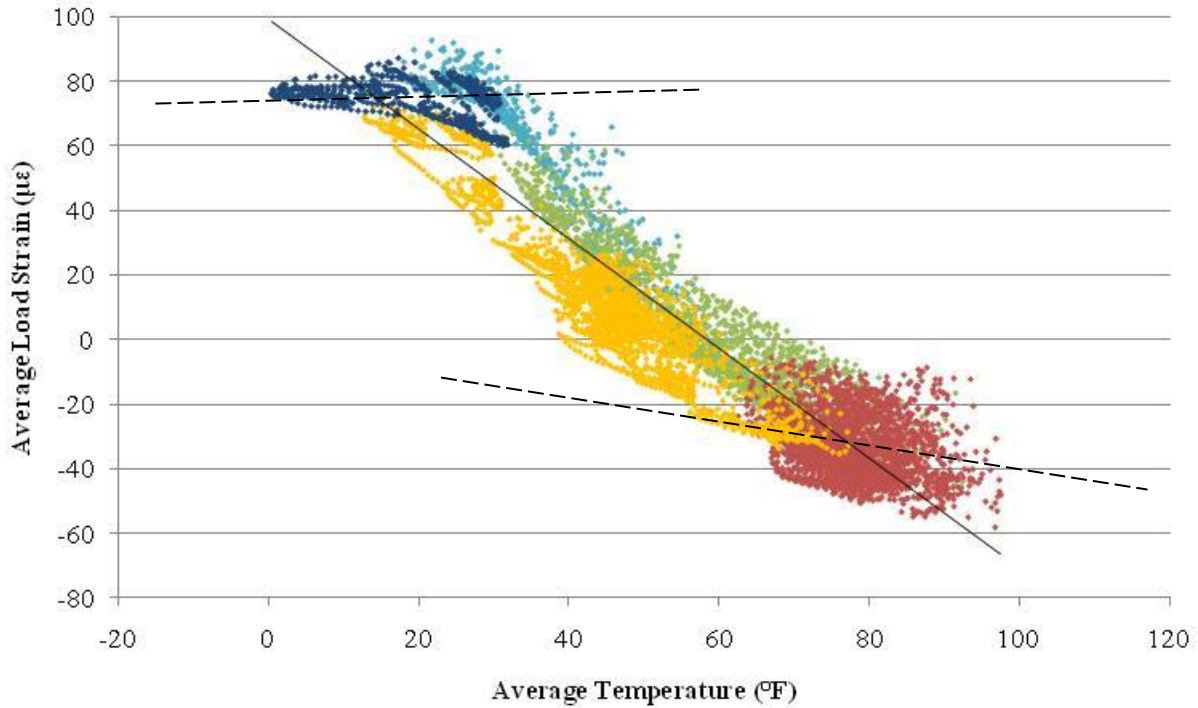
Figure 4.20. Average load strain with respect to average slab temperature

The average load strain of all the gauges in the entire approach slab is plotted with respect to the average slab temperature in Figure 4.20. A cyclical pattern emerges with the winter and summer having the maximum and minimum load strain, respectively, while the spring and fall are seen as the transition periods. Some evidence of short term cycling (dashed lines) is present in Figure 4.20, as was observed in the previous study (Bigelow et al. 2008).

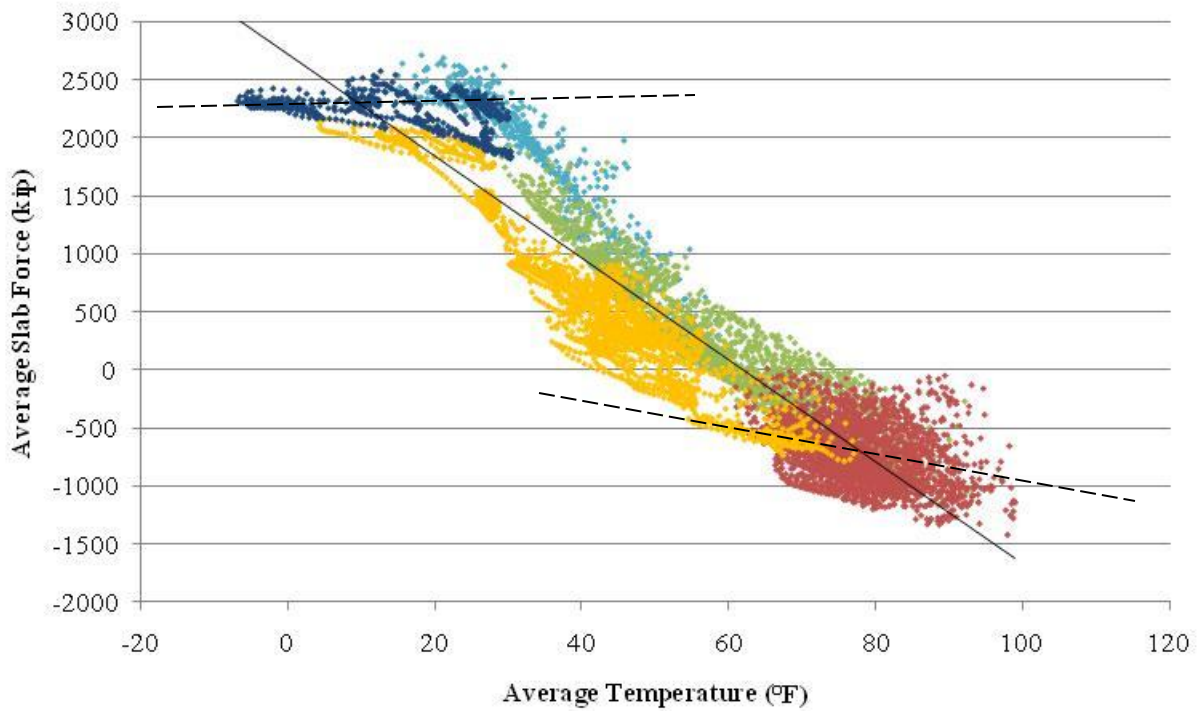
Figure 4.21. Average slab force with respect to average slab temperature

The average force from all gauges in the slab was plotted against average slab temperature and is shown in Figure 4.21. Figure 4.21 yields similar observations to those of Figure 4.20 with the same cyclical pattern found during the seasonal and short term changes. The slab forces tend toward compression in the summer and tension in the winter. The change in force in the slab ranged from 1166 kip (compression) in the summer to 2496 kip (tension) in the winter. The total

range of approximately 3662 kip relates to a 713 psi stress change in the slab from winter to summer.

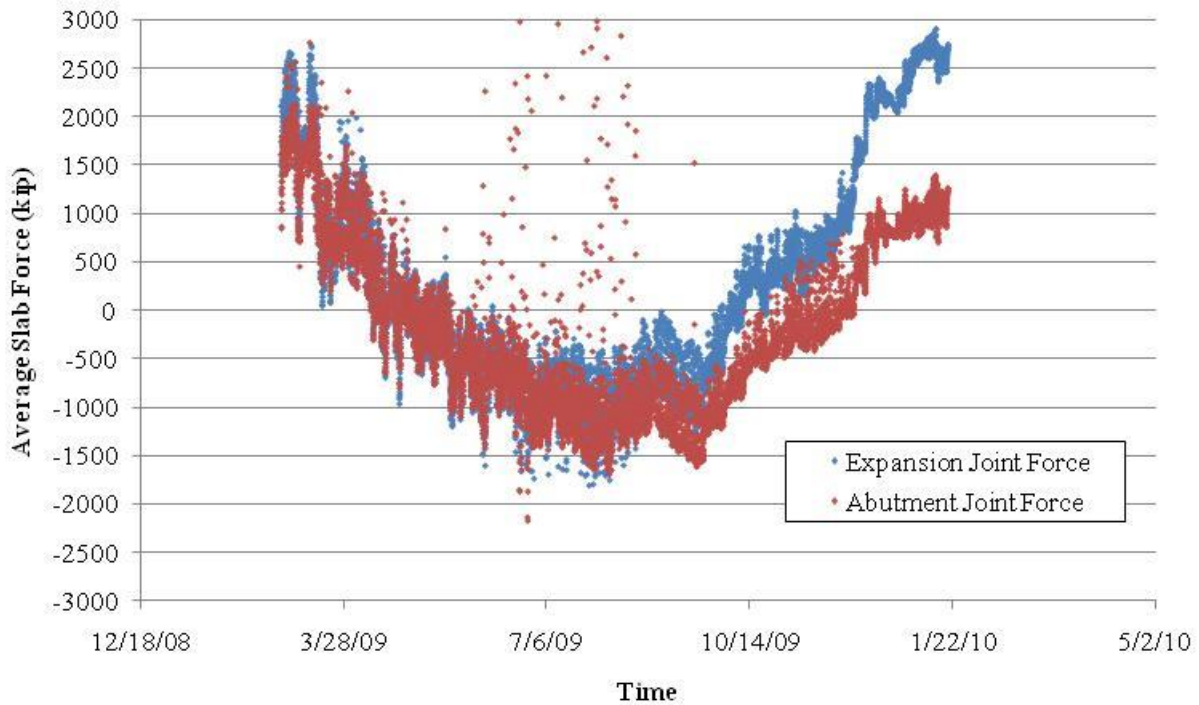
Figure 4.22. Average slab force across EF joint and abutment joint

The friction force on the slab was calculated as the difference between the average EF joint force and average abutment joint force (see Figure 4.22). Equation 4.7 relates the friction force in the bottom of the slab to the coefficient of friction.

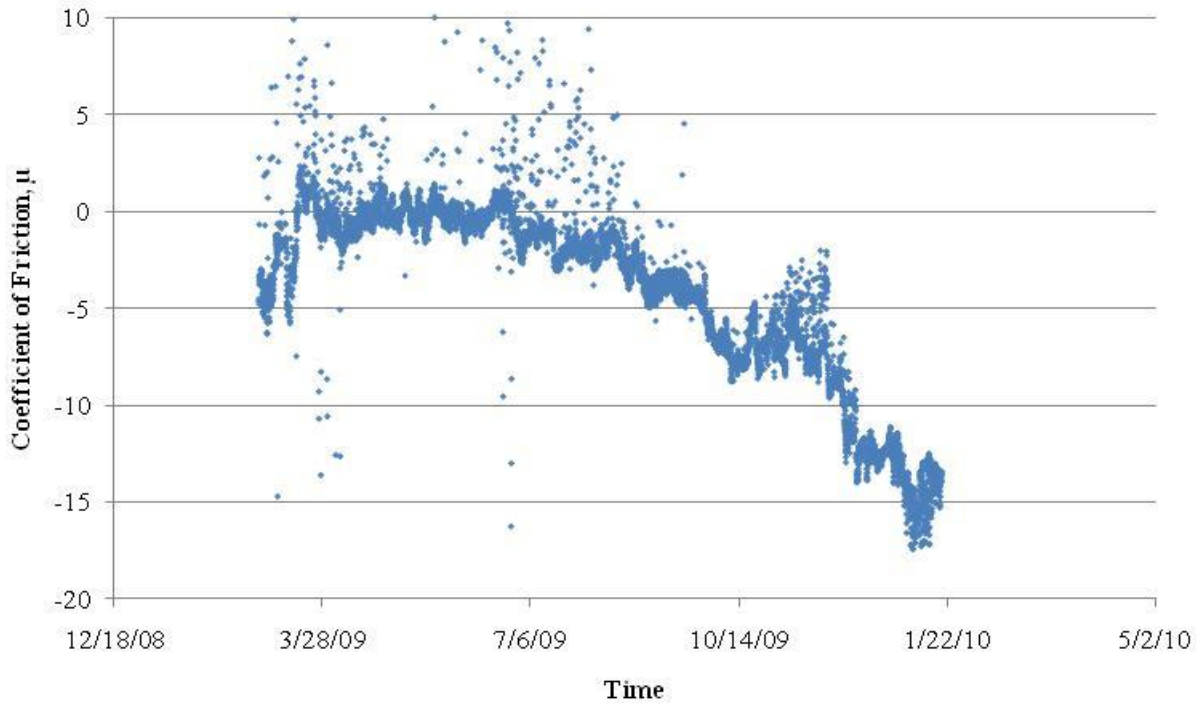
Figure 4.23. Coefficient of friction over time

Figure 4.23 is the time history of the coefficient of friction. During the summers months the coefficient of friction approximately ranges from -2.5 to 2.5. During the winter months, when the force in the EF and abutment joint varies more, the coefficient of friction of nearly 25 was reached, possibly because the approach slab and supporting soil were frozen as a unit. The larger variation of force in the winter months may also be due to the connection of the cast in place shoulder to the bridge wing wall.

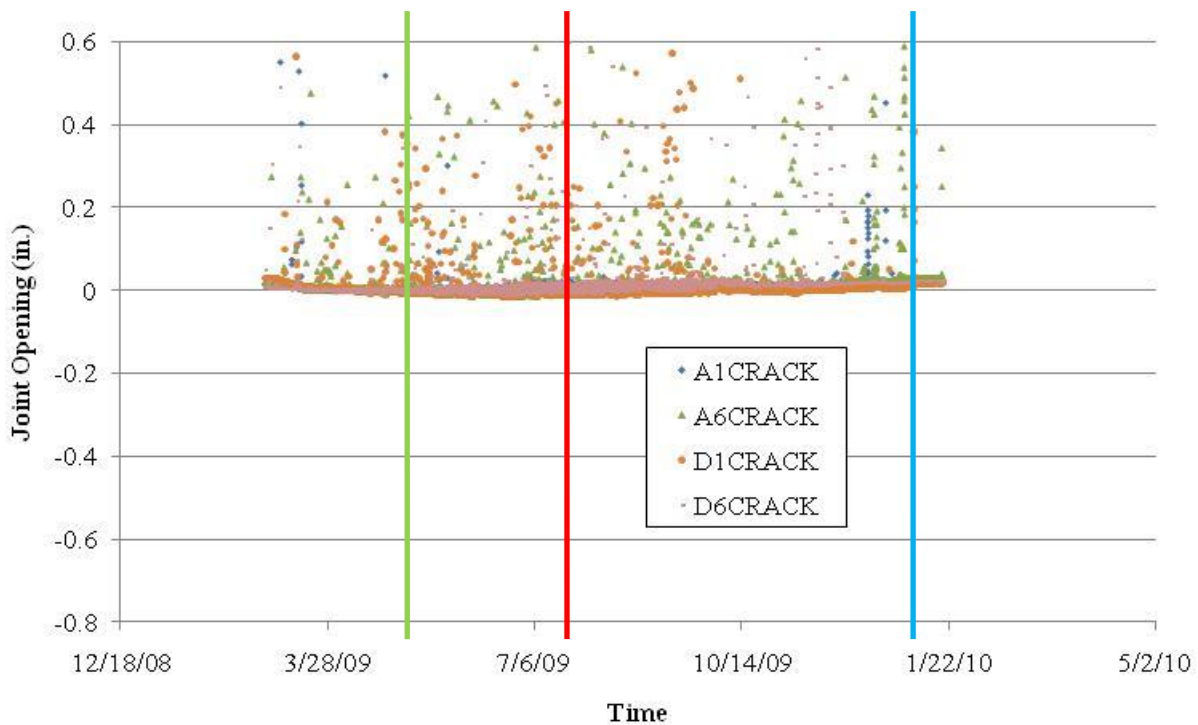
Figure 4.24. Precast approach slab opening at pavement and abutment joints

The crackmeter located at the expansion joint between the east shoulder and east travel lane, C3CRACK, was damaged at some point after installation and the data obtained from this crackmeter were deemed to be unusable. The remaining crackmeters provided usable data during the duration of the project. Figure 4.24 shows the joint movement data across the abutment and pavement joints of the approach slab. Figure 4.25 shows the joint movement data across the EF joint of the approach slab. A positive movement indicates that the joint is opening. Figure 4.24 shows the crackmeters located along the abutment joint and pavement joint had movements of less than 0.02 in. Figure 4.25 shows the crackmeters located along EF joint indicate relatively larger movements ranging from 0.35 in. during winter months to 0.55 in. during summer months for a total range of 0.90 in.

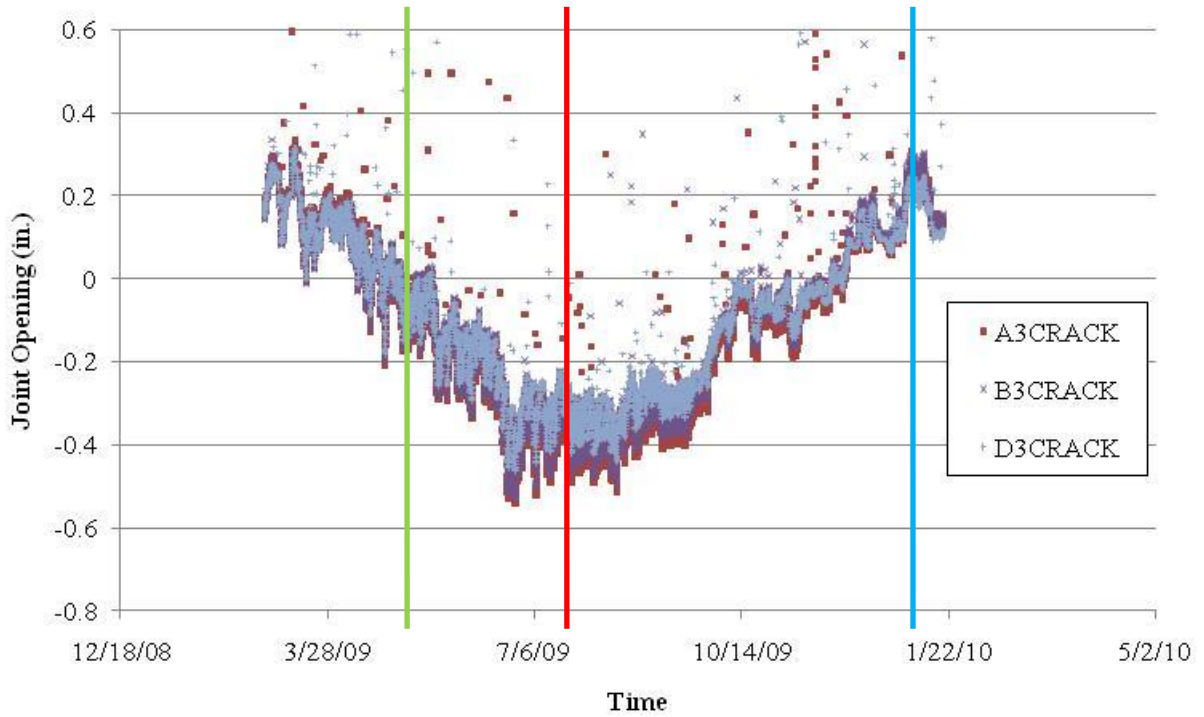
Figure 4.25. Precast approach slab opening at EF joint

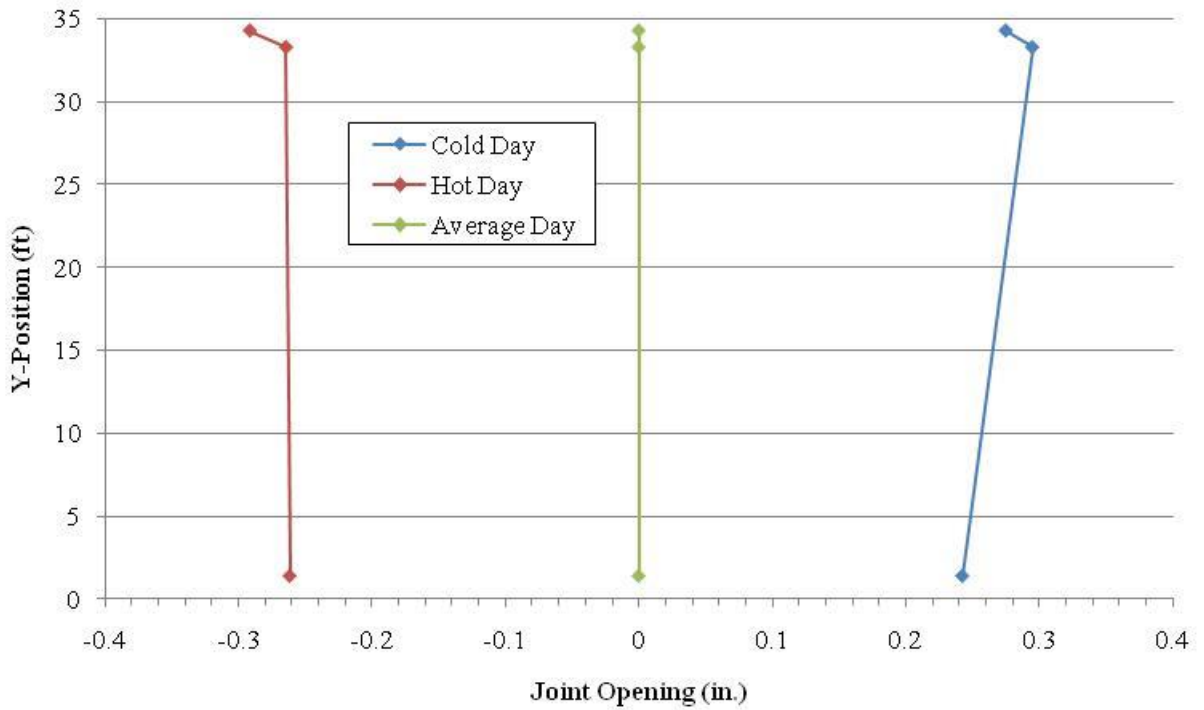
Figure 4.26. EF joint opening across approach slab for cold day, hot day and an average day

Figures 4.26 and 4.27 show the opening across the approach slab for a cold day, hot day and an average day for the EF and abutment joints, respectively. Comparing Figures 4.26 and 4.27 shows the EF joint opens more than the abutment joint on hot and cold days.

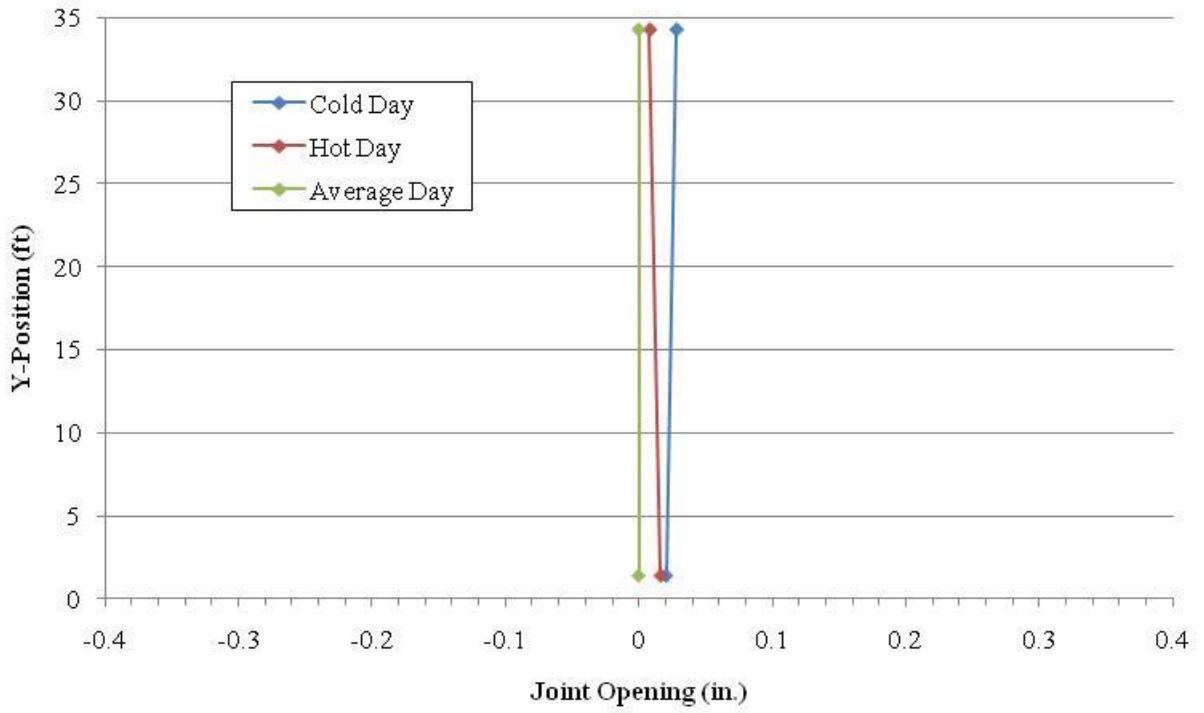
Figure 4.27. Abutment joint opening across approach slab for cold day, hot day and an average day

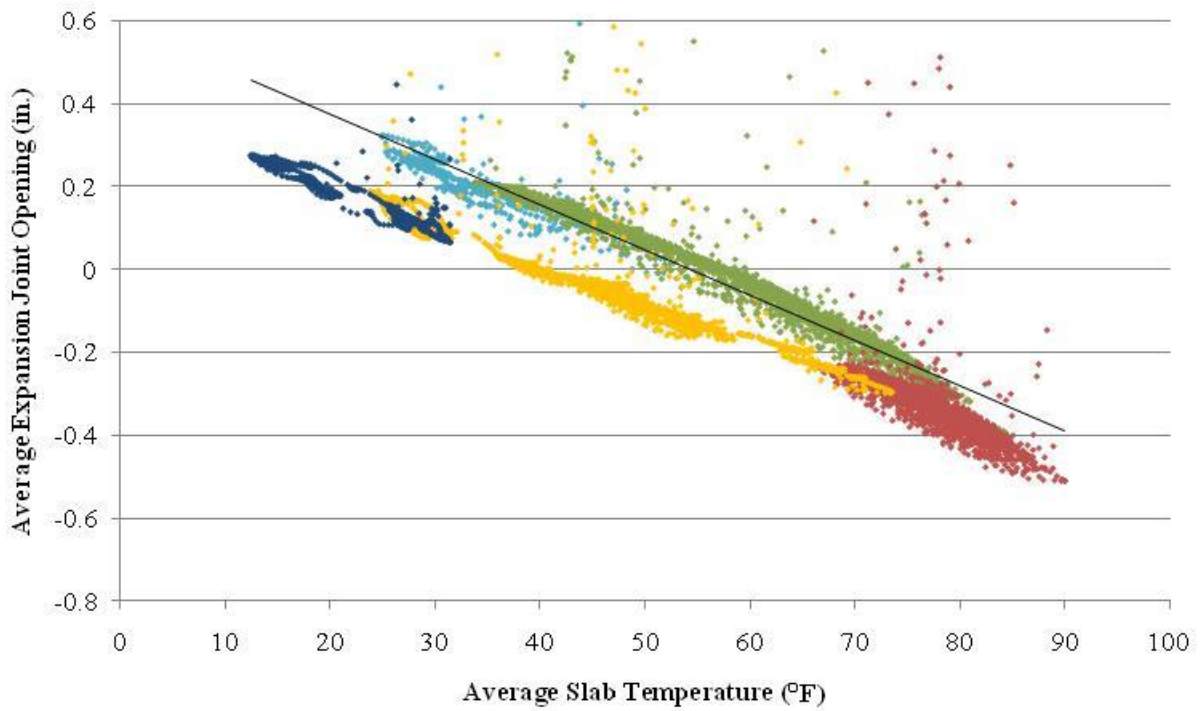
Figure 4.28. Expansion joint movements relative to average slab temperature

The average expansion joint opening is shown relative to average slab temperature in Figure 4.28. The opening of the expansion joint has an inverse relationship with average slab temperature. As the temperature increases the joint opening size decreases.

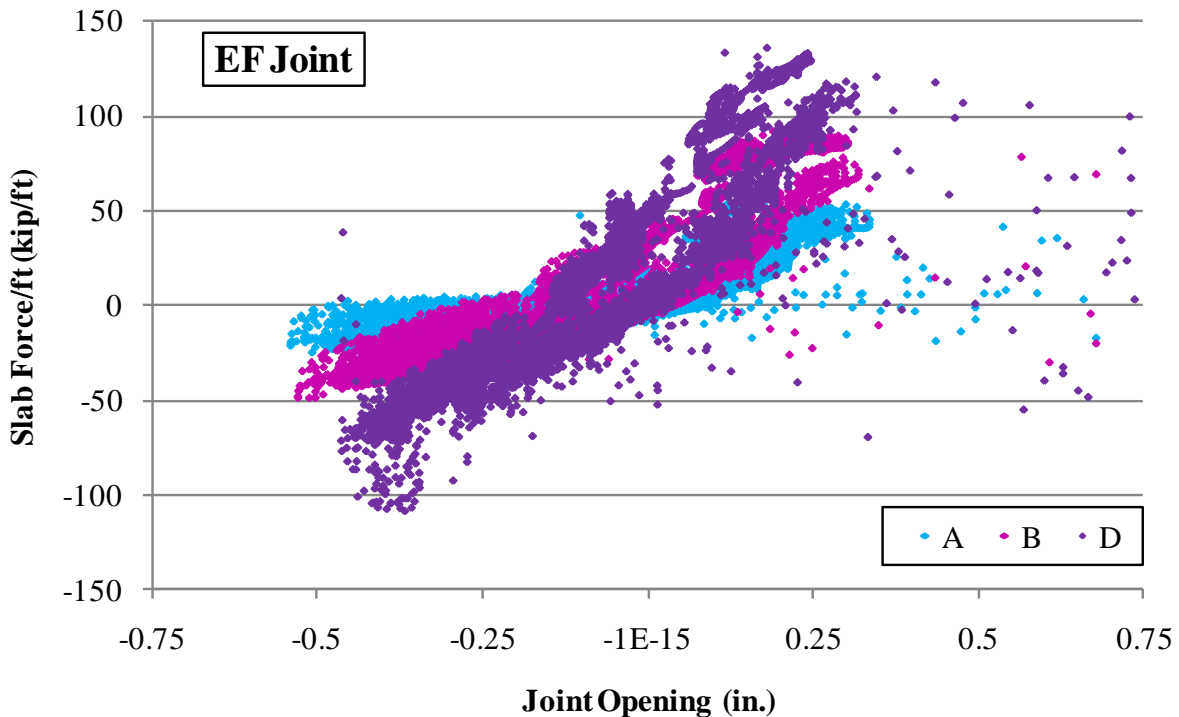
Figure 4.29. Expansion joint movements relative to average slab temperature

Slab force per foot of the approach slab versus joint opening for the EF joint is shown in Figure 4.29. The range of slab forces shown in Figure 4.29 is comparable to the force found in the approach slab of the Bigelow et al. (2008) study. Figure 4.29, similar to Figure 4.15, shows the force in the slab along line D of the slab behaves differently from the force in other areas of the slab. Apparently, the EF joint at line D is not functioning as well as elsewhere resulting in larger thermal forces, which may be affected by the connection of the cast in place shoulder to the bridge wing wall.
