# Precast Concrete Elements for Accelerated Bridge Construction

**Volume 1-1. Laboratory Testing of Precast Substructure Components: Boone County Bridge**

**Volume 1-2. Laboratory Testing of Full-Depth Precast, Prestressed Concrete Deck Panels: Boone County Bridge**

**Volume 1-3. Field Testing of a Precast Concrete Bridge: Boone County Bridge**

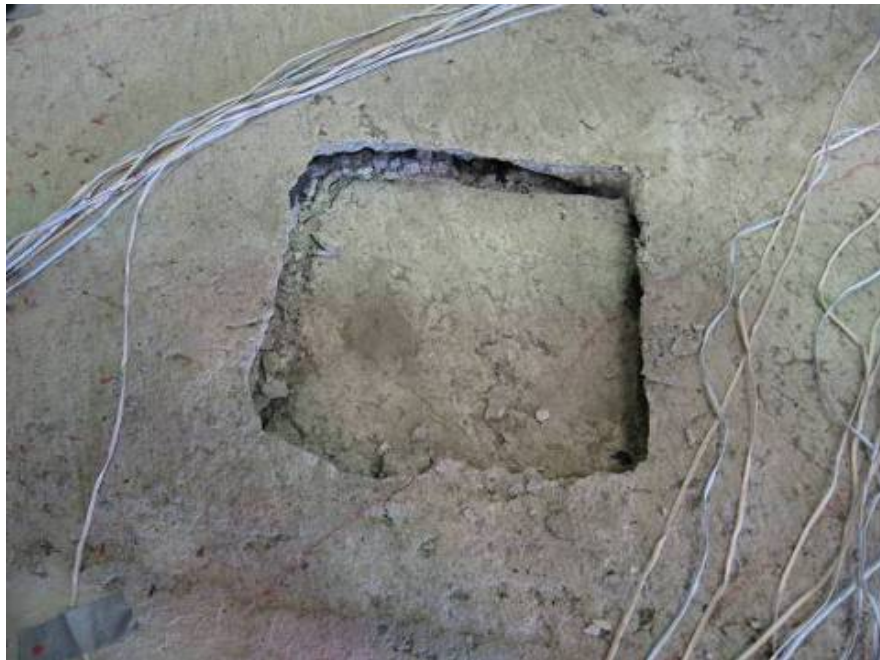
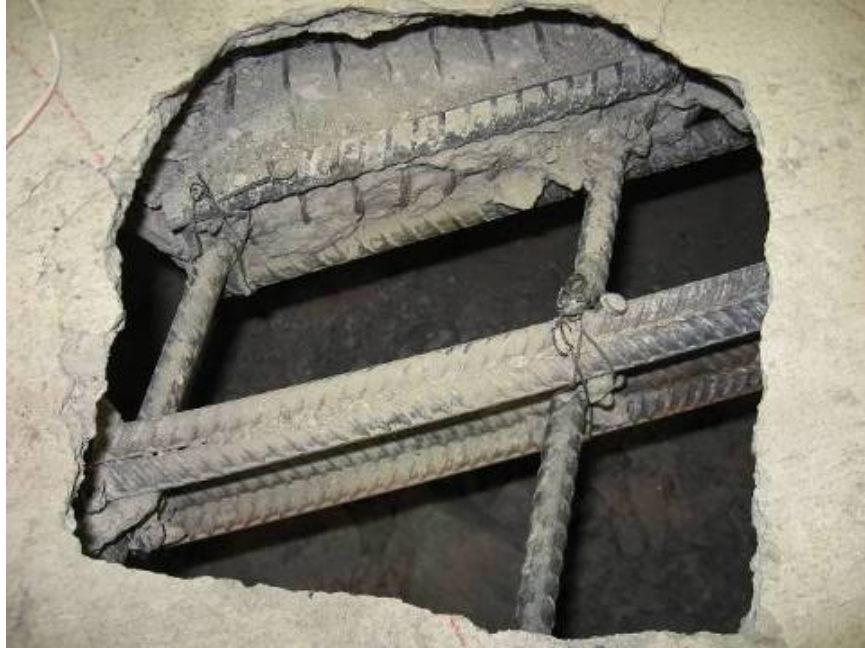
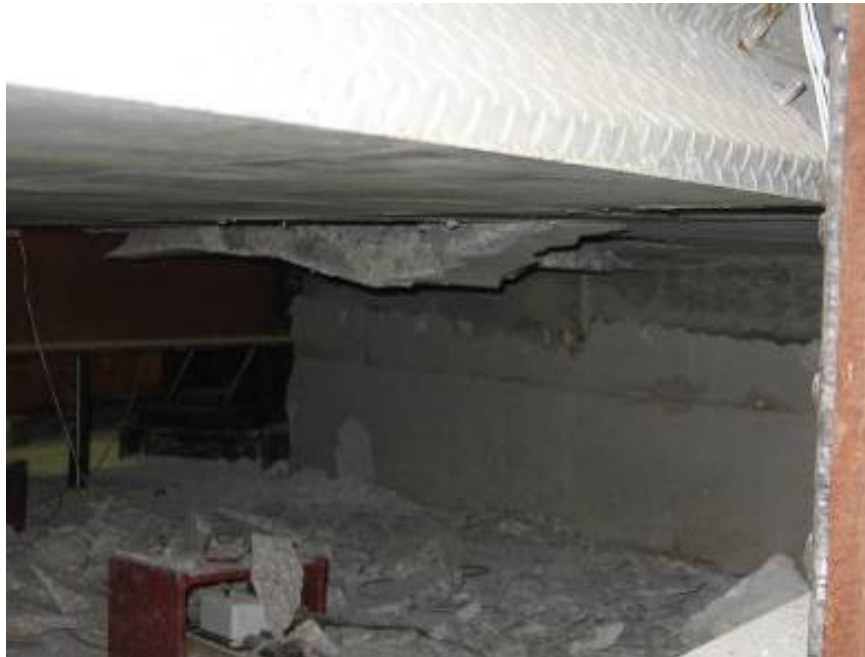
**a) Top view of punching shear failure footprint**

**Figure 3.22. Photographs of the deck panel after a punching shear failure**

**b) Top view after concrete removal**

**c) Underside of the deck panel**

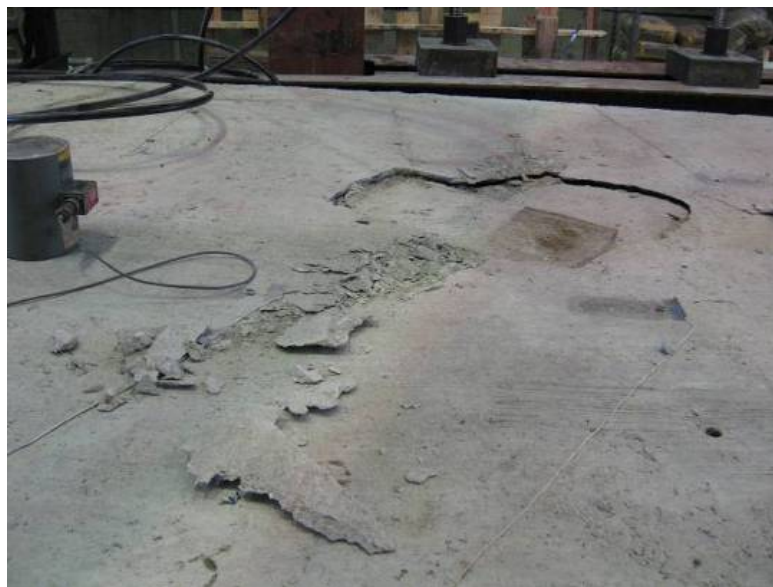
**Figure 3.27. Punching shear and flexure failure due to tandem wheel footprint**
