Remote Health Monitoring for Asset Management

Final Report
July 2008

Sponsored by
University Transportation Centers Program,
U.S. Department of Transportation
(MTC Project 2007-05)

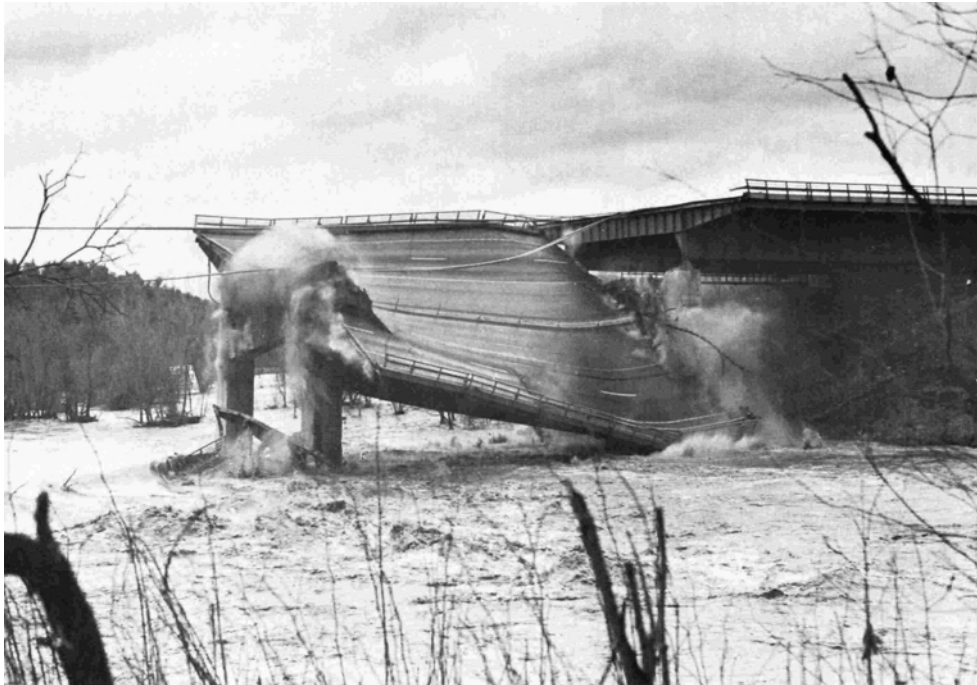
Figure 2.1. Photograph of the Skoharie Creek Bridge collapse, 1987

The collapse of the Skoharie Creek Bridge in 1987 (shown in Figure 2.1) introduced a new era of concern regarding the structural stability of highway bridges and the fidelity of the substructure systems supporting them. The tragic collapse and others that have followed have focused attention on the need for dependable methods of monitoring the structural stability of highway structures. Bridge scour that results in a loss of structural stability is the most common reason for collapse of highway bridges, and innovative, cost-effective monitoring methods are urgently needed. Presently there are more than 26,000 bridges in the U.S. identified as scour critical (1, 2). More than 3,700 bridges were damaged by scour during the period of 1985–1995 (2).

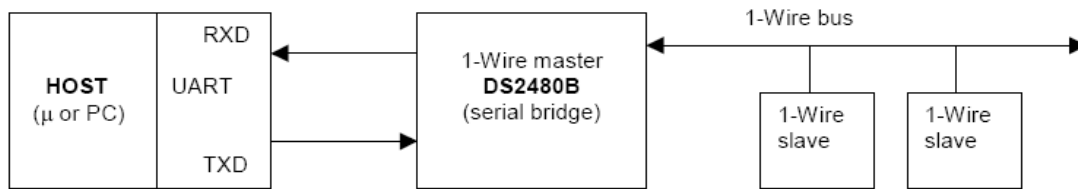
Figure 3.1. DS2480B usage layout

The DS2480B is used as a microcontroller for 1-Wire applications. It is described as a “serial bridge to the 1-Wire network protocol.” A simplified image of the usage of a DS2480B is shown below in Figure 3.1 with two slave devices (DS18S20) attached in a daisy-chain configuration.

It is possible to control the 1-Wire devices with a computers IO functions, but the DS2480B relieves the host of this duty and is programmed with the correct timing and waveforms needed. The DS2480B is controlled by a variety of hexadecimal commands each 8 bits long.

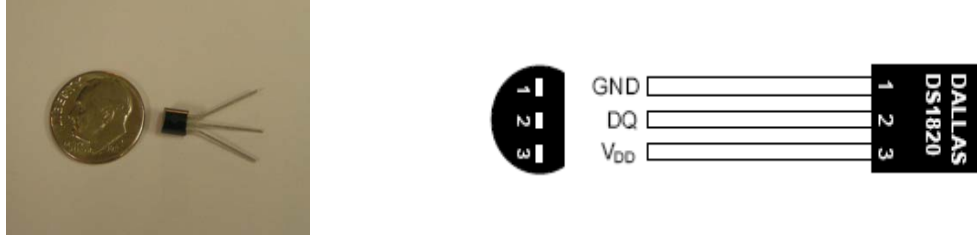
Figure 3.2. Image and pin layout of DS18S20

The DS18S20 is a high precision 1-Wire digital thermometer. Its operating temperature ranges from -55°C to +125°C with an accuracy of $\pm 0.5^\circ\text{C}$ between -10°C and +85°C. One microcontroller can regulate many DS18S20 sensors due to the 64-bit serial code given to each sensor during production. The main advantage of the DS18S20 over a basic thermocouple is its direct-to-digital temperature sensor. This reduces the effect of noise on temperature readouts and improves the sensor accuracy. Figure 3.2 below shows a photograph of a DS18S20 and the pin layout.

The DS18S20 can be powered by a technique called parasite power. In this mode, the sensor is powered by stealing electricity from DQ line (Figure 3.2) when the bus is high. A capacitor in the sensor is charged during this time to allow the sensor to operate while the bus is low. The simpler way to power the devices is by connecting the V_{DD} pin to a power supply, which is how the sensor is implemented in this project. The manufacturer does not recommend the use of parasite power for temperatures over 100°C due to high leakage currents, and encourages the use of the V_{DD} pin for power connection in applications where the extra wire connection is possible and allowable. Using parasite power makes operation much more difficult because the bus must always be held high during any 1-Wire device function. This causes problems with the timing and voltage requirements for reading the data.

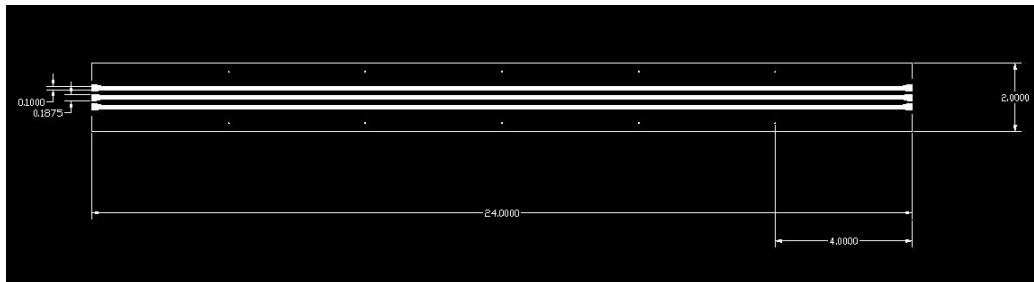
Figure 3.3. AutoCAD drawing used for printing circuit boards

The AutoCAD drawing of the trunk line design is shown in Figure 3.3. The trunkline design consisted of three conductor lines that run the length of a 24 in. board, a commonly available size for the circuit board materials. Solder tabs are etched at either end of the trunklines to enable the board to be connected by short wires, so that a 24 in. module can be manufactured and then several boards could be connected to create the appropriate length sensor array. The sensors themselves can be soldered to the trunk lines at any spacing interval; a sensor every three or four in. was selected as a suitable spacing for this project. This allows for up to four measurements per ft of pile, adequate for estimating the soil line depth along the pile. This spacing was based on discussions with bridge maintenance engineers that indicated that information on the depth of scour holes to the nearest ft was adequate for effective decision making and asset management. By placing three sensors per ft, measurement redundancy would exist to provide improved reliability in field applications, and ensure that system resolution met the requirement of determining the depth of a scour hole to the nearest foot.

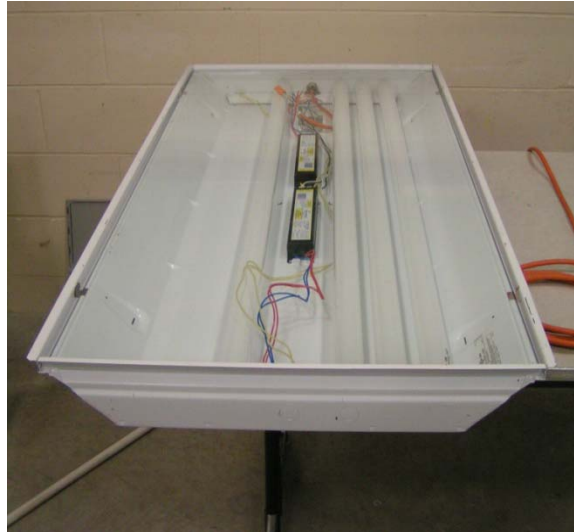
Figure 3.4. Setup for exposing circuit boards

Figure 3.4 below shows the setup used for exposing the circuit boards to ultraviolet (UV) light. Four fluorescent UV lights were used to maximize the amount of UV light along the entire length of the circuit boards. The large (24 in. long) circuit boards that were required for this project exceeded the size of the exposure beds that were available, and as such a new exposure bed needed to be developed. The exposure bed consisted of a common, 48 in. fluorescent light

fixture with a custom-made tempered glass lens. Testing was conducted to determine the optimum exposure times for properly exposing the board so that it could be etched to produce a clear pattern of conductive lines on the surface of the board. Several different commercially available ultraviolet lamps were tested to determine the appropriate wavelength of light to effectively expose the board to generate sharp, clear lines through the etching process.

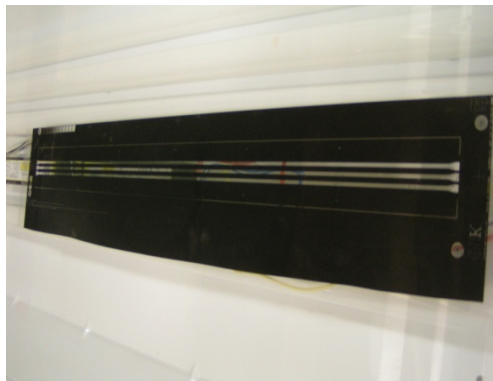
Figure 3.5. Photonegative used for exposure

Figure 3.5 shows the photonegative produced for exposure of the circuit board. This photonegative was produced by a local photography lab based on the AutoCAD drawing of the pattern for the board (See Figure 3.3). This photonegative was used to shield the stock board material. The UV light hardens the exposed film that covers the circuit board, so that the exposed areas of the board will not be etched in subsequent acid baths.

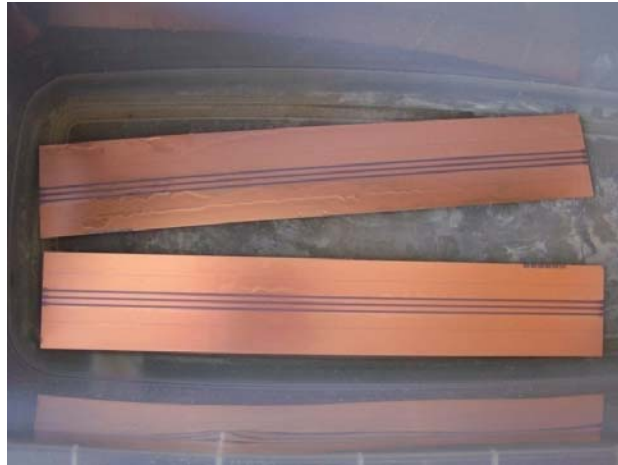
Figure 3.6. Exposed boards in the chemical bath

The circuit board was then exposed to UV light. A study was conducted utilizing sample board materials to determine the effective exposure time for the board materials. As a result of this study, the boards were exposed for two minutes and then placed immediately into an acid bath to minimize the amount of ambient light exposure. The exposed board materials (shown in Figure

3.6), show the purple film removed and the bare copper exposed in the areas of the copper that are to be removed in subsequent etching. This allows the acids to remove the extra copper, leaving only the three conductive strips necessary to provide a trunk lines for attaching the sensors.

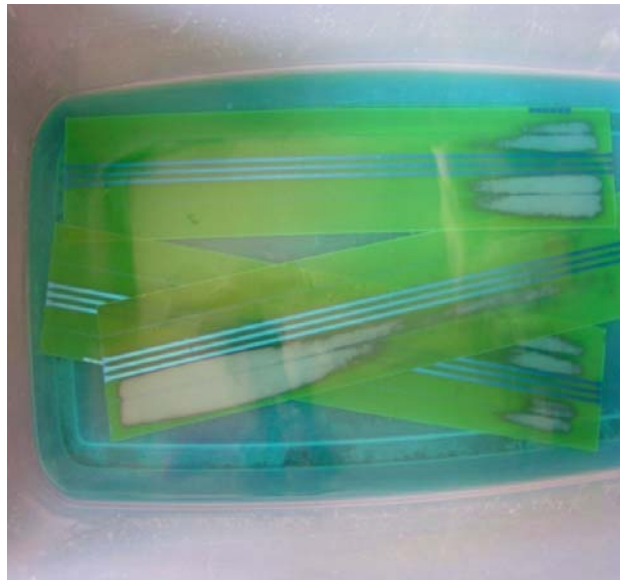
Figure 3.7. Excess copper being removed from the printed board

Figure 3.7 shows the excess copper being removed by the acid solution but the lines that are protected by the hardened film from the UV light remain. Once all the unwanted copper is removed the boards are washed to remove the acid and then placed in the next bath. This manufacturing process developed through an iterative process to improve the consistency of the process and ensure that the copper trunk lines that are to remain on the board had clear edges to ensure long-term reliability.

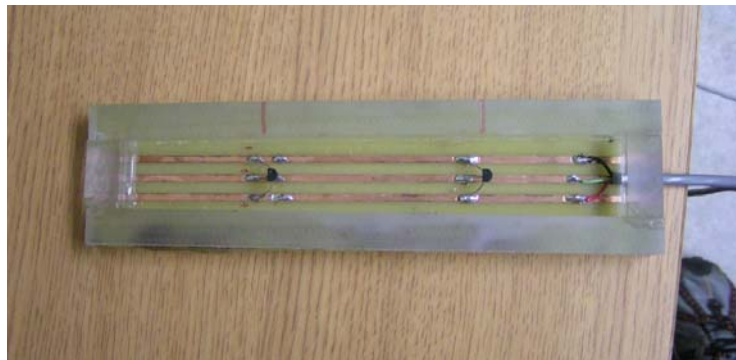
Figure 3.8. Photograph of small test sensor array with two sensors

Two different sized test arrays were created in the lab. The goals were to prove that the temperature measurement system worked effectively and expand our knowledge of what to expect from the actual pile deployment. A photograph of a small, two-sensor array can be seen below in Figure 3.8. In this photograph, the two DS18S20 sensors are soldered to the trunk lines along with the attachment cable that leads back to a standard PC. Communication with the sensors is achieved through the serial port of a standard personnel computer. The board material was attached to a polycarbonate frame as shown in the photograph. This frame allowed for the sensors to be potted inside a special epoxy that provides protection from damage to the sensors and supporting trunk lines, and has a high thermal conductivity (close to that of steel). Potting of the sensor array in the special epoxy allows for rapid conduction of changes in the thermal environment of the array, in addition to stabilizing the sensors to provide protection from the environment.

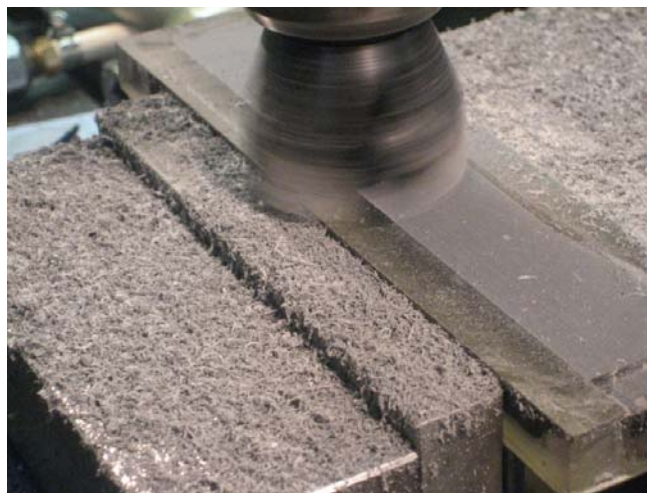
Figure 3.9. Photograph of the milling operation to level epoxy

After allowing the epoxy to harden for over 24 hr, it went through a mill to level the surface of the epoxy to the elevation of the polycarbonate walls. This provided a machined surface that could then be mounted onto the surface of any type of structure, for example, the side of a steel pile. The flat surface of the sensor array allowed for direct contact with the surface of the steel to ensure effective heat transfer across the joint.

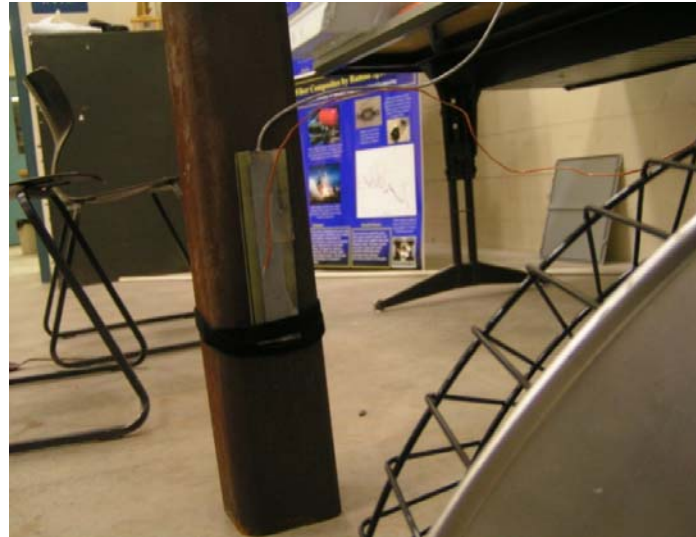
Figure 3.10. Small sensor array test setup

To conduct initial testing, the final milled array was attached to the outside of a two-ft long, five sq in. HSS member. Using a parabolic heat dish to supply the temperature changes, the sensors proved to respond very quickly to these changes from the dish. The figure below also shows a K type thermocouple that was attached to the front of the array to test the lag between the two different types of sensors.

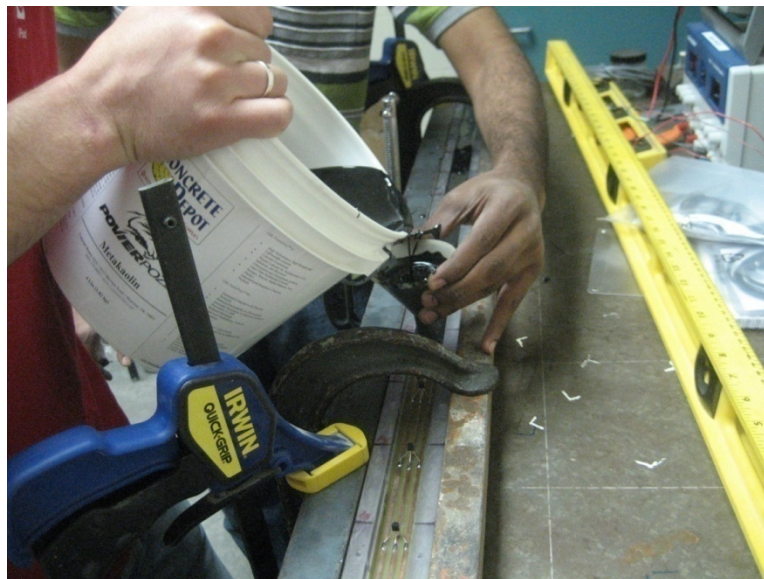
Figure 3.12. Pouring epoxy into large test array

A software program was also developed to record data from each of the 16 sensors included in the array, to display that data in real time and to store the data. The array of sensors was again potted in the epoxy to protect the sensors and provide a corrosion protection. Figure 3.11 shows the manufacturing of the sensor array, specifically the application of epoxy in the array housing. After curing, this epoxy was again milled and planed so that the array sensor could be applied to the surface of a steel pile.

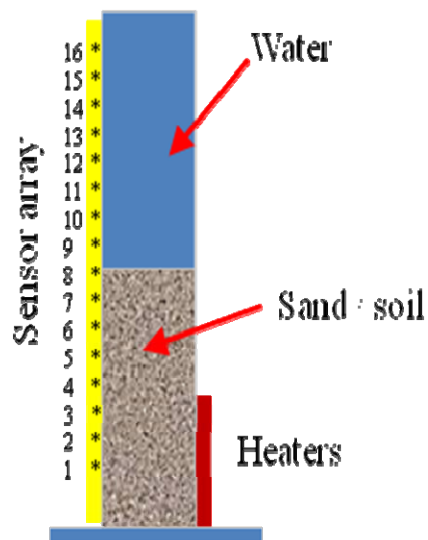
Figure 4.1. Schematic diagram of test set-up showing heaters, sensor array, and sand/water interface

The laboratory set-up included a 6 x 6 x ½ in. HSS member 48 in. in length to provide a model test pile as shown in Figure 4.1. This test pile was mounted on a 18 x 24 in. steel plate by angle clips. A rubber gasket was used to ensure that the HSS would hold water without leaking. The sensor array was attached to the outside of the pile. Inside the test pile, sand was placed in the pile up to a height of approximately 24 in., then the pile was filled to the top with water. During subsequent testing, the sand was replaced with soil. The test setup was intended to model the installation of the pile in the field, with the array and soil/water interface on opposite sides of the pile. In a field installation, the water and soil would be outside the pile and the sensor array would be installed within the pile, to measure the thermal behavior of the pile by attachment to the surface of the steel. This configuration was reversed for laboratory testing for convenience. This enabled the evaluation and testing of the effect of changing the temperature of the soil and water, and measuring these changes through the ½ in. steel pile wall.

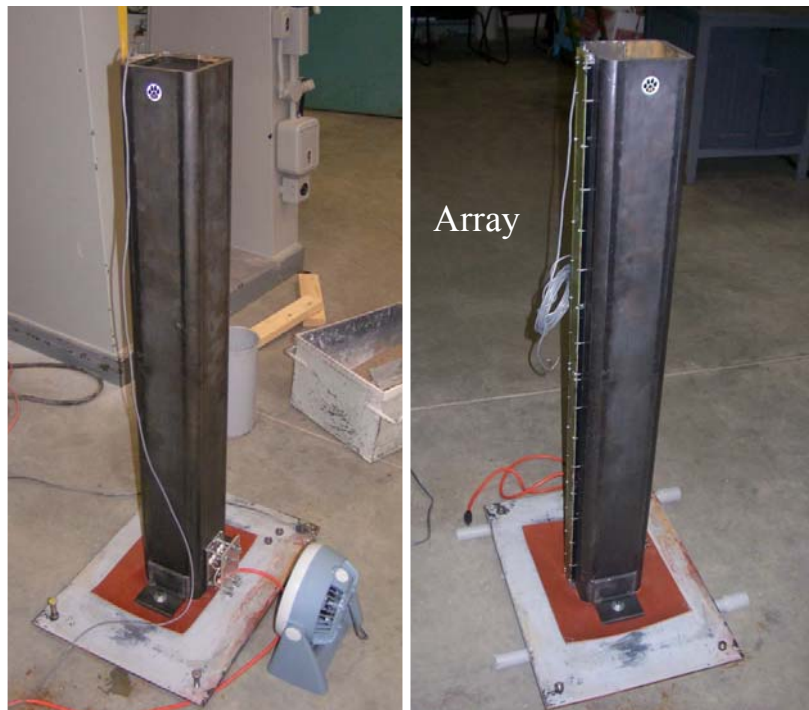
Figure 4.2. Both sides of large test pile, showing heater and array locations

Two ceramic heatplates were used to heat the test pile. The ceramic heaters were attached to the pile near the base as shown in Figure 4.2. These ceramic heaters were attached to a switch (120 V AC) that was under software control in a loop circuit that included one of the temperature sensors in the array. Using this configuration, a target temperature for the control sensor was selected, and the heaters were switched to maintain a certain temperature at the sensor location. Since the sensor location was on the opposite side of the pile from the heaters, the thermal inertia of the pile was expected to provide some variation in the thermal behavior of the test pile. Using this test set-up, a thermal gradient could be imposed on the pile, and subsequently quantified using the 16-element sensor array.

Figure 4.2 shows a photograph of the test pile from two angles. The 16-sensor temperature array was attached to the side of the pile, extending from the base to the top of the test pile as shown in the figure. A single three-conductor wire was used to connect the array to the data acquisition computer. The ceramic heaters, attached near the base plate of the test pile, were concealed by a polycarbonate plate to ensure that the heater connections were not inadvertently contacted during the testing. A fan was also used during the testing to speed the cooling of the pile by convection.

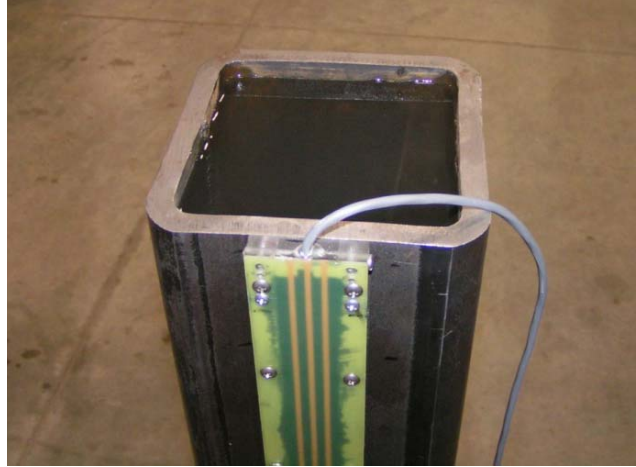
Figure 4.3. Image of sensor array and water-filled test pile

A closer photograph of the test pile is shown in Figure 4.3. The outside of the 16-sensor array of the large array can be seen. The three copper trunk lines are visible through the back of the circuit board, along with the black epoxy. The gray three-conductor wire attaches all of the sensors to the serial port of the test computer through a DS9097U adapter from Dallas Semiconductor. Also, the water can be seen that fills the inside of the pile. The combination of water and sand/soil within the test pile was expected to allow for thermal gradient changes such as would be expected in the field.

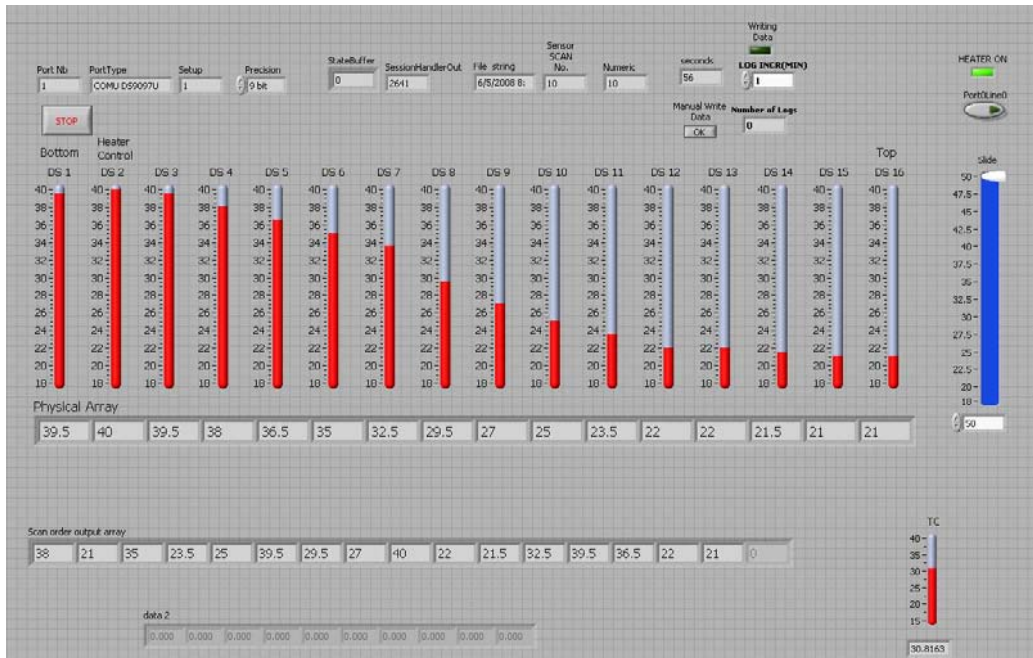
Figure 4.4. Front panel of Labview program

To achieve these objectives, the ceramic heaters were used to impress a thermal gradient in the pile. Typically, the target temperature was set in the range of 30°C–50°C and maintained at that temperature. Testing intervals range from a few hours to more than two weeks to evaluate the longer term performance of the array and the data acquisition system reliability. The software suite that was developed was capable of detecting and measuring the outputs from the 16 temperature sensors and controlling the heating circuit. A screen shot of the software front panel is shown in Figure 4.4.

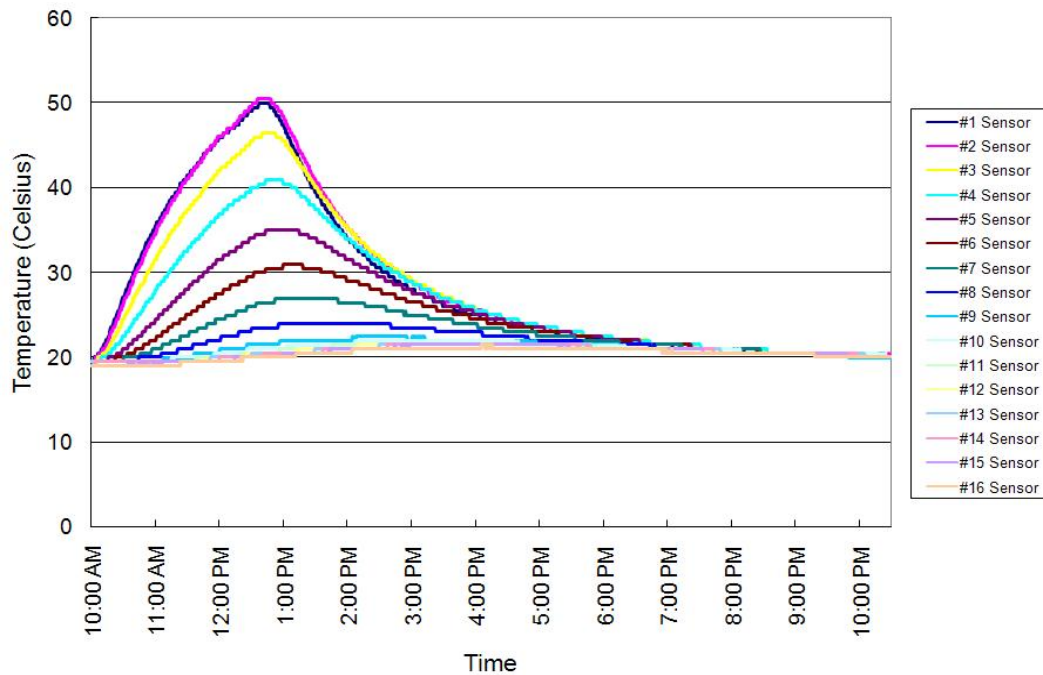
Figure 4.5. Sensor array measurement during heating to and cooling

The testing of the 24-sensor array demonstrated the effectiveness of the new measurement technology. Figure 4.5 shows one test where the whole pile started at room temperature and was heated. When the sensors nearest the heater reach 50°C the heater was turned off. From the start of the test to the peak temperature took about three hours, and from there back to equilibrium took about seven hours. The eighth sensor, which was the last sensor on the first circuit board, was the furthest away from the heat source that registered a significant differential from the adjacent sensor. The test illustrated the gradient measured along the pile that was detected by the sensors in their complete array configuration, and data was successfully stored for later processing. The test also illustrated that the sensor array responded in a timely manner to impressed thermal changes.

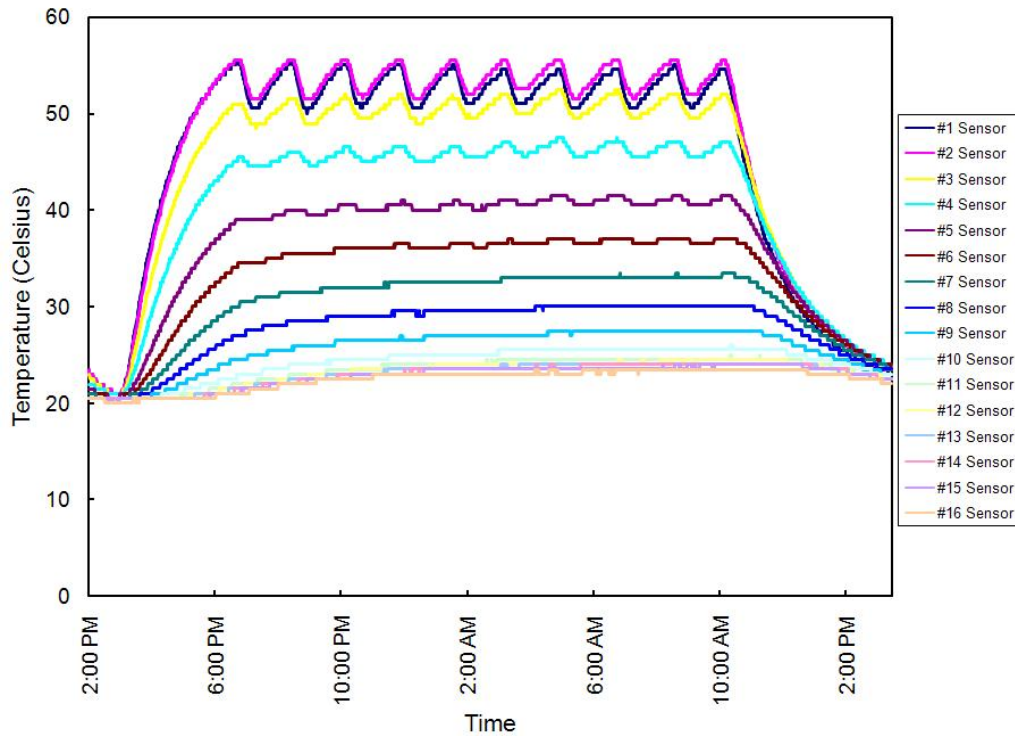
Figure 4.6. Sensor array output during one-day, 55° test

Results are plotted in Figure 4.6 for a test where the target temperature of 55 °C was maintained for about 18 hrs. Again, it took about the same amount of time to heat and cool, but this time the ninth and tenth sensors registered a significant differential from adjacent sensors. The maximum temperature reached by the coldest sensor was 25 °C. The figure illustrates that sensors 1 and 2 responded rapidly to the application of heat from the ceramic heaters mounted on the test pile.

The control system for these ceramic heaters turned the heaters on and off as a result of temperature measurements received from sensor 2. As a result of the thermal inertia of the steel pile filled with soil and water, there was a delay in the response of the system to applied heat. This delay manifested itself in the variations in the temperature measurements in time shown in the figure.

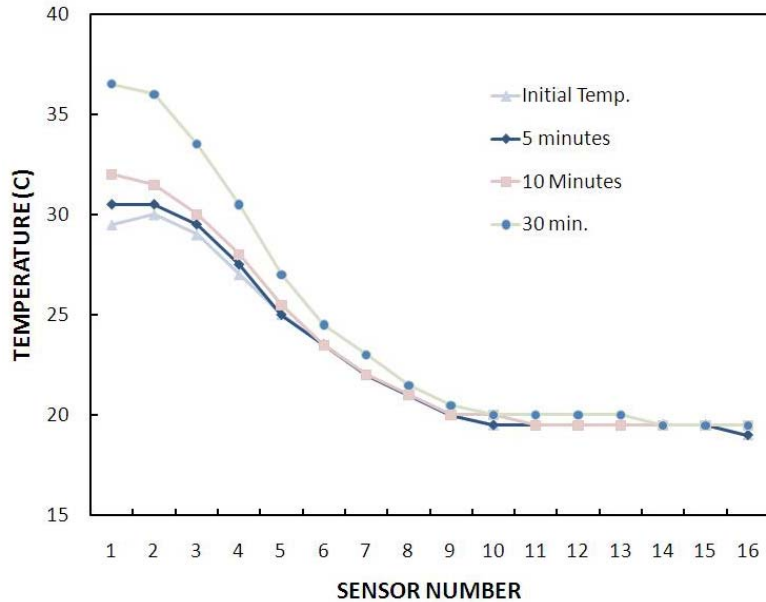
Figure 4.7. Temperature gradient in the test pile during heating

It is as useful to examine data from the test pile as the thermal gradient along the pile. Figure 4.7 shows the thermal output of the sensors along the length of the pile, starting with sensor 1 located nearest the heaters and ending with sensor 16, which is the furthest sensor from the heaters, located at the top of the pile. The vertical axis is temperature as usual. The figure shows the development of the thermal gradient in the pile as heat is applied by the ceramic heaters. As shown in the figure, the sensors nearest the heaters responded to applied heat, and a thermal gradient was developed in the pile as intended. Sensors farthest from the pile did not respond to the applied heat. It is also easier to see how much each sensor changed during the test; for example, the output of sensor 1 significantly changed in the final 20 min of the test. Graphing data as the gradient along the length of the pile improves the ability to identify where the soil/water interface exists, and how this interface changes over time. This is achieved by rotating the graph 90° so that it is aligned with the pile in the ground and with the sensors on the vertical axis from deepest in earth to the water on top.

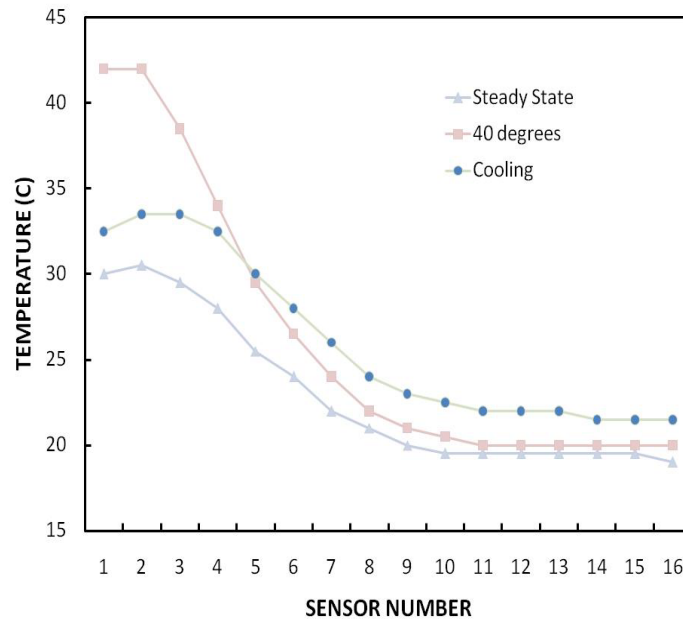
Figure 4.8. Temperature gradient in the test pile during heating and cooling

Figure 4.8 shows the thermal gradient along the length of the pile for three conditions. The steady-state condition is the thermal gradient in the pile after a test temperature of 30°C has been established and maintained for several days. This is an established, steady thermal gradient along the length of the pile. The test temperature was then raised to 40°C, resulting in the increased thermal gradient along the length of the pile as expected. The test temperature was subsequently adjusted to 20°C. During the cooling of the pile, the thermal gradient was reduced as sensors responded to the pile reaching toward thermal equilibrium. This is illustrated by the increased temperatures of sensors 9–16, as the thermal wave resulting from the increased test temperature propagated through the pile. This testing illustrated that the sensor array was sensitive to changing thermal conditions and was capable of determining the thermal gradient along the test pile under a variety of thermal conditions.

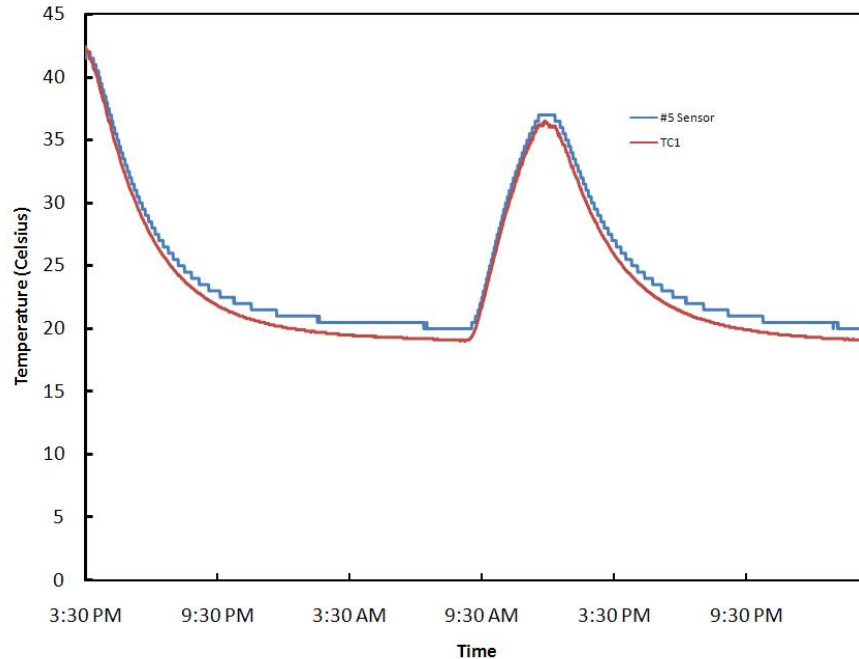
Figure 4.9. Thermocouple and DS18S20 readings during cooling and heating

It was also necessary to establish the time delay for the sensor array to respond to a thermal change relative to the thermocouple, to determine if system performance would be negatively impacted by the array design. Because the sensors are embedded in epoxy, it is expected that some delay will exist between changing thermal conditions outside the array and the actual array response. Figure 4.9 shows the results of testing to determine how much lag exists from the sensor array relative to a basic K-type thermocouple. The thermocouple was placed directly along the side of the large array, in-line with sensor 5. All other sensors had been removed from the graph for simplicity. At the outset of the test, the thermocouple read 42.4 °C, while the DS18S20 read 41.5 °C. They both cooled for almost 18 hr, after which the thermocouple read 19°C and the DS18S20 read 20°C. The heater was turned on, and the thermocouple first showed a temperature increase at 8:57 a.m. The DS18S20 showed its first increase at 9:03 a.m. Note that the DS18S20 only has a resolution of 0.5 °C, so that the output may not change until 0.5 °C temperature variation is experienced. At the top of the next peak, at 12:15 p.m., the thermocouple read 36.5°C while the DS18S20 on the array read 37. Finally, at the end of cooling, the thermocouple showed 19.1°C while the DS18S20 was at 20°C. In this test, the sensors reacted very similarly to applied heat, and there was only a small lag in the response of

the sensor array relative to a thermocouple device. The DS18S20 sensor also registered a slightly higher temperature than the thermocouple throughout the test, possibly due to calibration differences between the sensors.

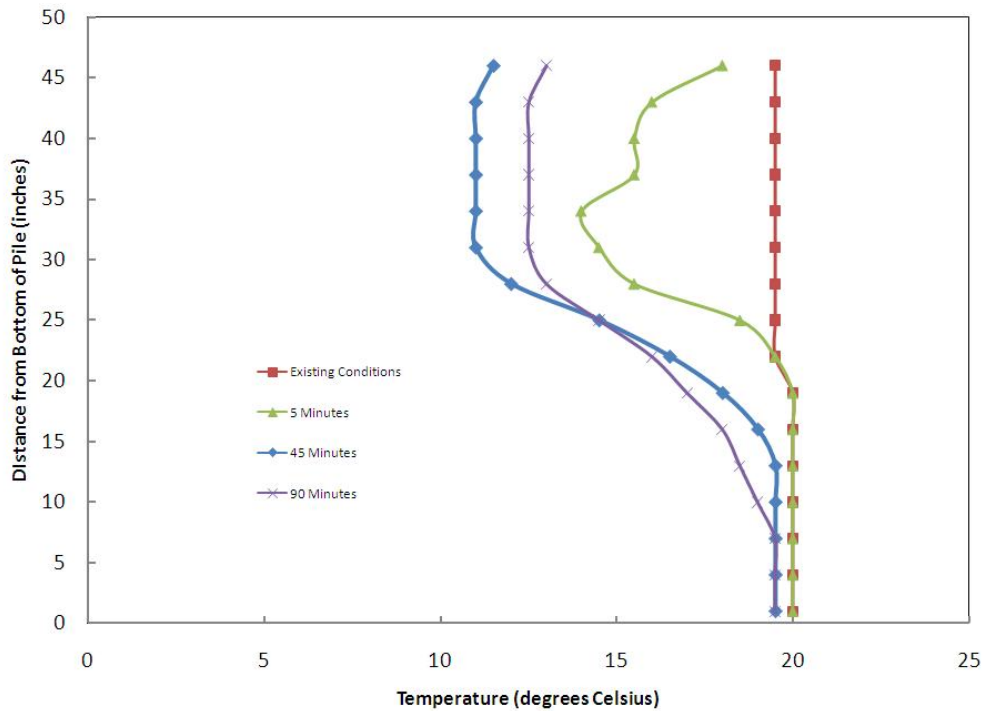
Figure 4.10. Thermal gradient along the length of the test pile during cold water test

fill the test pile with cool water during the testing, to model the behavior of running water in a streambed. The water in the test pile was replaced with cool water. This was done by using two siphons, one deep in the pile to remove the ambient temperature water, and one pouring cool water into the pile. The results of this test are shown in Figure 4.10, which shows a number of thermal profiles of the pile at different times after the initiation of the water exchange in the test pile. The figure shows the thermal profile in the pile at the initiation of the test (existing conditions), and 5, 45, and 90 min. after the test initiation. The large difference in temperature of the water and dirt created results that clearly showed the interface to be between the fifth and the 11th sensor, corresponding to 13 and 31 in. from the bottom of the test pile. The actual interface is located at approximately 24 in. from the bottom of the pile. As illustrated in the figure, the interface resulted in a significant change in the thermal gradient along the pile that was detected by the sensor array. This test illustrates that the sensor array prototype is capable of making the desired measurement to monitor changes in this water/soil interface. A total temperature difference of 8.5°C existed between the hottest and coldest sensor.

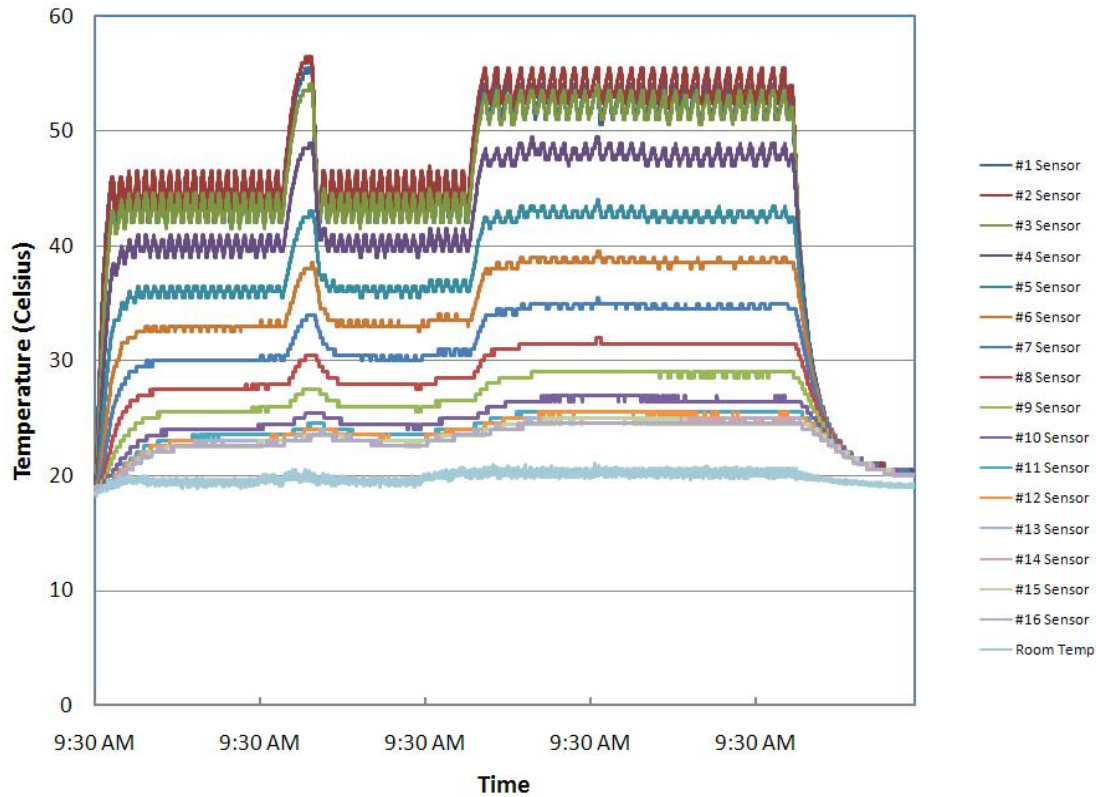
Figure 4.11. Results of monitoring the sensor array over a five-day period

Figure 4.11 shows the output of the sensor array mounted on the test pile over a time period of five days, with several changes in thermal conditions impressed on the pile by the ceramic heaters. During this particular test, the temperatures ranged from 18.5°C to 56.5°C. Room temperature remained just below 20°C for the duration. When the test began, the whole pile was at room temperature. The heater control temperature was set to 45°C for over 24 hours. The control temperature was then raised to 60°C and returned back to 45°C as it approached this control temperature. The control temperature was again raised to 55°C and allowed to stay there for almost 48 hr. The heater was then shut off so that the pile could return to room temperature.

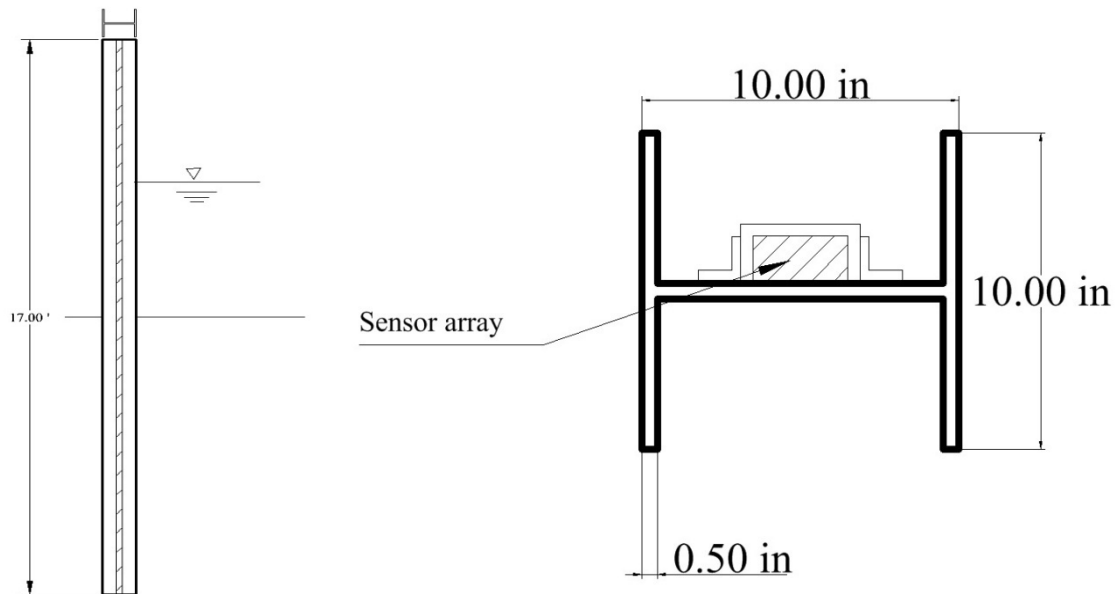
Figure 4.12. Schematic diagram of prototype pile for field installation

A design for a prototype pile to be installed in the field has been developed, and construction is ongoing. A 10-in. H-pile that is 17 ft in length has been selected and purchased. The innovative sensor array technology developed during this project will be installed along the web of the pile as shown in Figure 4.11. The sensor array is armored inside a 3/8-in. thick C-shaped steel cover as shown in the figure. This will protect the array during pile-driving operations. The sensor array will include a sensor every four in. along the length of the pile to be installed in the field. A total of 64 sensors are to be utilized along the length of the pile. The pile will be driven into the stream bed so that approximately 1/2 of the pile is exposed to flowing water. The sensor array will be connected to a computer located in a nearby test house. This computer will utilize a cell phone modem to provide data in near real-time to monitor the conditions at the pile.

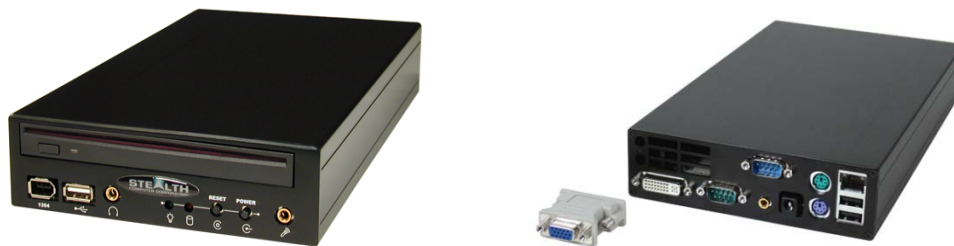
Figure 5.1. Front and back image of LPC-350

An LPC-350 Mini PC from Stealth Computer Corporation was recently purchased for the on-site data collection. It was selected due to its small footprint and because it has a serial connection, which was needed for data acquisition through our setup. Figure 5.1 shows the front and back of the Mini PC. An on-site enclosure will house the computer and data acquisition system. This enclosure will include the Mini PC, keyboard, mouse, monitor, and a small air conditioner. Future research and development is required to develop a final implementation of this new technology. Because the 1-Wire sensors utilized are extremely low power and require a minimal amount of wiring, it is anticipated that this technology can be brought to maturity by the design of the solar- or battery-powered data acquisition system that can be installed on a pile in the field. Using a single-board computer, a data acquisition system with a very small footprint could be developed. This would enable the technology to be widely implemented for the monitoring of bridge assets in the field.
