# Recommendations for Achieving Safety Edge Consistency during Paving

Iowa Department of Transportation  
Federal Highway Administration  
Accelerating Safety Activities Program  
(InTrans Project 11-407)

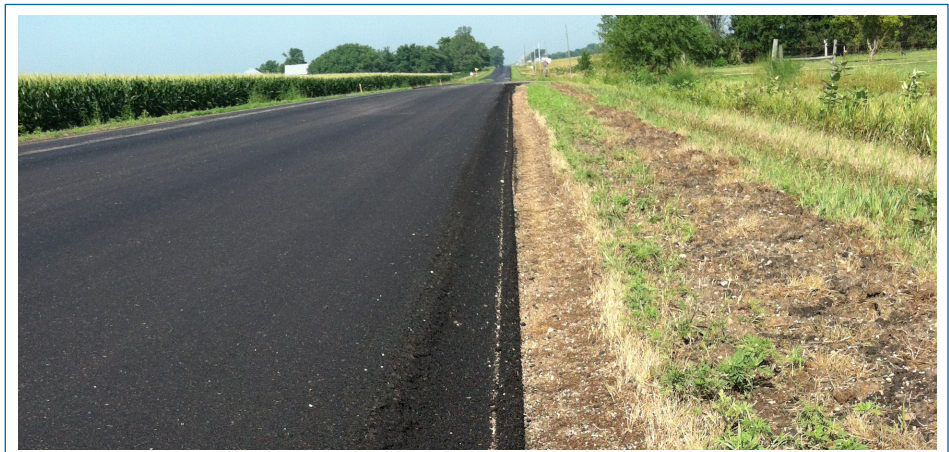
Figure 1. HMA Safety Edge in Kossuth County, Iowa

The Safety Edge is a design feature that creates a slope along the outermost edge of the paved section of the roadway. The Safety Edge is placed most commonly during hot-mix asphalt (HMA) paving using a device that shapes and consolidates the asphalt material at the pavement edge into an approximate 30 degree fillet as shown in Figure 1.

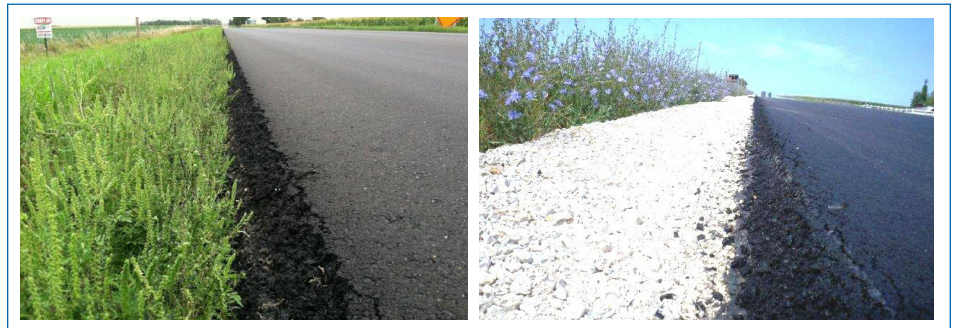
Figure 2. Insufficient base widths

Even when properly applied, the long-term stability of the Safety Edge can be compromised if the base width is insufficient to accommodate the design width of the surface layer. When this occurs, the upper layer width will extend beyond the base resulting in lack of proper support for the Safety Edge (with results as shown in Figure 2).

For efficiency of operations and an acceptable final Safety Edge, a plan must be devised to establish a base width (Figures 2 and 3) necessary to accommodate the width of succeeding upper layers, while also following the pavement centerline as closely as possible.

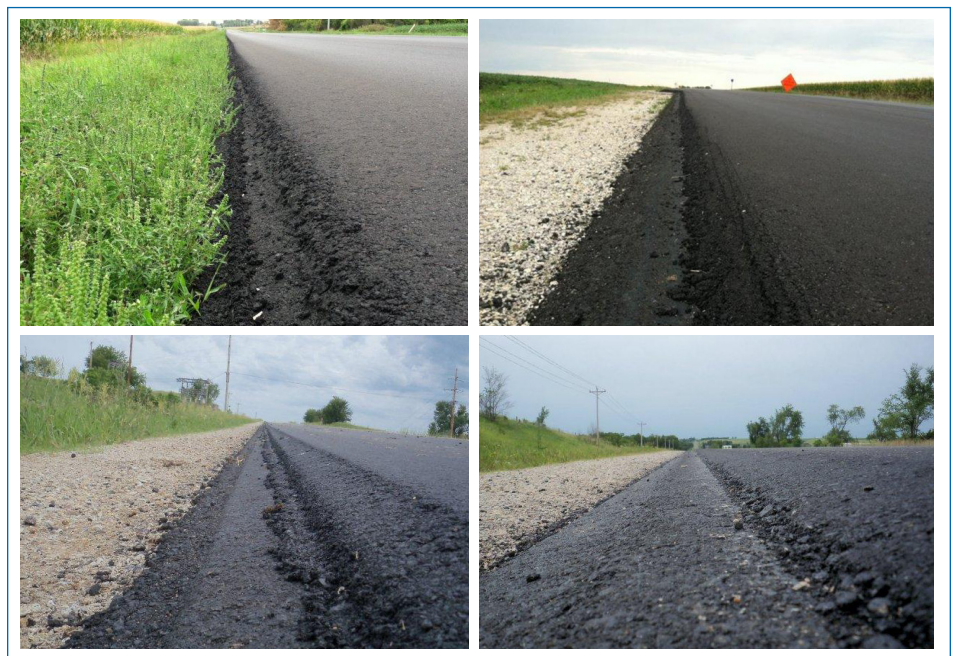
Figure 3. Excess base widths

Where multiple lifts are designed, prior planning and proper paver operation are needed to avoid excess (and unused) base width with lower lifts and/or insufficient width to support the upper layer(s) completely. If the base width is too great, the results could be as shown in Figure 3 with wasted material.

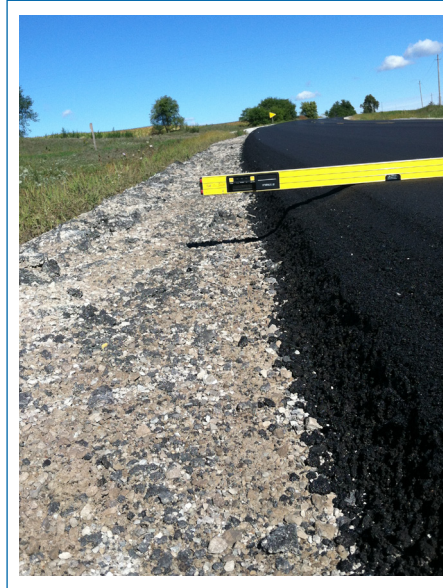
**Figure 4. Severe pavement edge drop-off near outside of curve**

Figure 4 shows a large elevation difference in a tangent section (which can also occur outside of curved areas), where the vertical alignment of a segment is being improved or corrected.

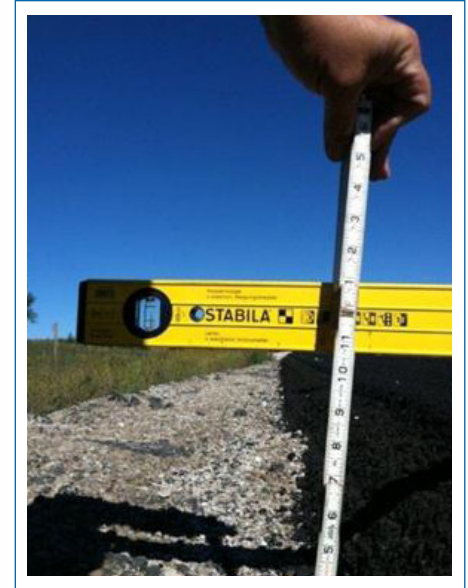
**Figure 5. Severe pavement edge drop-off (10-12 inches)**

As illustrated in Figure 5, even with a perfect 30 degree Safety Edge slope, smaller errant vehicles could easily high center on the pavement edge and lose control with an excessive drop-off height.
