Evaluation of the Safety Edge in Iowa: Phase II

Final Report
December 2012

Iowa Department of Transportation
Federal Highway Administration
Accelerating Safety Activities Program
(InTrans Project 11-407)

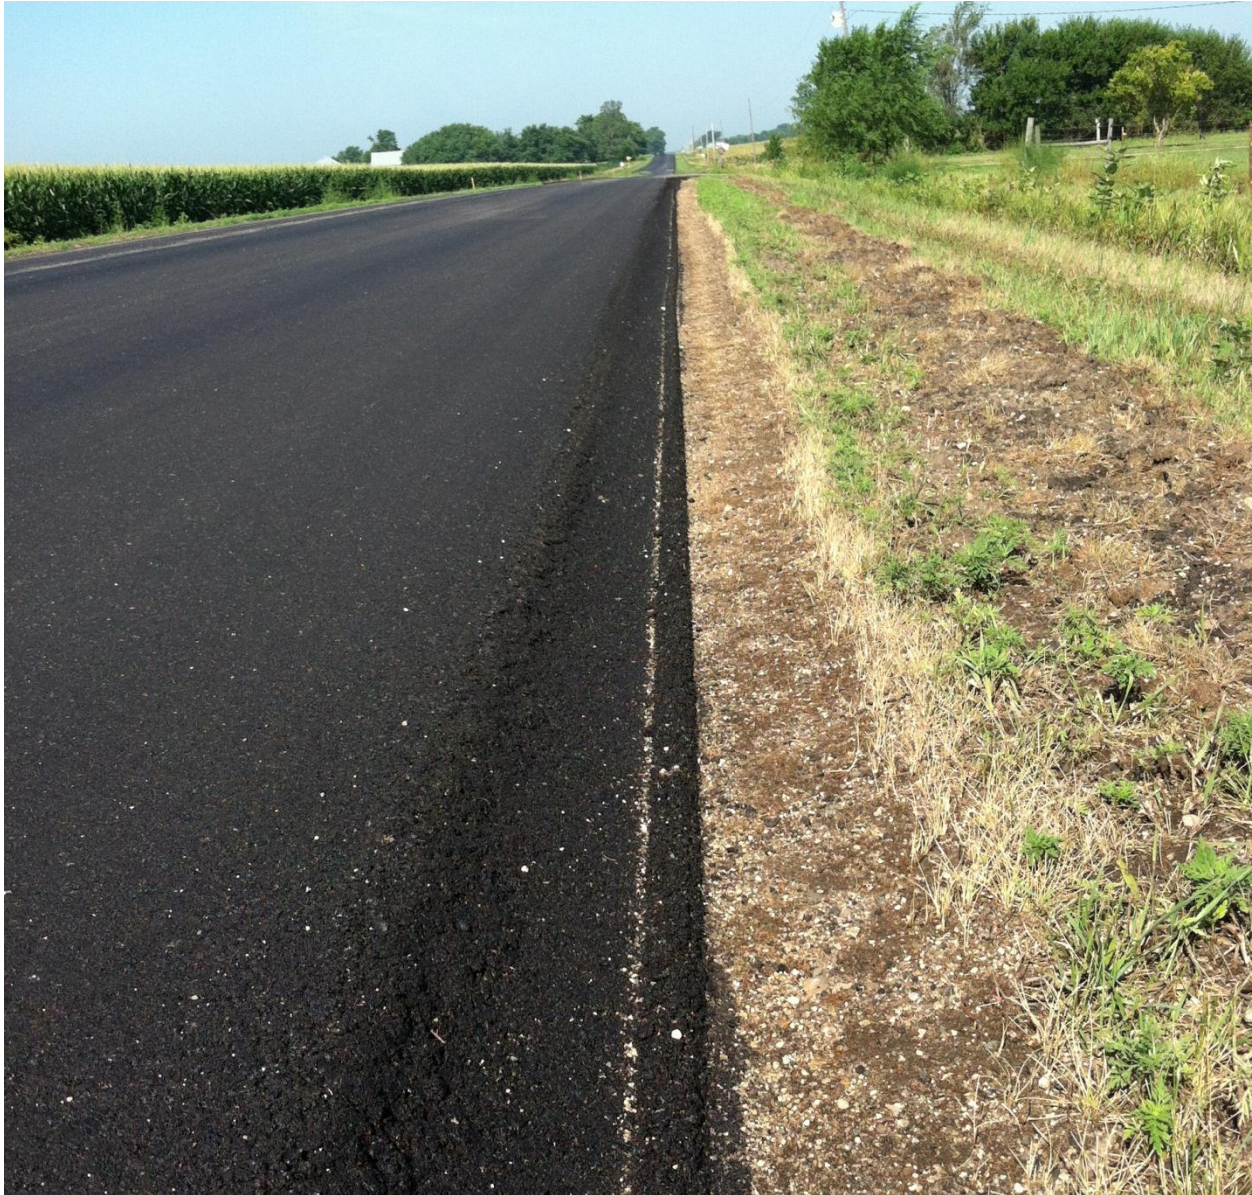
Figure 1. HMA Safety Edge in Kossuth County, Iowa

The Safety Edge is placed during HMA paving most commonly using a device called a shoe that shapes and consolidates the asphalt material at the pavement edge into an approximate 30 degree fillet as shown in Figure 1.

The Safety Edge shape reduces the likelihood that scrubbing will occur and provides a gradual rather than abrupt transition back to the roadway as an errant vehicle remounts the pavement surface. The Safety Edge provides this benefit before unpaved shoulders have been restored after resurfacing, as well as when the shoulder material has migrated away from the pavement edge over time due to wear or erosion.

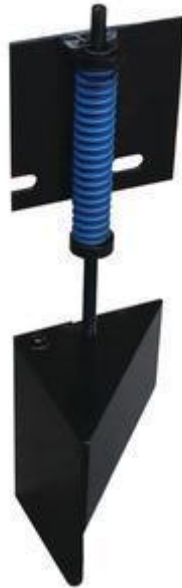
Figure 2. TransTech Shoulder Wedge Maker

This is a first-generation shoe that was used on many of the construction projects evaluated with the earlier study. This design was also used for eight projects that were reviewed for this report.

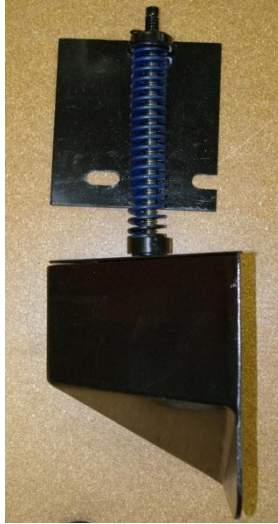
Figure 3. Troxler SafeTSlope Edge Smoother

This is a first-generation shoe that is designed very similar to the TransTech model listed above. It was reported to have been used on a DOT project in eastern Iowa, but upon further review, it appeared that the TransTech shoe was the model actually used. It is believed that the Troxler shoe might have been manufactured by TransTech for the Troxler company but apparently no further distinctive improvements to that design have been made.

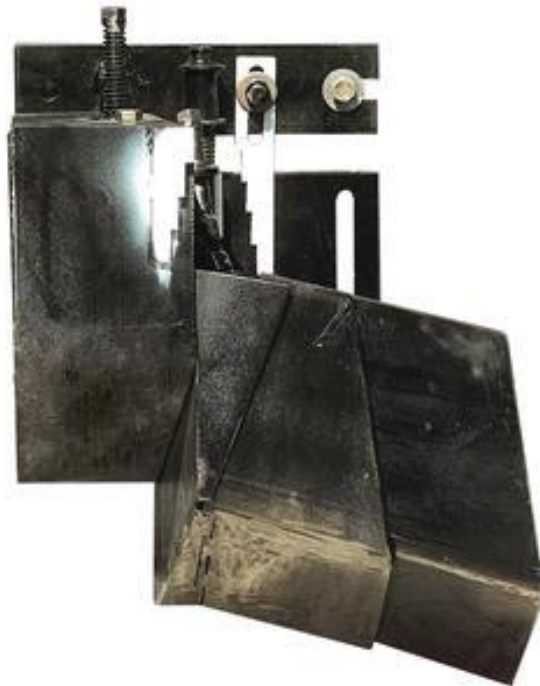
Figure 4. TransTech Notched Wedge Joint Maker

This shoe design has been used successfully for three years by one local Iowa agency and many of those projects have been reviewed by the research team. Although the consistency of the final slope angle seems to vary with the depth of HMA lifts, the design appeared to have worked well.

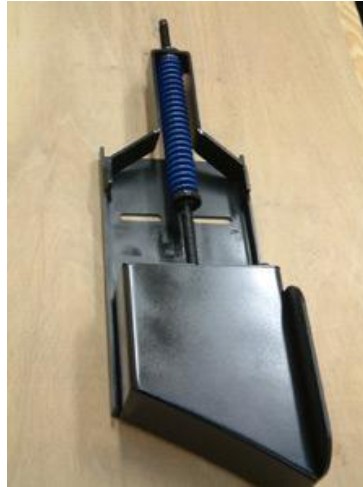
Figure 5. Advant-Edger

Work performed with this first-generation shoe was reviewed and reported in the 2010 evaluation, and this shoe was also utilized again on a 2011 project, which is included in this report.

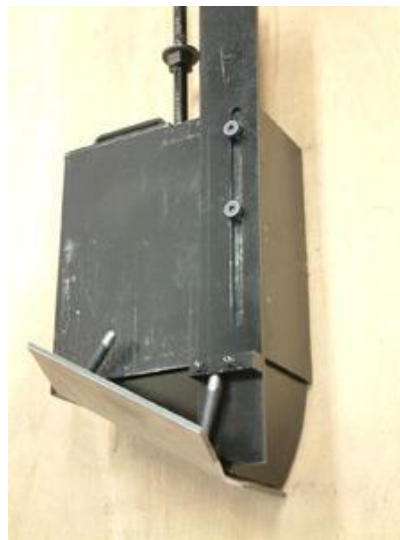
Figure 6. Advant-Edge Ramp Champ

This is a second-generation shoe. Work performed on six projects in two separate counties was evaluated in 2011/2012 and found to provide more consistent and desirable results than the earlier model for the most part.

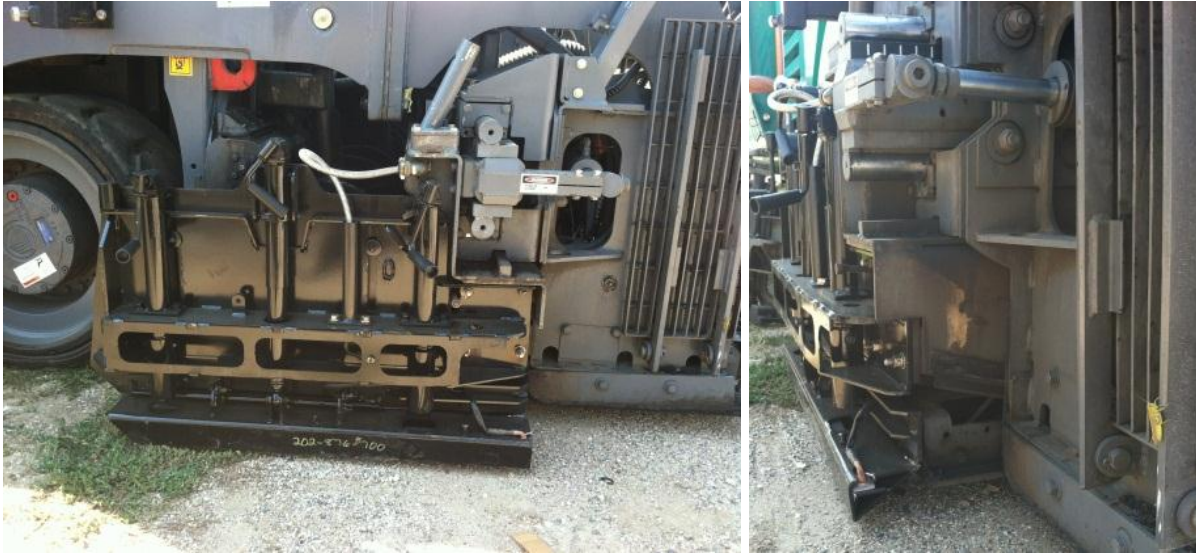
Figure 7. Carlson Safety Edge EndGate

This differently designed Safety Edge device could be considered a second-generation model, although it is the first by this company. It was used on only one 2012 project that was reviewed and appeared to have potential for producing a good product.

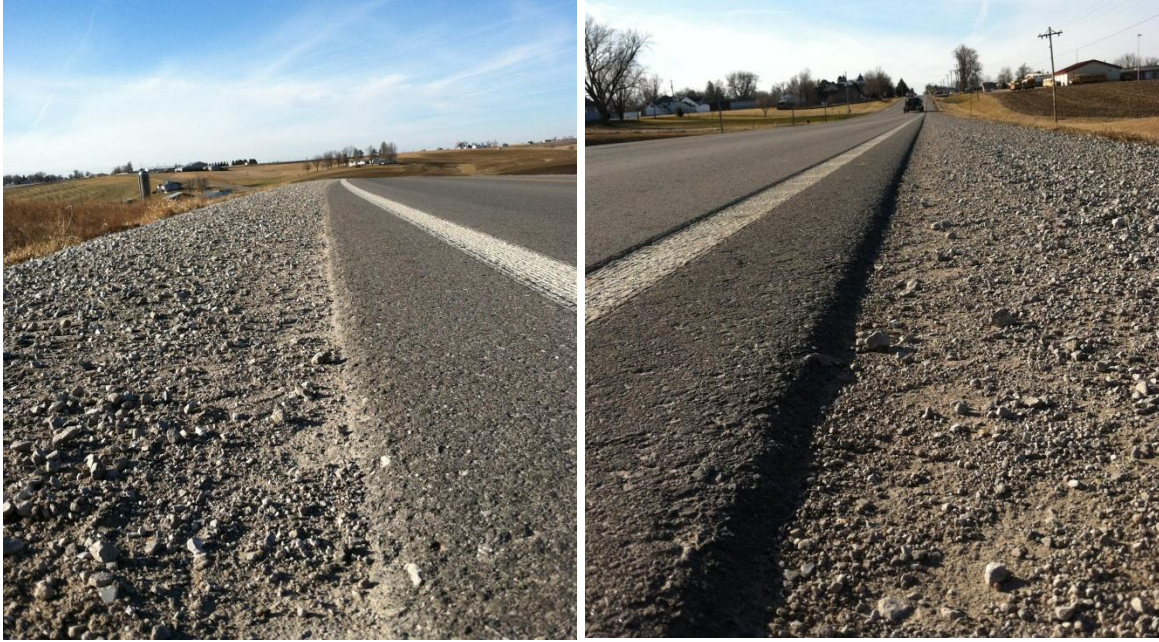
The images shown in Figures 8 and 9 are typical of the edge drop offs observed and measured on both HMA and PCC pavements with and without the Safety Edge. Although the average settlement magnitudes were nearly identical with and without the Safety Edge, it was obvious that an errant driver's ability to remount the pavement would be drastically different with or without the Safety Edge.

Figure 8. Typical shoulder degradation for HMA pavements with the Safety Edge (left) and with less than 30 degree slope (right)

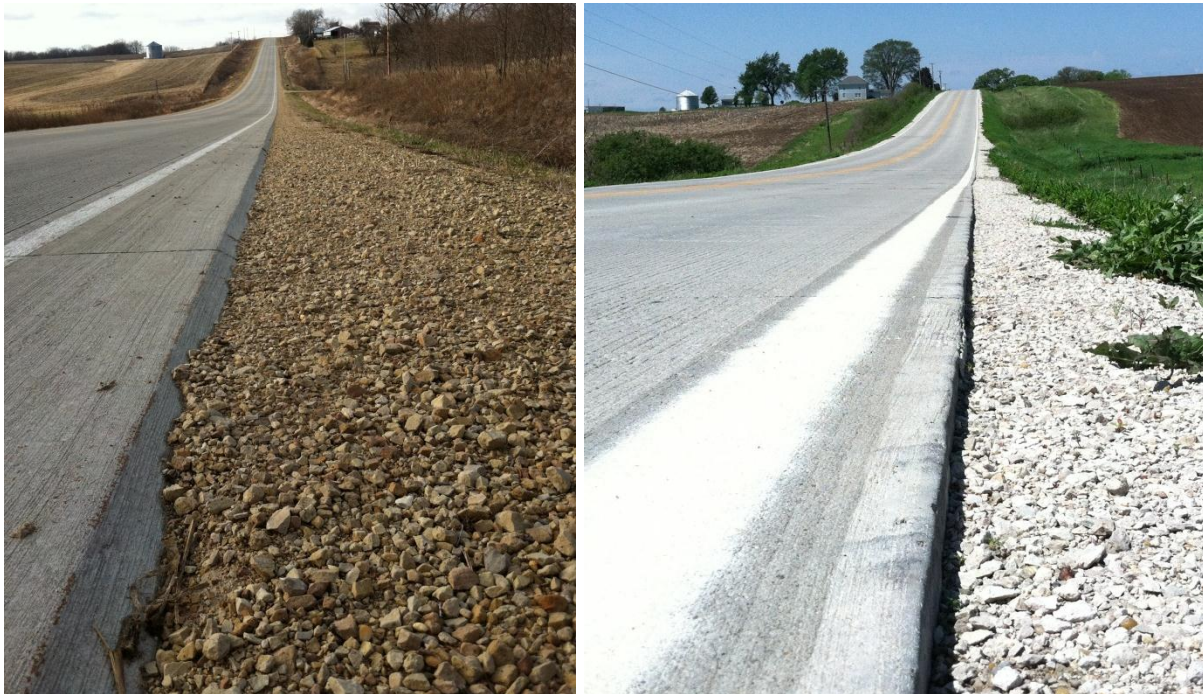
Figure 9. Typical shoulder degradation for PCC pavements with the Safety Edge (left) and without it (right)

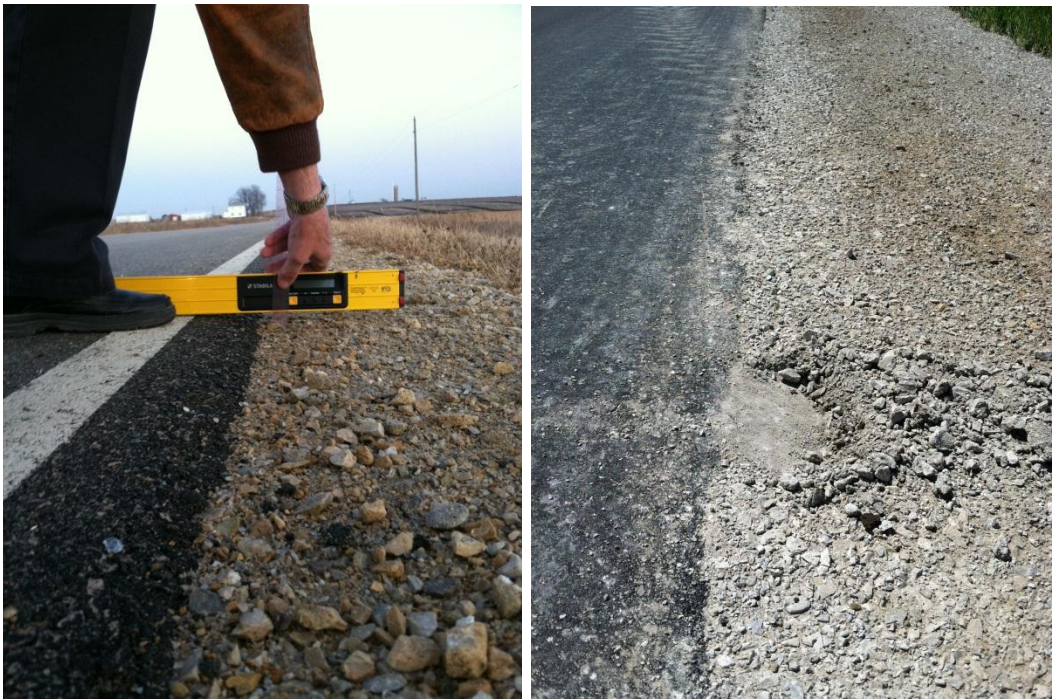
Figure 10. Exposed Safety Edge slope faces

removal of the granular shoulder material was necessary, which also presented the opportunity to examine the sloped edge for deterioration, as illustrated in Figure 10.

During these investigations, no areas were observed that showed evidence of any increased deterioration. However, in some locations, pavement cracking (Figure 11) was evident, indicating probable construction problems, such as inadequate base width and/or support, that were not related to the Safety Edge.

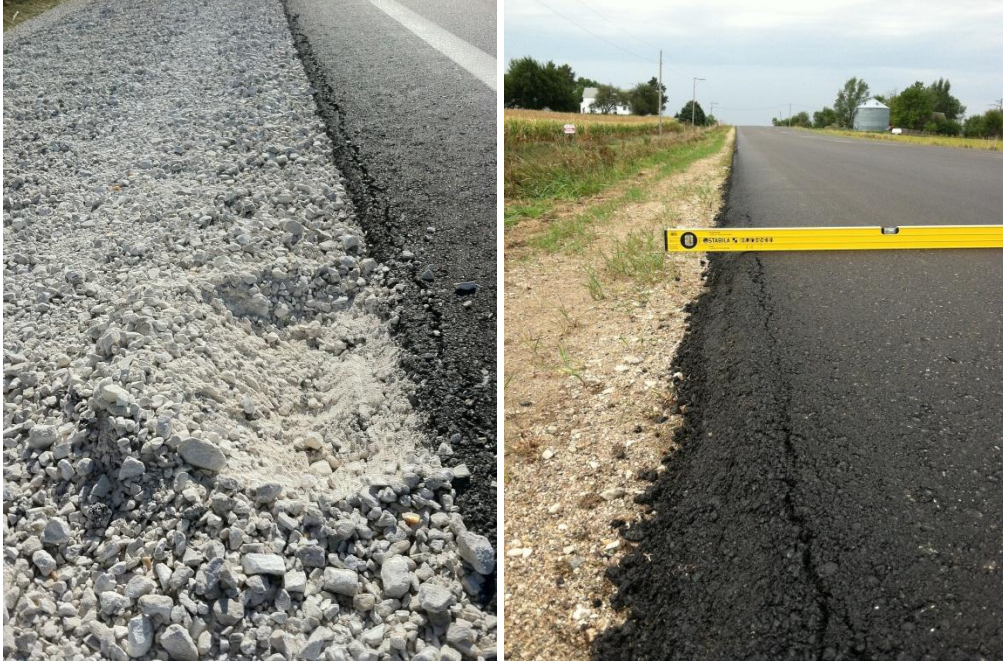
Figure 11. Edge cracking from apparent lack of shoulder support

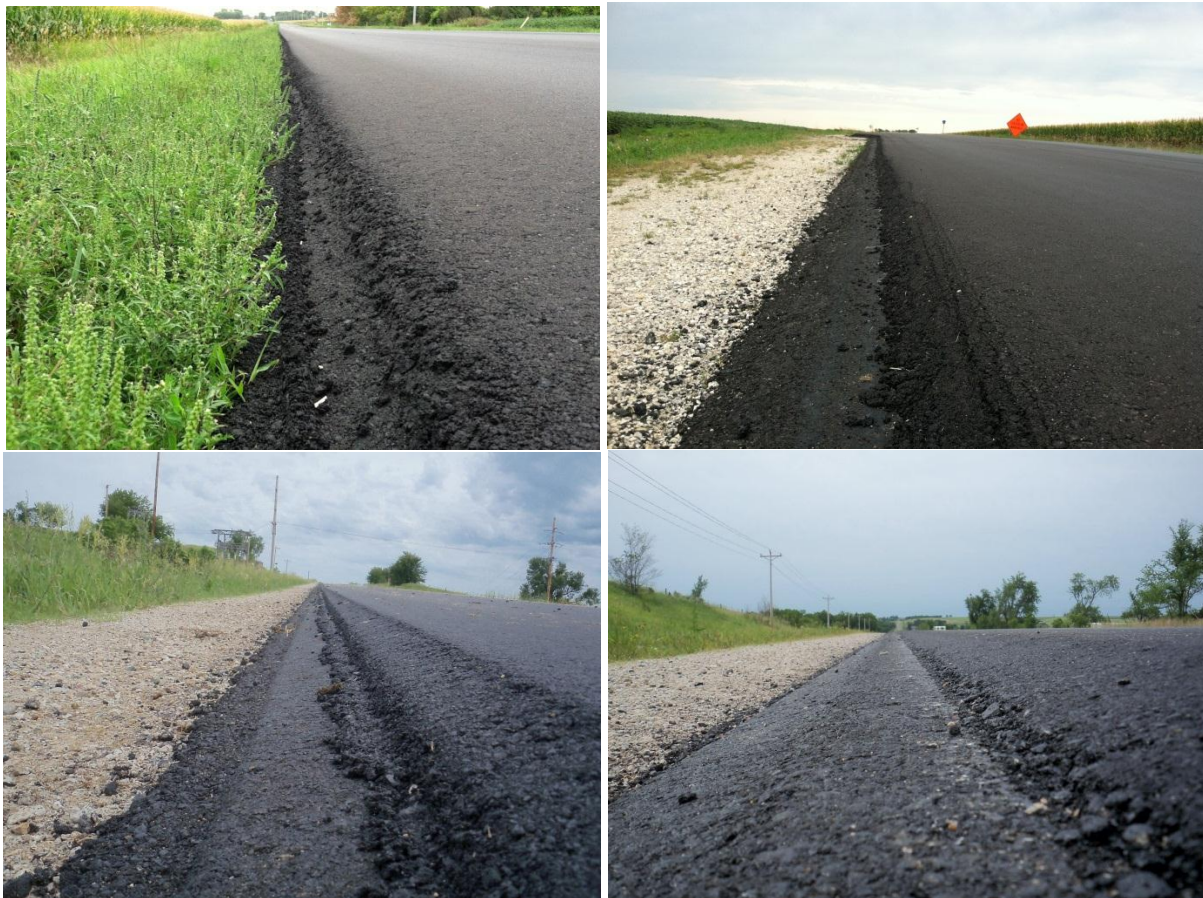
For efficiency of operation and an acceptable final Safety Edge, a plan must be devised to establish a base width necessary to accommodate the width of succeeding upper layers, while also following the pavement centerline as closely as possible. If the base width is too great, the results could be wasted material as shown in Figure 12.

Figure 12. Excess base width examples

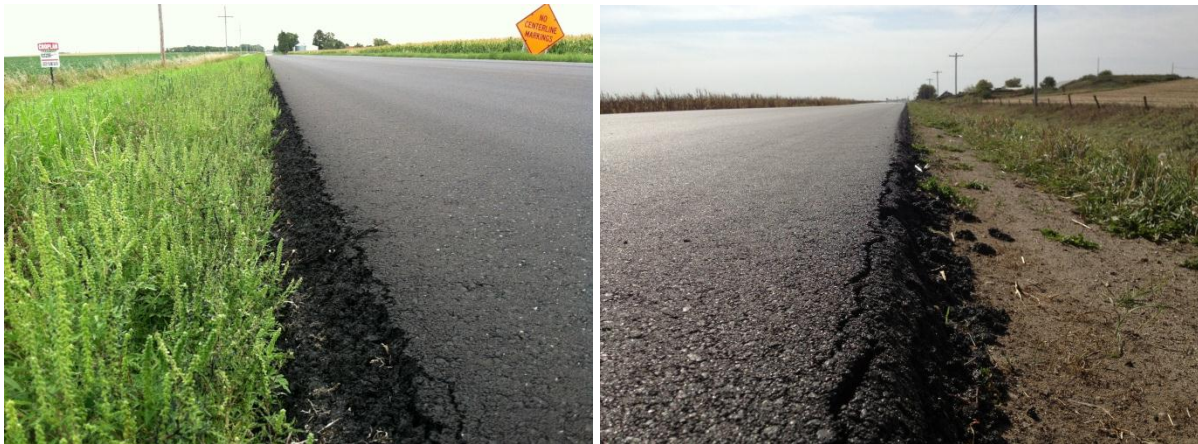
Conversely, if the base width is insufficient, the upper layer width could extend beyond the base resulting in lack of proper support for the Safety Edge as shown in Figure 13.

Figure 13. Insufficient base width examples

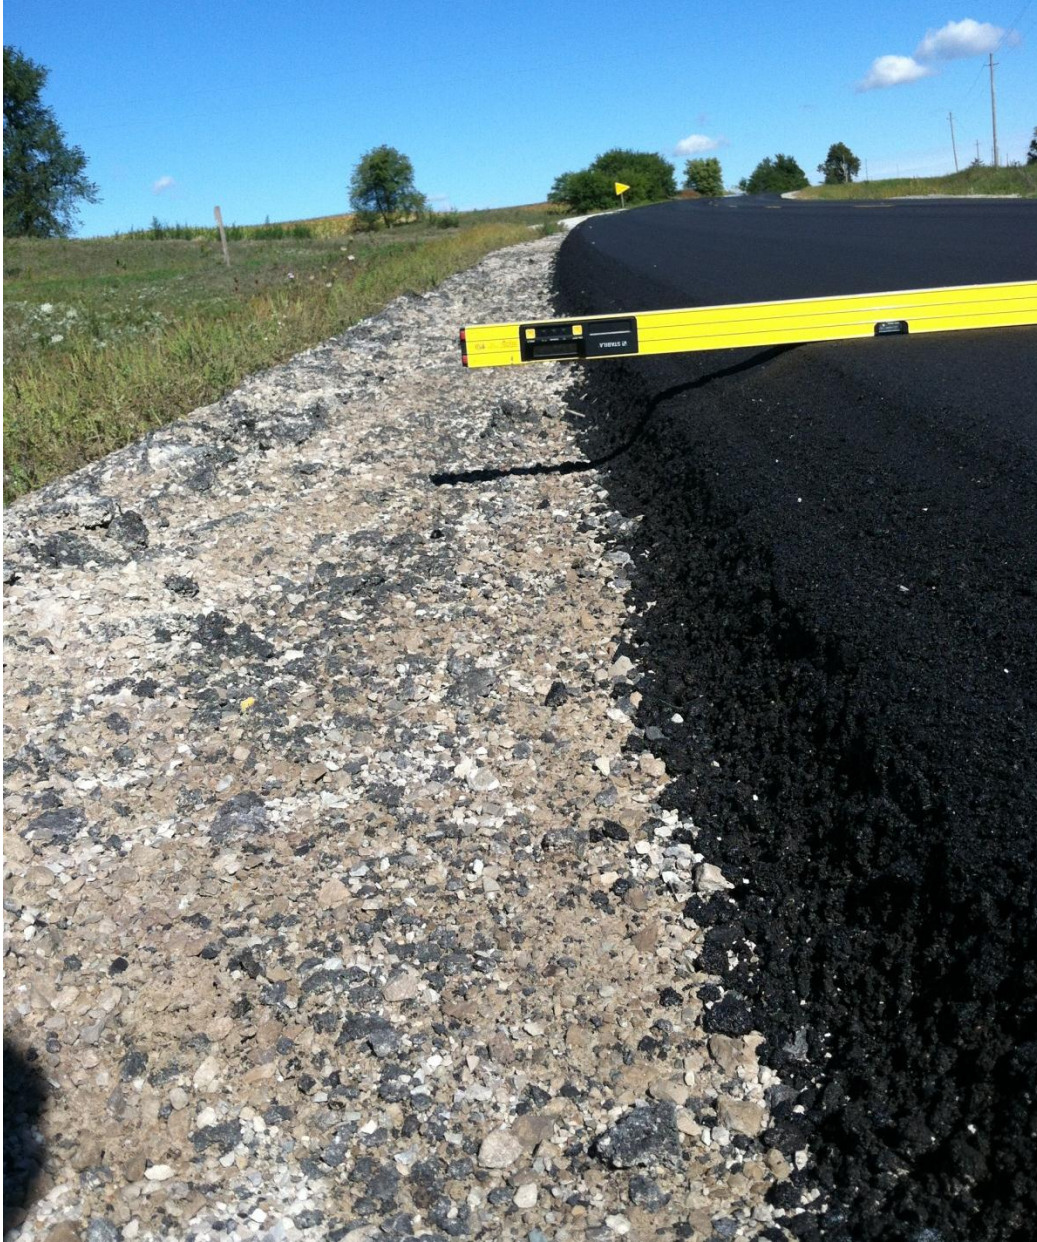
In addition, if the roadway is open to traffic during construction, attention must be given to the drop-off height created in super-elevated locations, even if the Safety Edge slope is acceptable. Figure 14 shows a large elevation difference in a tangent section, which can also occur outside of curved areas, where the vertical alignment of a segment is being improved or corrected.

Figure 14. Severe pavement edge drop-off near outside of curve

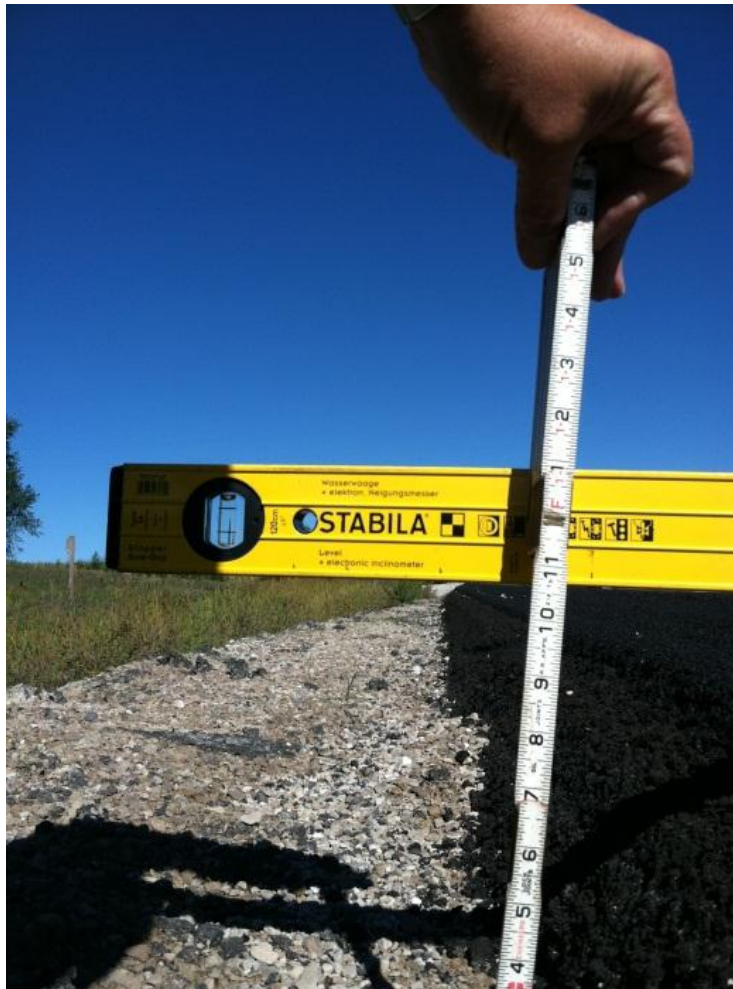
Figure 15. Severe pavement edge drop-off

An interim degree of shouldering should be required where excessive vertical differences in the shoulder and pavement elevations have been created. As illustrated in Figure 15, even with a perfect 30 degree Safety Edge slope, smaller vehicles could easily high center when leaving the pavement and lose control.
