Evaluation of Low Cost Traffic Calming for Rural Communities – Phase II

**Updated Final Report
October 2013**

Federal Highway Administration
Iowa Department of Transportation
Iowa Highway Research Board
(IHRB Project TR-630)
Midwest Transportation Consortium
(InTrans Project 11-393)

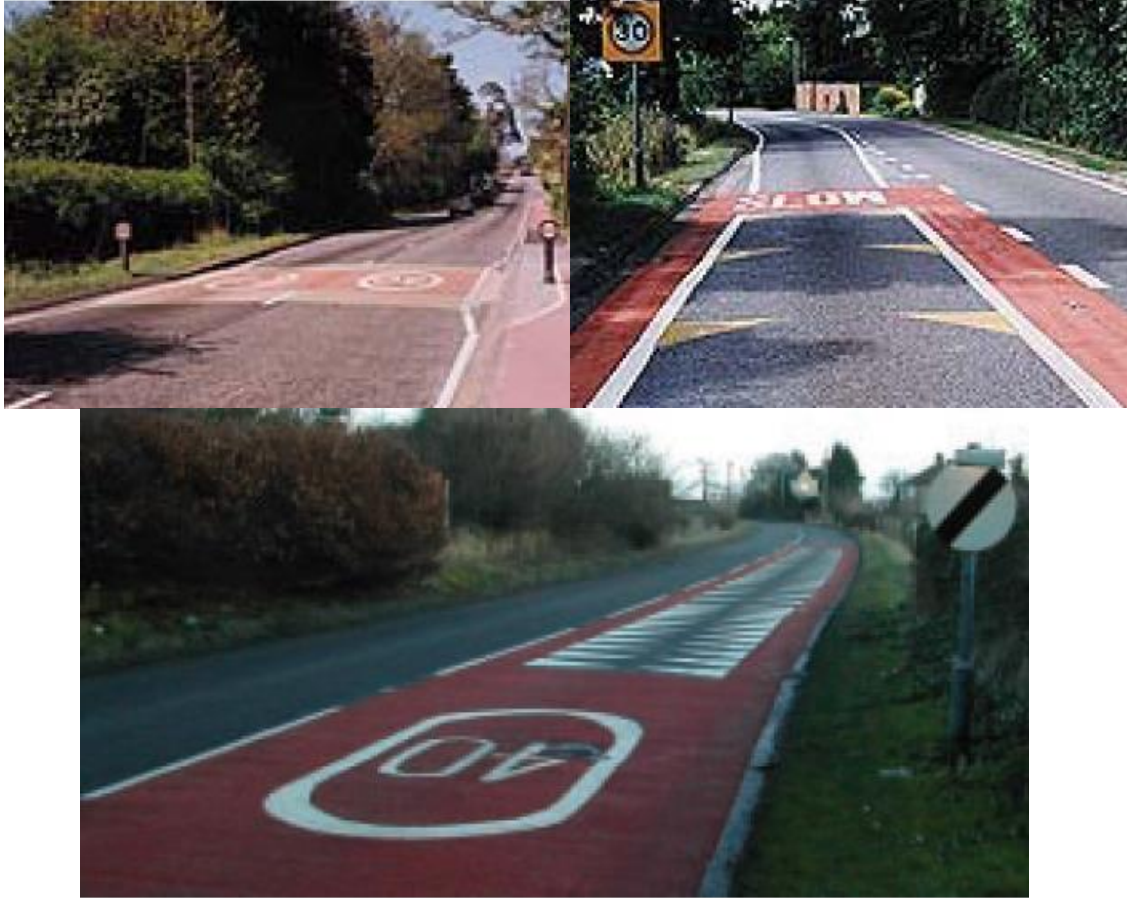
Figure 3-4: Red markings with posted speed limits used in European gateways (Sustrans 2004)

Colored surface dressing or textured surfaces are common traffic-calming treatments in the United Kingdom (UK) and are often used in conjunction with gateways or other traffic-calming measures to emphasize the presence of traffic-calming features. Colored or textured surface treatments draw attention to the fact that something about the roadway is changing and provide visual clues to drivers that they have entered a different area. Some common European entrance treatments using lane narrowing and red surface markings are shown in Figure 3-4.

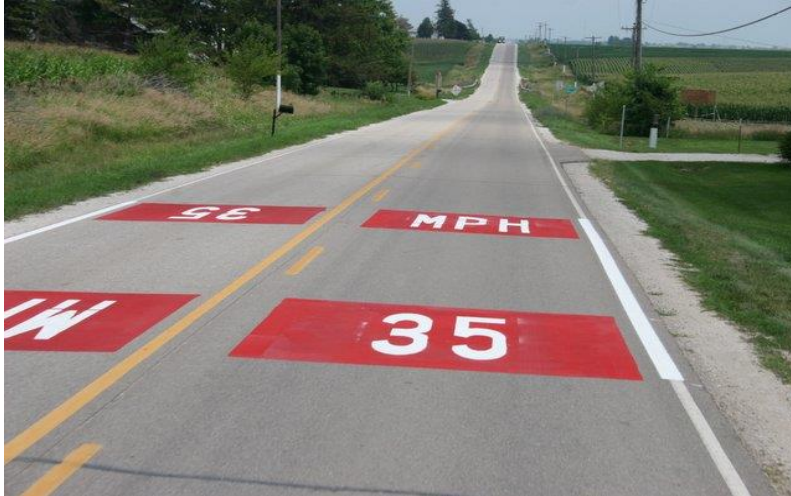
Figure 3-5: European-style traffic-calming treatment used in Dexter, Iowa

In a previous Iowa study, a modification of the European treatment was evaluated at the entrances to Dexter, Iowa along 350th Street (State Highway 925), as shown in Figure 3-5.

The treatment in Dexter resulted in a reduction in mean speed of 5.4 mph and a reduction in 85th percentile speed of 8 mph. The percentage of drivers traveling 5 or more mph over the posted speed limit was reduced by up to 32 percent and the percentage of drivers traveling 10 or more mph over the posted speed limit was reduced by 14.5 percent (Hallmark et al. 2007).

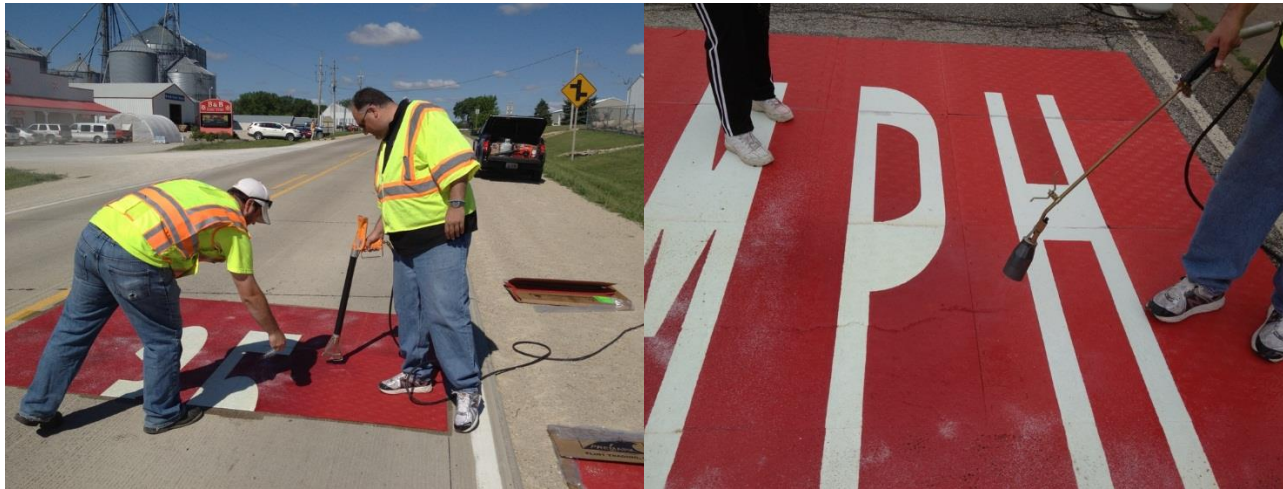
Figure 3-8: Installation of colored entrance treatment

The colored-box portion of the treatment was constructed from a thermoplastic high-friction material so that the area is skid resistant. The treatment is placed on the roadway by heating as shown in Figure 3-8. Glass beads are added while the treatment is placed to increase the visibility and skid resistance. The dragon's teeth were added on June 5, 2013 using the same process.

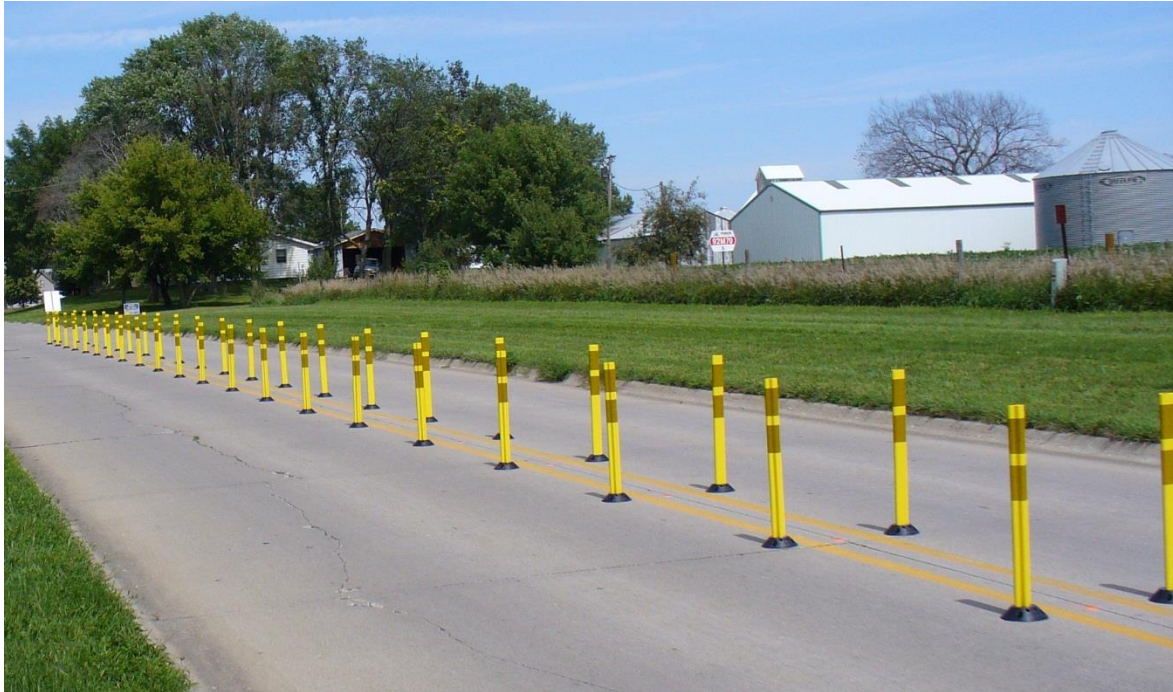
Figure 3-9: Temporary island treatment in Slater, Iowa (Hallmark et al. 2007)

Use of vertical devices creates the sensation of less space and some discomfort to drivers, which encourages them to slow. In the previous traffic-calming study conducted by CTRE, 36 inch tall yellow tubular channelizers were spaced approximately 2 feet apart creating a center island, which narrowed travel lanes to approximately 11 feet for each direction as shown in Figure 3-9.

The treatment was placed in Slater, Iowa and was very effective with reductions of up to 3 mph in both mean and 85th percentile speeds (Hallmark et al. 2007).

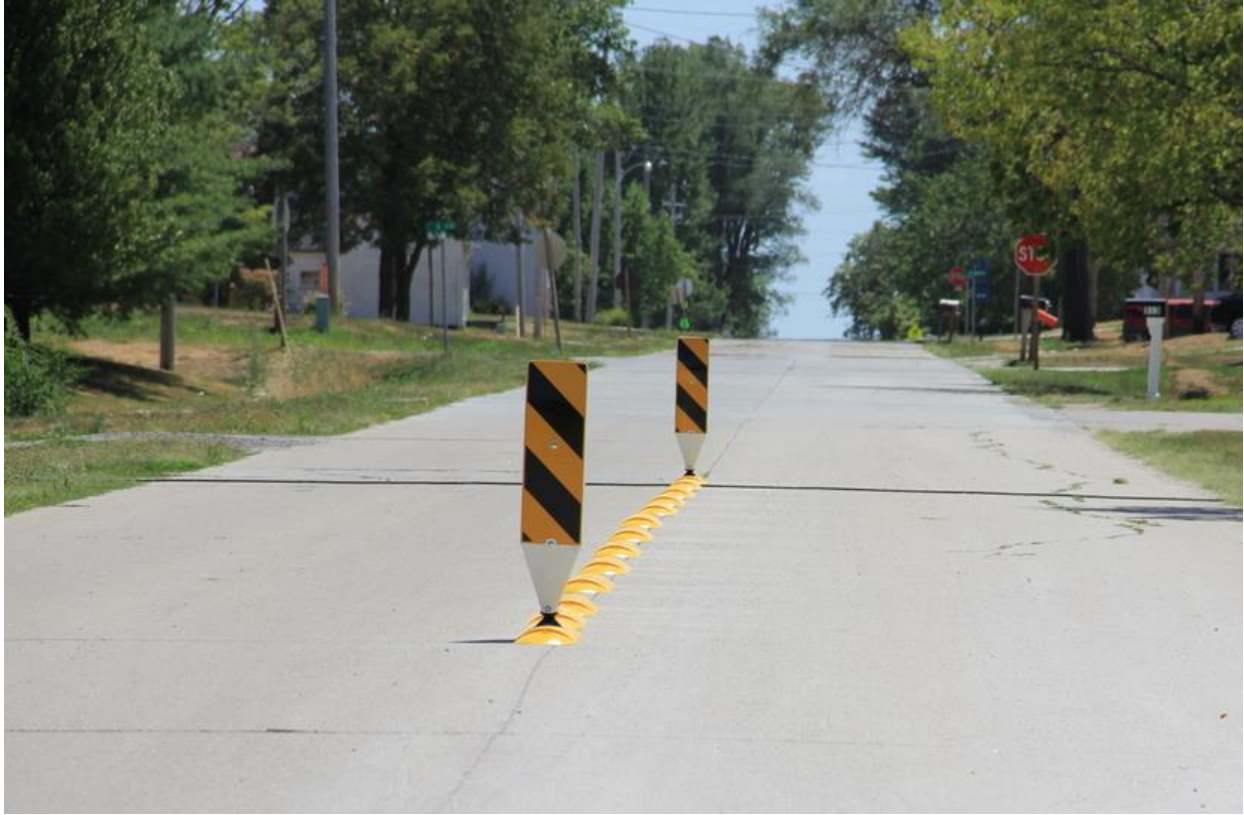
Figure 3-10: Raised median with hazard markers at each end

Hazard markers were placed at the beginning and end of the treatment so that drivers were aware that a vertical object was located within the traveled roadway as shown in Figure 3-10.

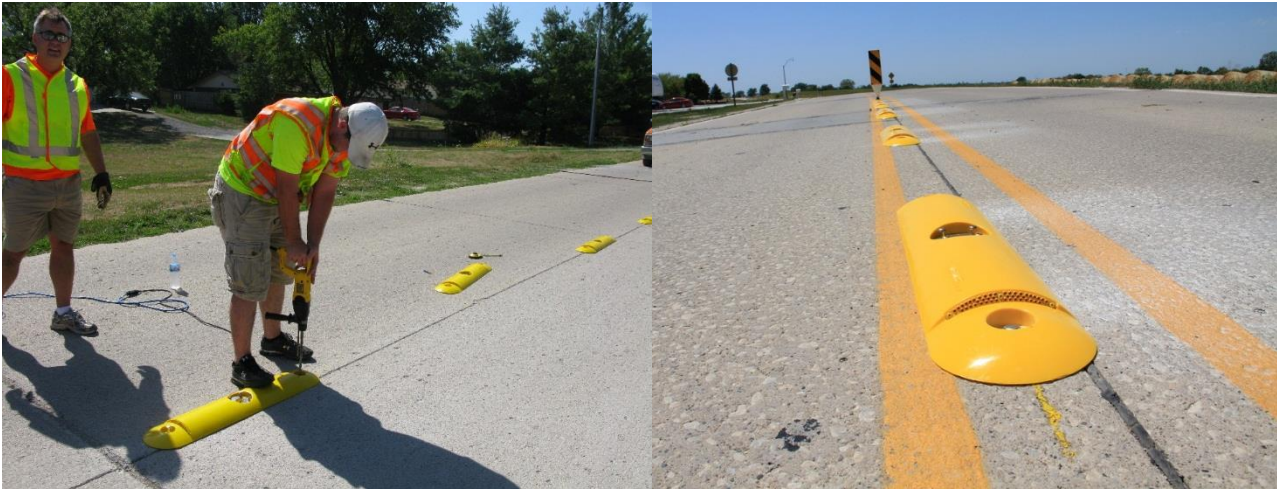
Figure 3-11: Installation of raised curbing (left) and close-up of raised curbing (right)

The treatment was affixed to the pavement using bolts as shown in Figure 3-11. As a result, the treatment could be removed and replaced as needed. This was important given the treatment needed to be removed for the winter months so that the city and county snowplow operators did not need to worry about plowing around the treatments during winter storm events.

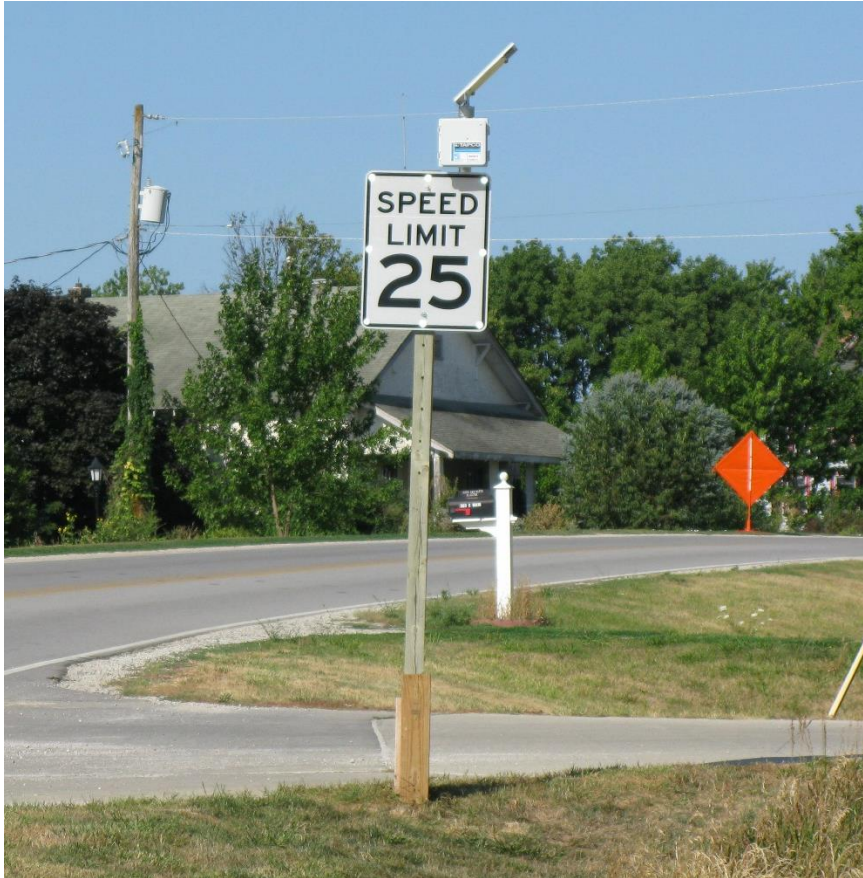
Figure 3-12: Radar-activated LED speed limit sign

Another treatment evaluated was a speed limit sign that has radar-activated light-emitting diodes (LEDs) embedded around the border of the sign. The LED signs have been used extensively on stop signs and were recently available for speed limit signs. The sign is a normal speed limit sign with white LEDs around the periphery as shown in Figure 3-12.

The purpose of the radar-activated LEDs is to get the attention of drivers traveling above a set speed threshold. As far as the team is aware, no studies have evaluated the effectiveness of the signs in reducing speeds.

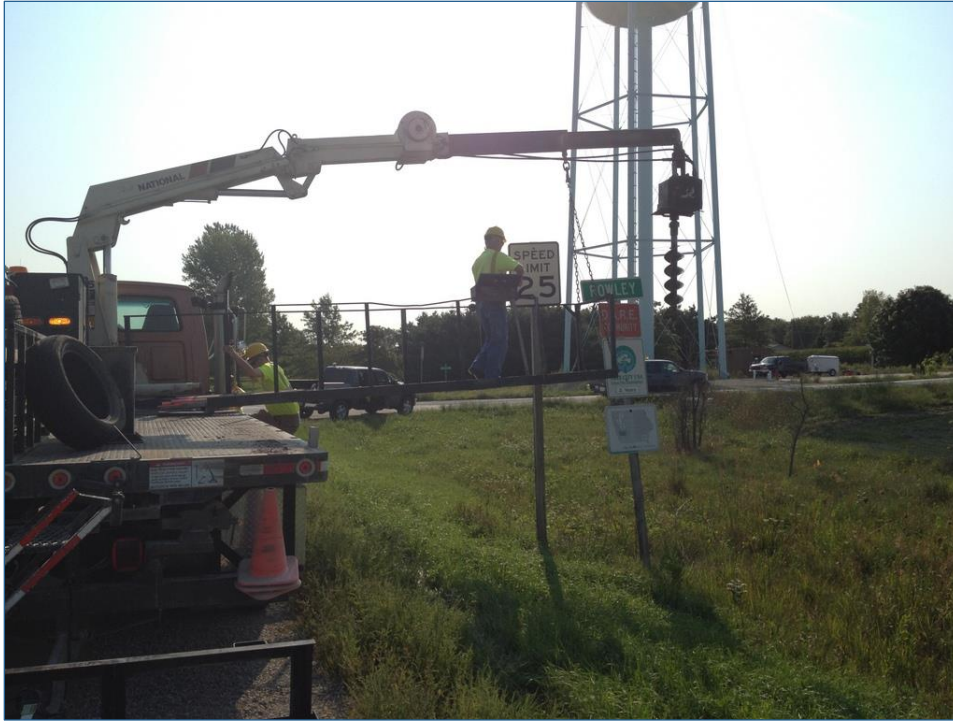
Figure 3-13: Installation of LED speed limit sign

The LED signs were used for the first speed limit sign at two community entrances after the transition speed zones. The signs, which use solar panels for power, replaced existing speed limit signs on the existing posts (Figure 3-13).

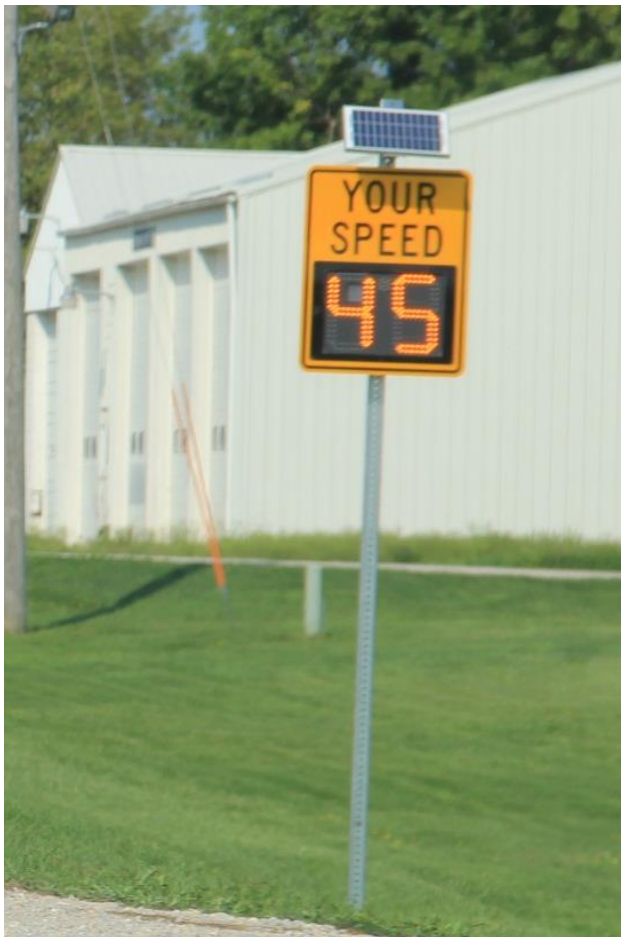
Figure 3-14: Dynamic speed feedback sign

One dynamic speed feedback sign was installed as shown in Figure 3-14. The sign was placed near the first static speed limit sign entering the community.

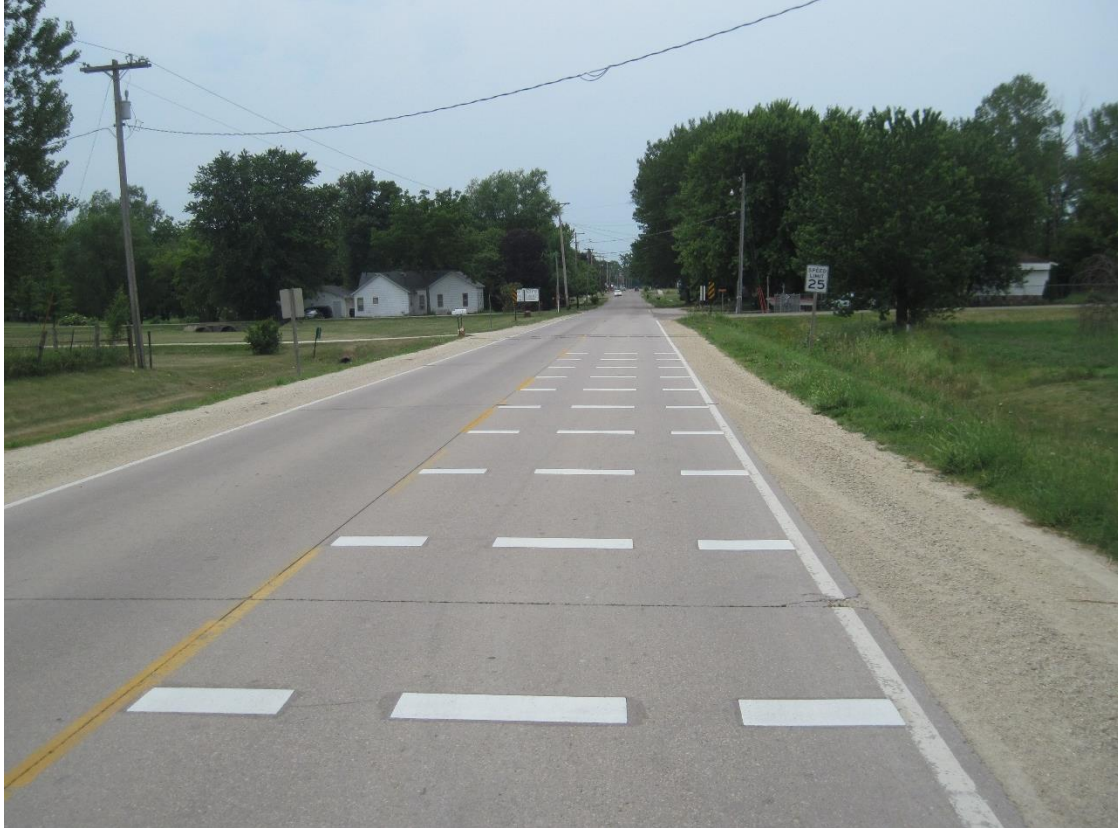
Figure 5-2: Transverse bar treatment at Hazleton east entrance

A transverse bar treatment was installed at the east side of the community (Figure 5-2). The bars were placed so they terminated at the first 25 mph speed limit sign. The treatment was placed in May 2012. The team worked with the Buchanan County engineer for installation and monitoring. The west community entrance was also a concern but, due to the presence of a bridge just at the community entrance, a suitable traffic-calming treatment was not available.

The most significant change was in the fraction of vehicles traveling over the posted speed limit. An 8 percent decrease was noted for vehicles traveling 5 or more mph over with a 12 percent decrease for vehicles traveling 10 or more mph over, and 25 percent for 15 or more mph over. Results were similar for the 12 month after period for vehicles traveling 5 or 10 or more mph over. Smaller reductions were noted for 15 or more mph over (decrease of about 16 percent).

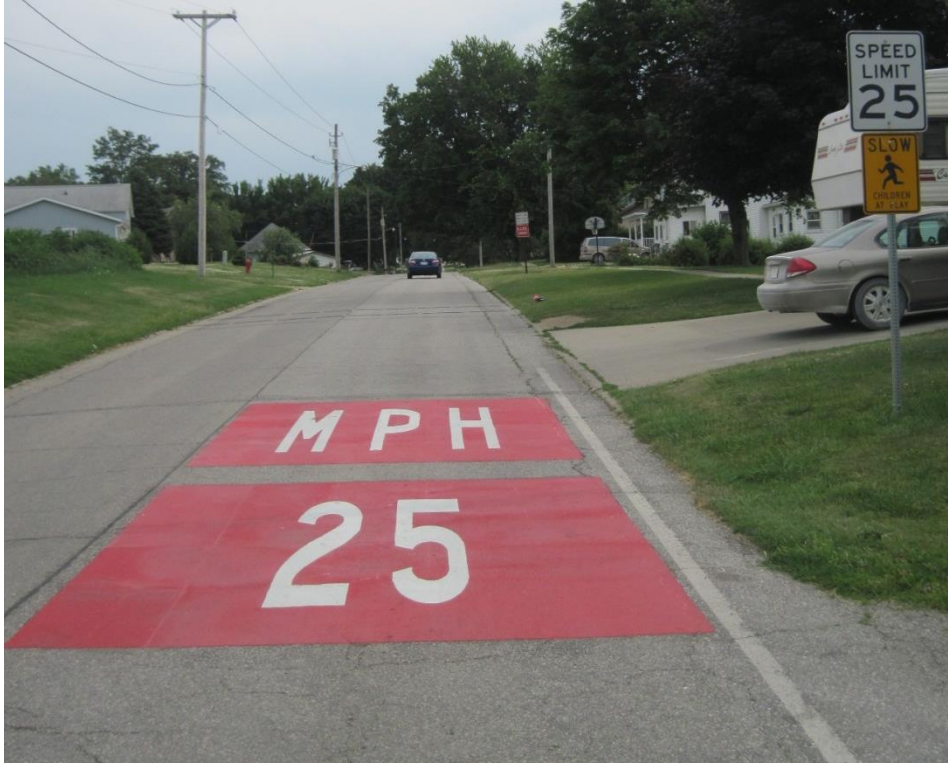
Figure 5-8: Colored entrance treatment for north community entrance in Ossian

The treatment was placed so that it terminated at the first 25 mph speed limit sign as shown in Figure 5-8. The initial treatment was placed in May 2012. Dragon’s teeth were added approximately 12 months later as shown in Figure 5-9.

Reductions in mean and 85th percentile speeds from 1 to 2 mph resulted for the 1 and 12 month periods after installation of the initial treatment. At 1 month, the fraction of vehicles traveling 5 mph over the posted speed limit of 25 mph decreased by almost 30 percent, while the fraction traveling 10 or more mph over decreased by more than 36 percent. The fraction of vehicles traveling 15 or more mph over decreased by almost 60 percent. Decreases were also noted for vehicles traveling 5, 10, or 15 mph over the posted speed limit at 12 months, but they were less than half the reduction noted for 1 month.

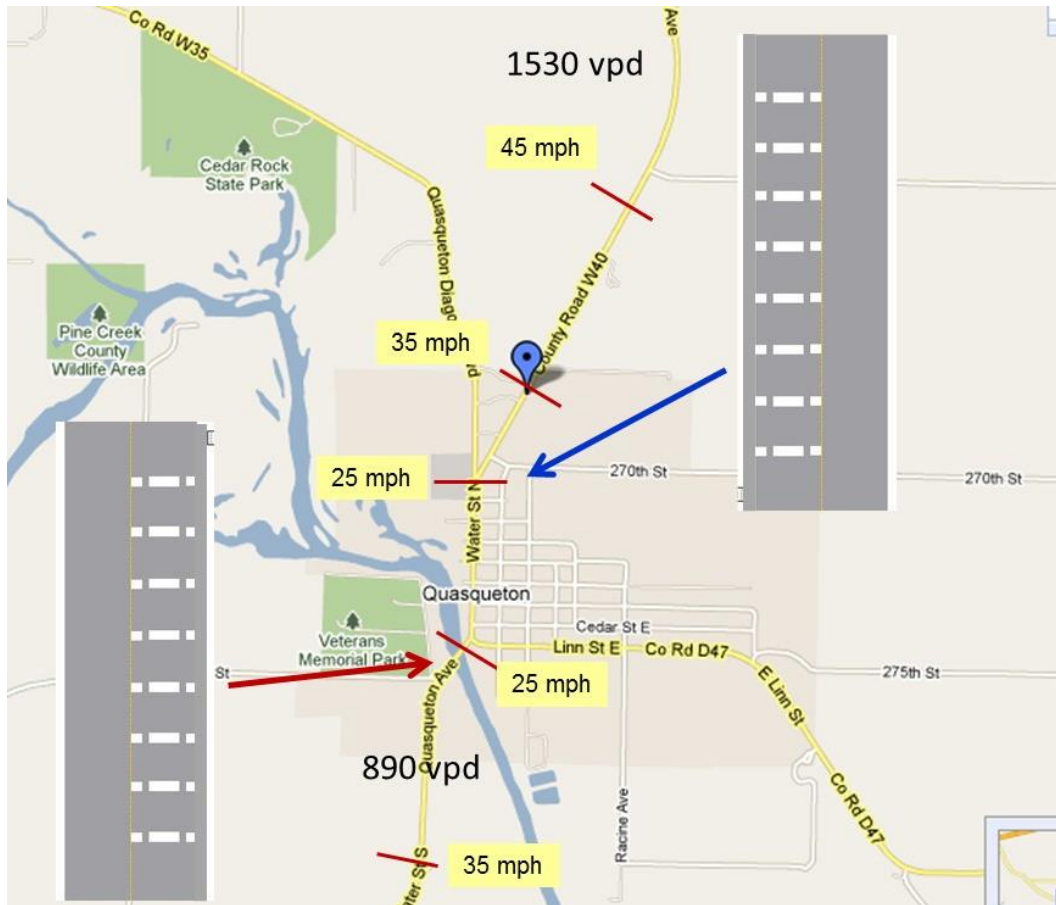
Figure 5-10: Locations of transverse bars for Quasqueton, Iowa (Google map)

Transverse bar treatments were installed in Quasqueton, Iowa (population 574) along the main road, Country Road W-40, through the community, as shown in Figure 5-10.

A number of business and residential areas are located along both sides of the roadway. The speed limit is 55 mph outside of the community and it drops to 35 mph at the community entrance on the north. At the north entrance (1,530 vpd), the speed limit remains 35 mph until well into the community, so the treatment was placed at the community entrance at the 35 mph speed limit sign. At the south entrance to the community (890 vpd), the speed reduces to 25 mph and the treatment was placed to end at the first 25 mph speed limit sign..

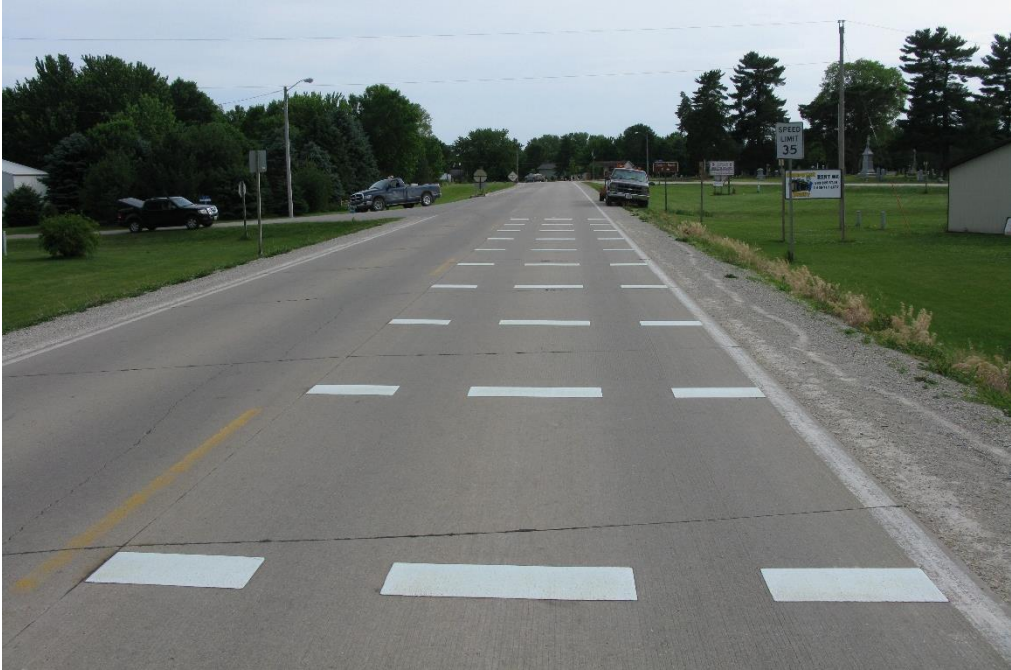
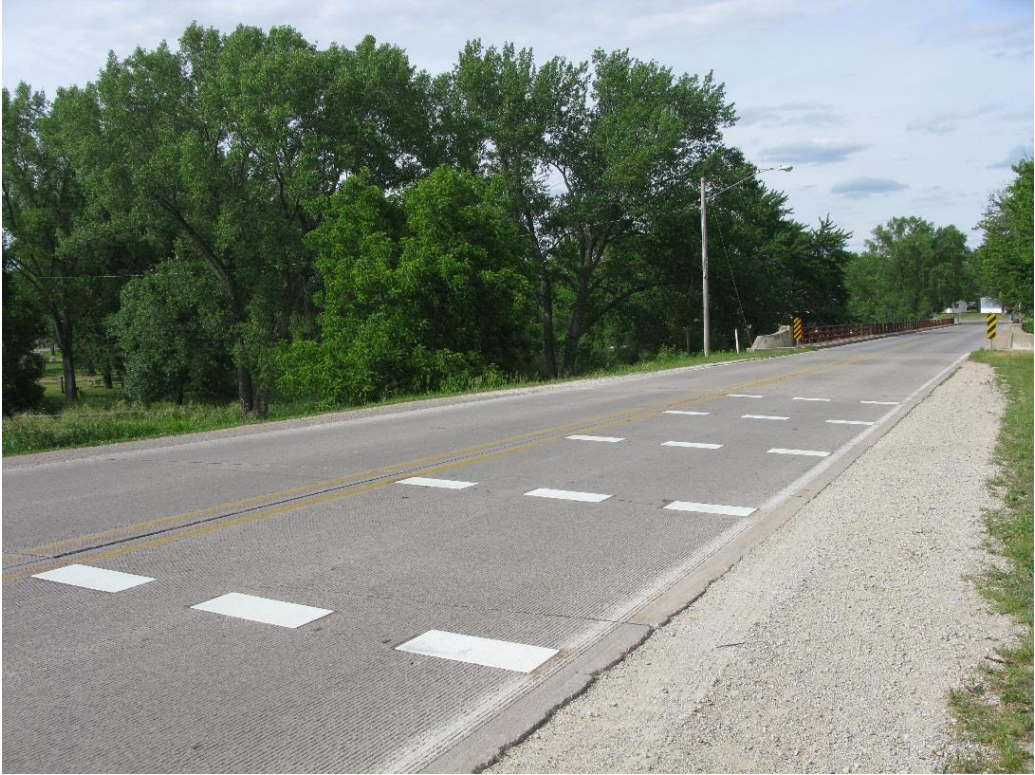
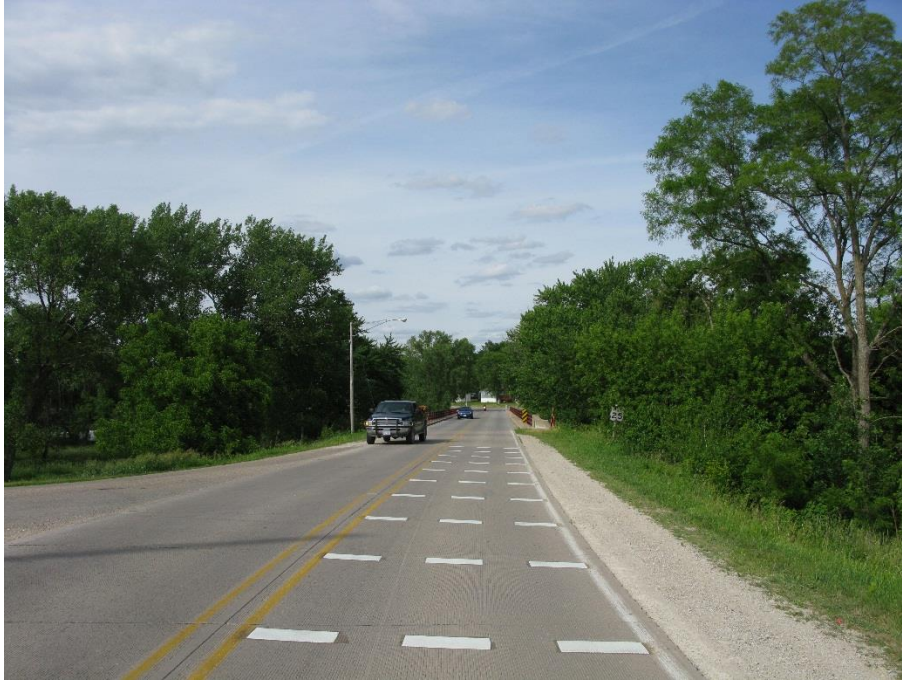
The treatments are shown in Figures 5-11 through 5-13.

Figure 5-11: Transverse bar treatment for north Quasqueton community entrance

Figure 5-12: Close-up of transverse treatment at south Quasqueton entrance

Figure 5-13: Transverse bar treatment at south Quasqueton entrance

At the south entrance, mean and 85th percentile speeds decreased by only about 1 mph while significant decreases were noted in the fraction of vehicles traveling over the posted speed limit. The results showed a decrease of almost 9 percent in the fraction of vehicles traveling 5 or more mph over the speed limit and 12 percent in the fraction traveling 10 or more mph over. Large decreases were also noted for vehicles traveling 15 or more mph over (almost 17 percent).

Larger decreases were noted at 12 months for all speed metrics. Decreases of about 2 mph resulted for mean and 85th percentile speeds. The decrease in the fraction of vehicles traveling 10 or 15 mph over the posted speed limit was more than double or triple, respectively, what was seen for 1 month after.

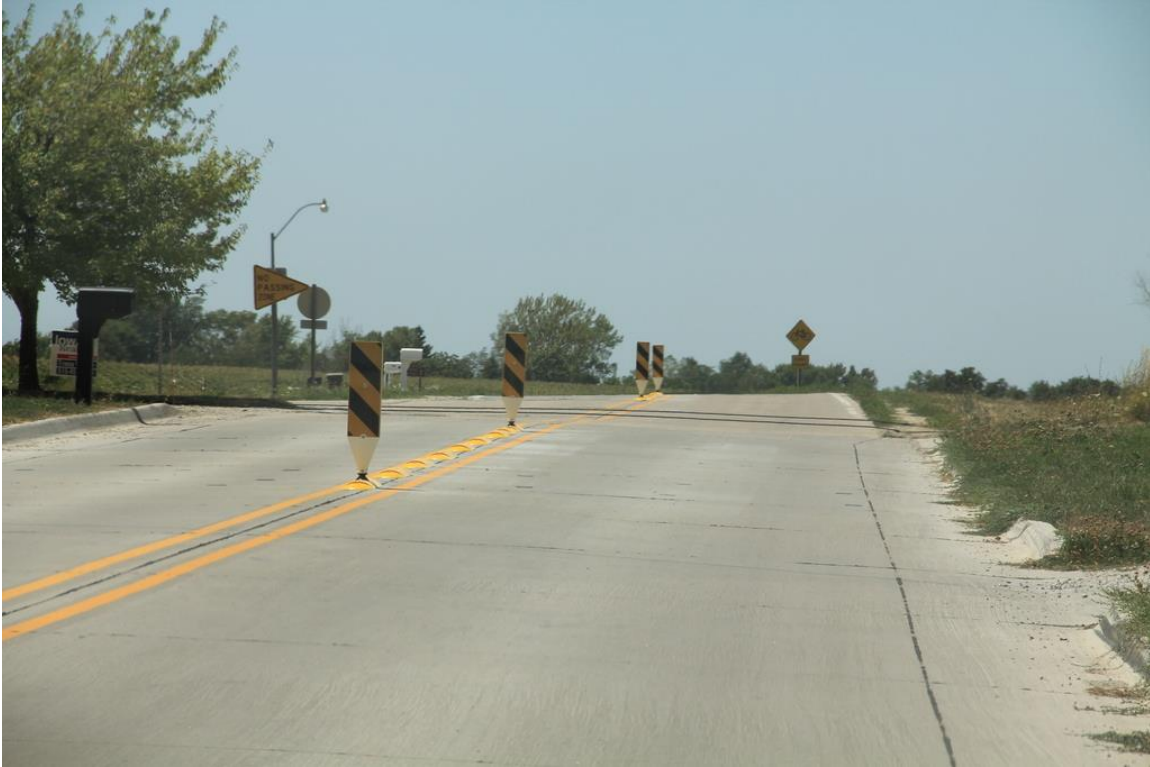
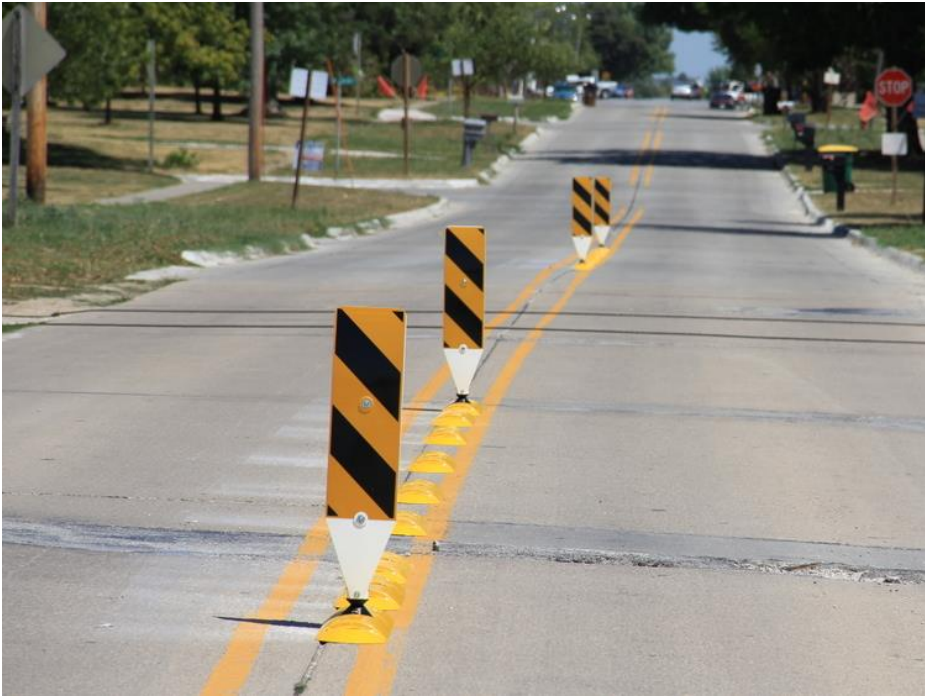
Temporary islands were created using mountable curbing at the north, west, and south entrances. A radar-activated LED speed limit sign was placed at the east entrance. Mountable curbing was not appropriate for the east entrance given a horizontal curve, which may lead to some sight-distance issues for drivers being able to see the curbing in time. The treatments are shown in Figures 5-15 through 5-17.

Figure 5-15: Mountable curbing installed at west St. Charles community entrance

Figure 5-16: Mountable curbing at south entrance to St. Charles

Mean speed decreased by 2.2 mph and 85th percentile decreased by 3 mph after installation of the temporary curbing. Significant decreases were found in the fractions of vehicles traveling over the posted speed limit. A decrease of almost 30 percent was noted in the fraction traveling 5 or more mph over and almost 46 percent in the fraction traveling 10 or more mph over. A much more significant decrease resulted for the fraction of vehicles traveling 15 or more mph over (71 percent). No change occurred in the mean speeds for the upstream comparison site.

Similar results were noted for the 12 month after period with decreases in mean and 85th percentile speeds of close to or about 3 mph. A slightly greater decrease in vehicles traveling 5 or 10 mph over the posted speed limit was noted for the 12 month after period.

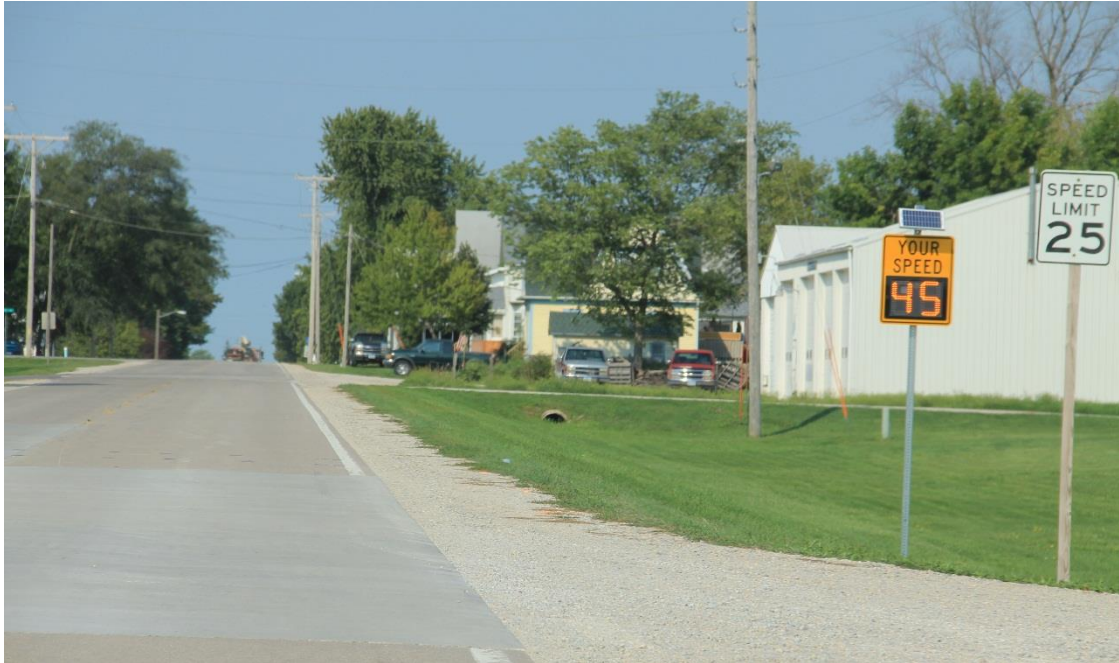
Figure 5-19: DSFS installed at east Rowley community entrance

The community was suggested by the Buchanan County engineer who was installing traffic calming at select communities within the county. A dynamic speed feedback sign (DSFS) was installed at the same point as the first 25 mph speed limit at the east entrance as shown in Figure 5-19. A radar-activated LED speed limit sign was installed at west community entrance at the first 25 mph speed limit as shown in Figure 5-20.

Table 5-11 shows results for the DSFS at the east community entrance to Rowley.
