Evaluation of the Performance of a Short-Span T-Beam Bridge

Final Report
September 2021

Sponsored by
Iowa Highway Research Board
(IHRB Project TR-705)
Iowa Department of Transportation
(InTrans Project 16-572)

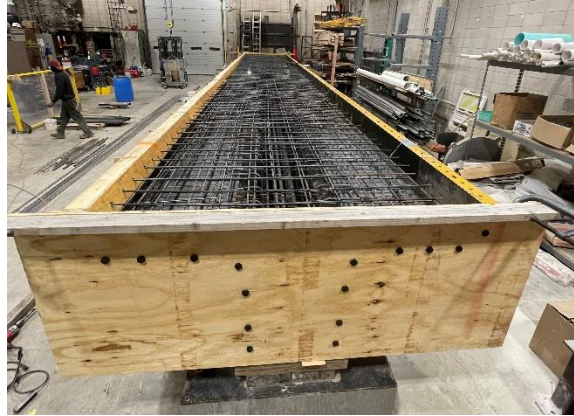
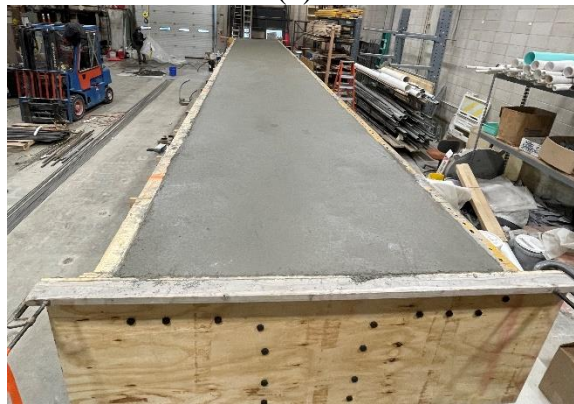
Figure 5. (a) Rebar mat, (b) pouring of concrete, and (c) poured beam specimen

The concrete in the T-beam was a C4 chip mix with a smaller aggregate size (maximum of 19.05 mm [3/4 in.]) to allow for it to flow smoothly between the congested spaces between the bottom reinforcing steel bars. The mix resulted in 6.7 ksi 28-day compressive strength. The individual beams required 13 yd³ of concrete to pour. The construction images of the first beam are shown in Figure 5.

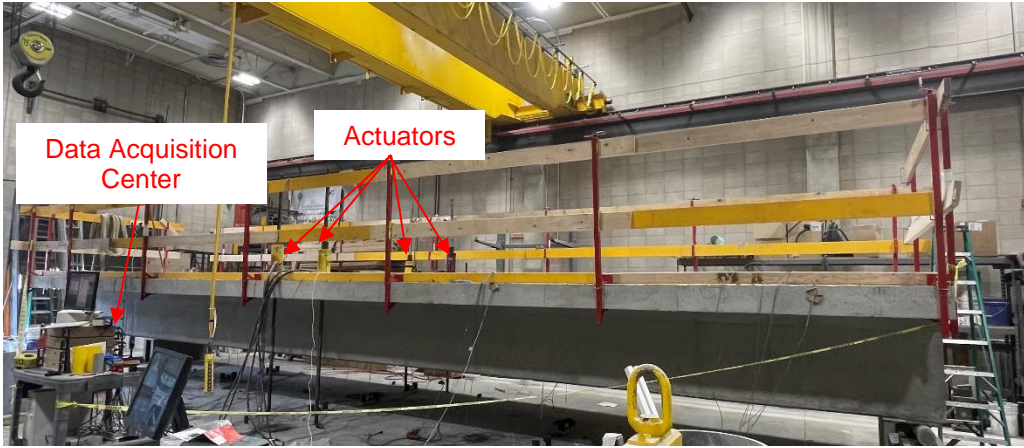
Figure 8. (a) Longitudinal, (b) cross sectional, and (c) top view for case 1

In case 1, the outer two loading points on each beam were loaded within service limit loads. The anticipated loading in the joint was tensile stresses on the top and compressive stresses on the bottom of the joint (see Figure 8).

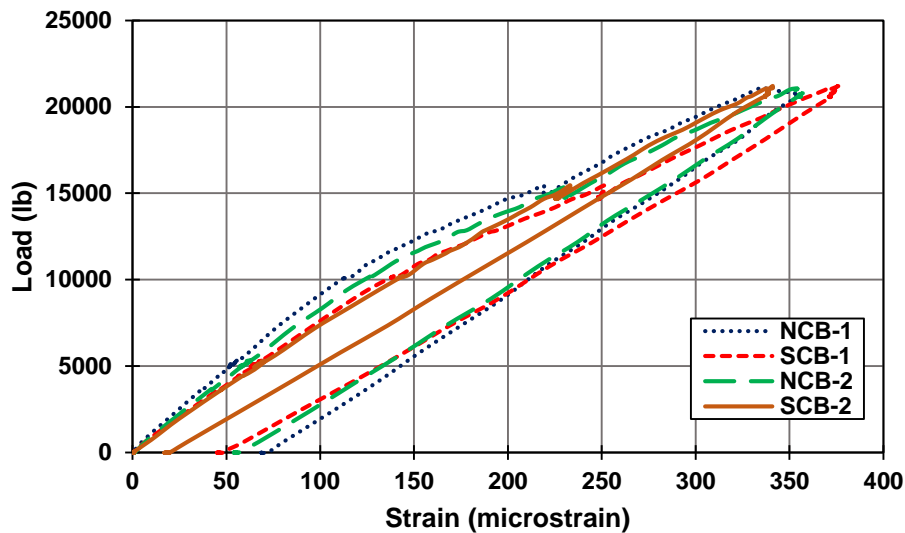
Figure 10. (a) Load deflections and (b) load strains for case 1

For case 1, the outer two loading points on each beam were loaded up to the service limit of 21 kips (a total of 42 kips). The load deflection data were monitored for these loadings (Figure 10(a)).

The load deflection data show that the beam behavior was linear elastic up to a 10 kips load, when a change of slope was observed. The load deflection behavior that stayed linear until 21 kips loading became a slope lower than the initial slope after that. The midspan and quarter span load deflection curves for each beam followed an almost similar path, highlighting the fact that the loading was symmetric and that both beams behaved in similar ways. The unloading curves also followed a similar smooth unloading curve. The observations from load deflection curves were complemented by the load strain curves for strains recorded at the bottom reinforcing steel bars of both beams at midspan (Figure 10(b)). Similar to the load deflection curves, the load strain curves also changed slope around 10 kips loading and stayed linear until the 21 kips loading, but with reduced slope.

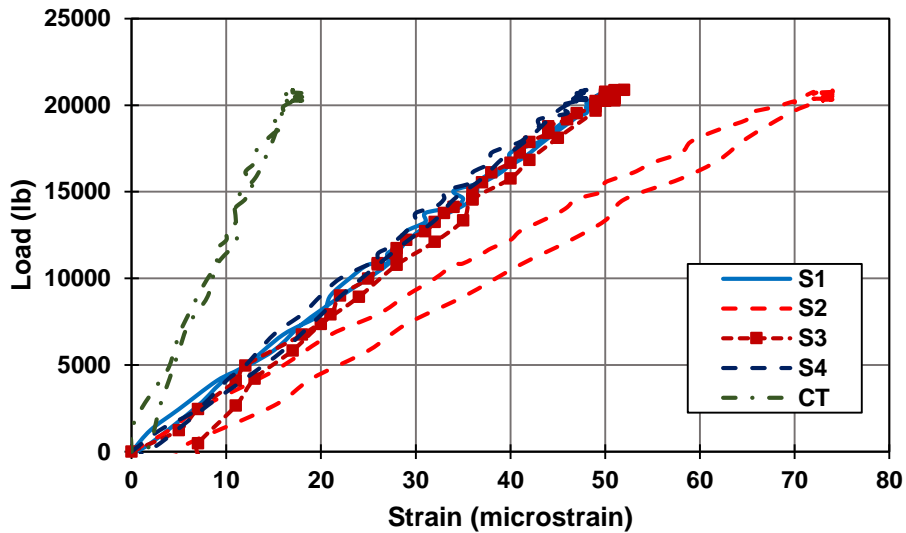
Figure 11. Load strains for (a) transverse strain in top and bottom rebars and (b) surface strains at midspan for case 1

The strains were recorded on the surface of the joint, in the joint reinforcing steel bar, and on the concrete deck adjacent to the joint. These values were recorded at midspan and quarter spans. Midspan had the largest number of strain gauges to measure all strains across the section of the bridge to measure transverse strains (Figure 11).

The strains recorded on the reinforcing steel bar in the deck show that all strains remained at very low values, i.e., less than 50 microstrain. The strain in the top reinforcing steel bars in the joint (i.e., TC1 and TC2) and deck (i.e., CCR-1 and CCR-2) was tensile while the strain in the bottom reinforcing steel bars was compressive for initial loading of 5 kips and then started to become tensile, as well; this indicates a more complex distribution of loading rather than a simple tensile load on top and compression at the bottom loading anticipated in the initial phase of loading. The tensile strain in both the bottom (i.e., BC1 and BC2) and top (i.e., TC1 and TC2) reinforcing steel bars indicated that the joint was under a combined action of flexural and axial loading. The joint was in pure flexure at lower values of loading (for loading below 5 kips) but at higher values of loading as the stress in the reinforcing steel bars in the joint became purely axial. The strain gauges located at the interface of the UHPC joint and the concrete beams, i.e.,

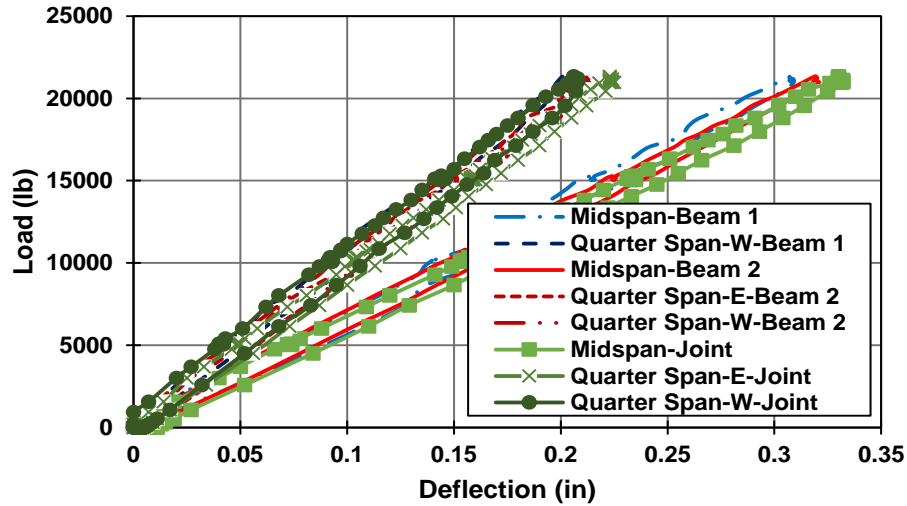
Figure 13. (a) Load deflections for midspan and quarter span and (b) load strains at the bottom rebars of the beams for case 2

In this test setup, the two inner points on each beam were loaded with an anticipation that it would result in tensile stresses at the bottom and compressive stresses at the top of the joint (Figure 8(a) in the previous chapter). The deflection was recorded at the bottom of the beam at midspan and quarter span. The load deflection curve is shown in Figure 13(a).

The recorded loads are for the loading at individual points. The load deflection curves show that the behavior stayed linear elastic. The setup came back to almost the same position, and the residual deflection was only 0.02 in. at midspan. No cracks were observed in the beams. The load deflection behavior showed a linear elastic behavior until 21 kips loading at each point and a smooth unloading curve was observed with no negligible residual measured deflection. Midspan and quarter span deflections resulted in the same behavior for both beams. The load strain curves recorded for the strains in the bottom reinforcing steel bars of the beams showed similar behavior as the load deflection curves (Figure 13(b)). SCB-1 and NCB-1 were at midspan at the bottom reinforcing steel bars and SCB-2 and NCB-2 were at the bottom reinforcing steel bars of beam 2 at midspan. The load strain curves were linear elastic during loading and

unloading. The strain resulted in almost the same strain values as those for case 1 (i.e., 350 microstrain).

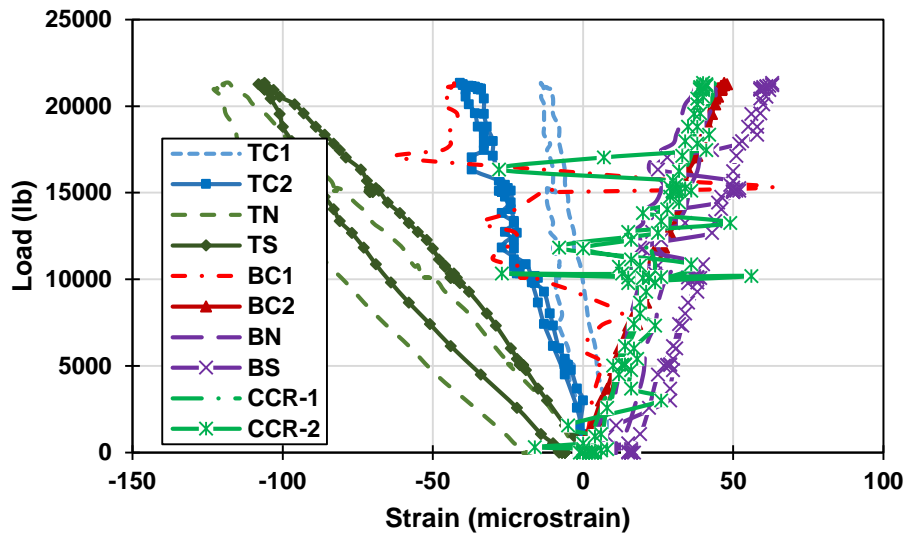
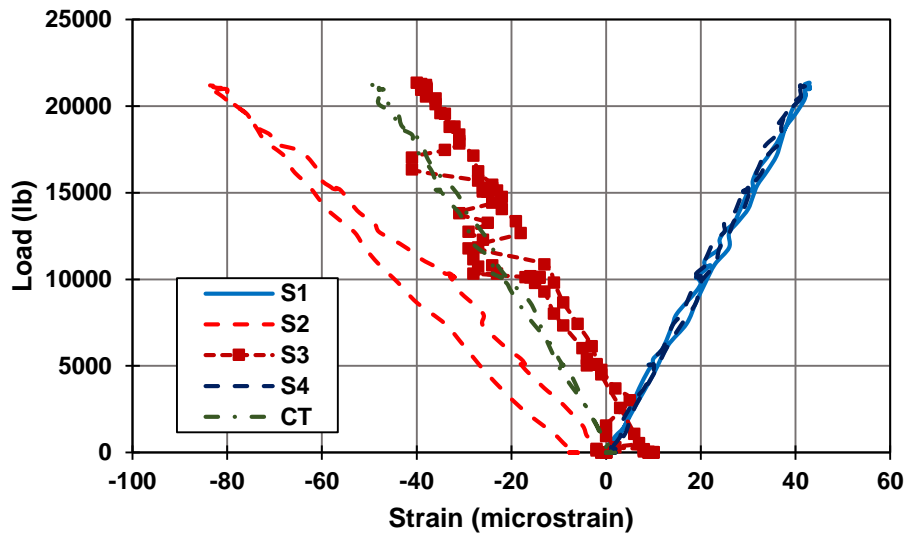
Figure 14. Load strains for (a) transverse strains in top and bottom rebars and (b) surface strains at midspan for case 2

The strains were also recorded in the transverse direction at the mid-section in the transverse direction. The strains recorded in the top reinforcing steel bars were compressive and the bottom reinforcing steel bars experienced tensile strain (Figure 14).

The strains recorded at the surface of the deck and joint are presented in Figure 14(b). It can be seen that all strain gauges located in between the loading point (i.e., CT on the joint and S2 and S3 on the deck) resulted in compressive strains, while the two strain gauges located on top of the deck, outside the loading points S1 and S4, resulted in tensile strain. Unlike case 1, the strain recorded in the joint was relatively high, i.e., 50 microstrain in case 2 compared to 18 microstrain in case 1. The strain recorded on top of the joint was compressive as opposed to tensile in case 1, as expected.

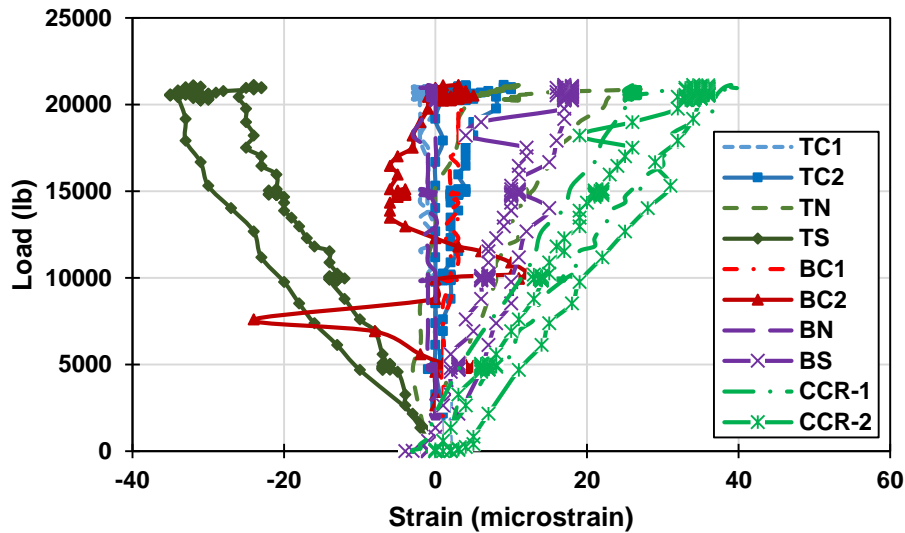
Figure 17. Load strains for (a) transverse rebar strains in top and bottom rebars and (b) surface strains at midspan for case 3

The load strain curves for the transverse strain gauges at midspan on the reinforcing steel bars in the joint and on the deck are presented in Figure 17(a).

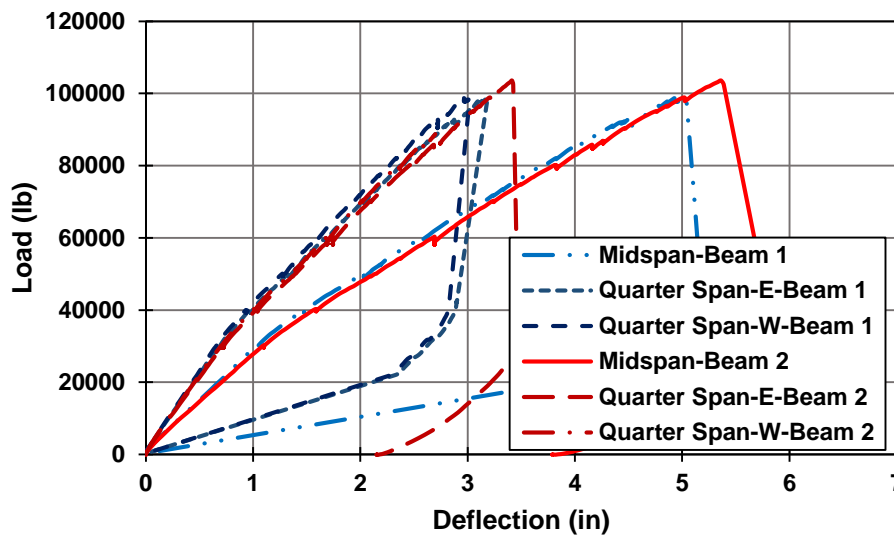
Figure 19. Load deflection comparison at ultimate stage

Beams 1 and 2 both showed a smooth linear loading curve (Figure 19).

The load deflection curve at the individual loading point and the deflection at the bottom surface of the beam showed that the load deflection was linear up until 25 kips, after which the load deflection curve showed a change in the slope but stayed linear until the ultimate load. The ultimate load was the load at which the concrete under the loading point crushed. This load exceeded 100 kips in both beams. The unloading curve showed a sudden drop in the load at failure and then a residual deflection of 2.4 in. and 3.8 in. for beam 1 and beam 2, respectively.

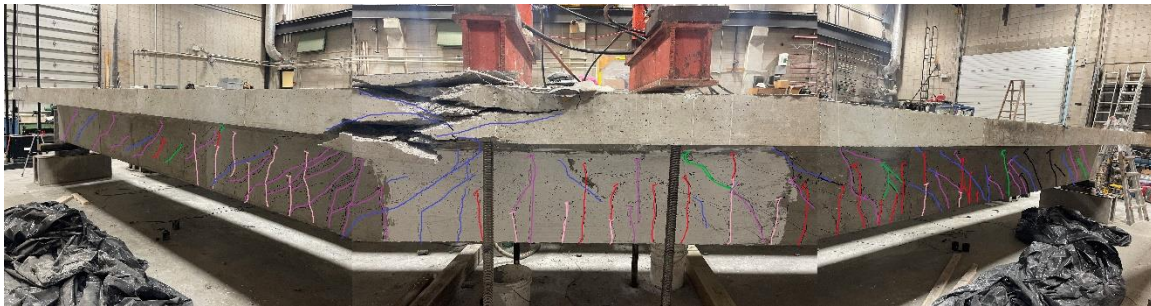
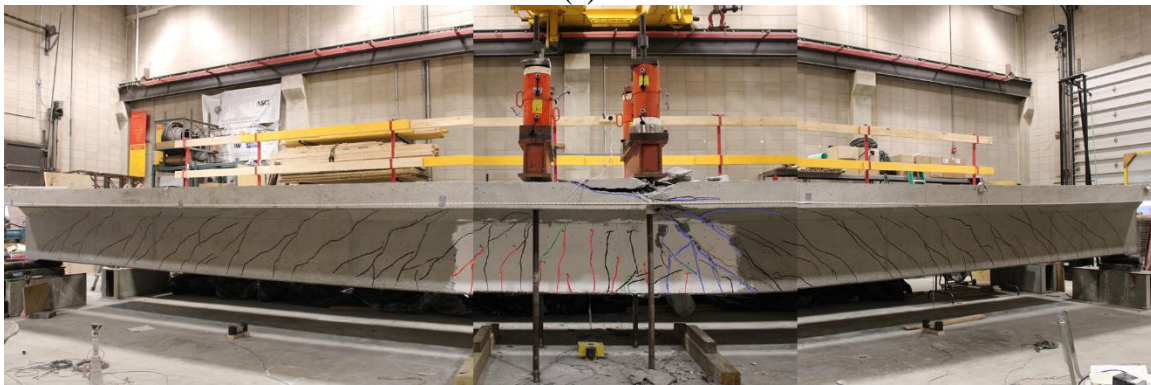
Figure 22. Crack maps for (a) beam 1 and (b) beam 2 at ultimate stage

The cracking in both beams are shown and color coded in Figure 22.

The beams were further loaded to 40 kips and the cracks were marked with green lines. As shown, the existing cracks extended, and a couple of shear cracks appeared.

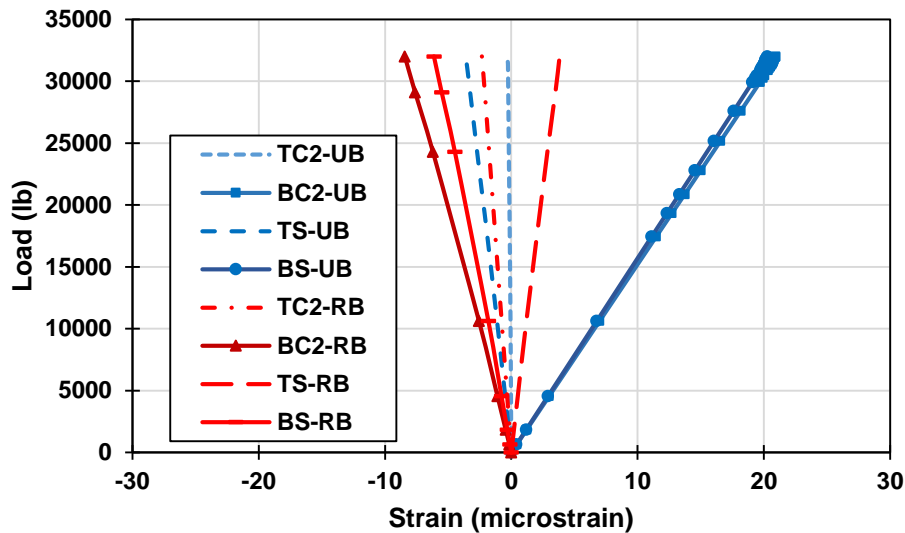
Figure 26. Rebar strains at the midspan cross section of the beams

The results for transverse reinforcing steel bar strains in the joint at the midspan cross section are presented in Figure 26.

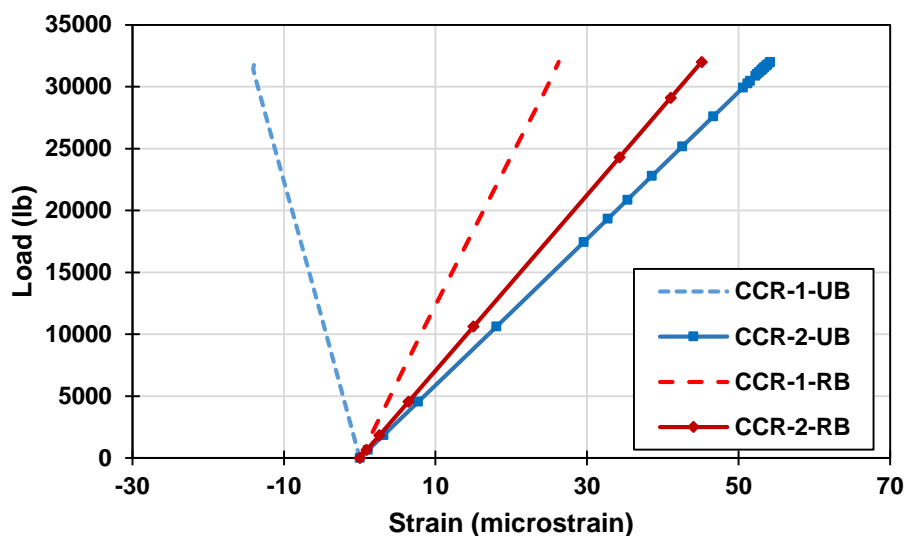
Figure 27. Top rebar strains in the middle of the deck for the UB and RB cases

The strain recorded in the top reinforcing steel bars at the center of both concrete decks further provides insight into the strain distribution in the deck. It can be seen that, under service limit loading, the greatest strains occur in the deck rather than the joint (Figure 27).

The strains recorded in the deck in the unloaded beam were about three times of that recorded in the joint, i.e., the strains recorded in the joint were 19 microstrain and that on the deck were 55 microstrain. This is for both the UB and RB case, with the UB case resulting in more strain than the RB case. Another important observation was that the strains in the UB case were greater than in the RB case, i.e., for CCR-2, the strain in the UB case was 55 microstrain, while that in the RB case was 45 microstrain. This could be explained by the fact that the deflections of the UB setup was greater than the deflection experienced by the RB setup.
