1. Report No. IHRB Project TR-577	2. Government Accession No.	3. Recipient's Catalog No.	
4. Title and Subtitle Evaluation of Rumble Stripes on Low-Volume Rural Roads in Iowa—Phase I		5. Report Date July 2009

EVALUATION OF RUMBLE STRIPES ON LOW-VOLUME RURAL ROADS IN IOWA—PHASE I

**Final Report
July 2009**

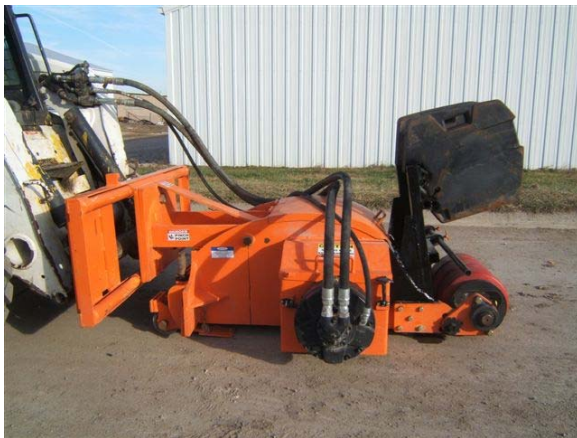
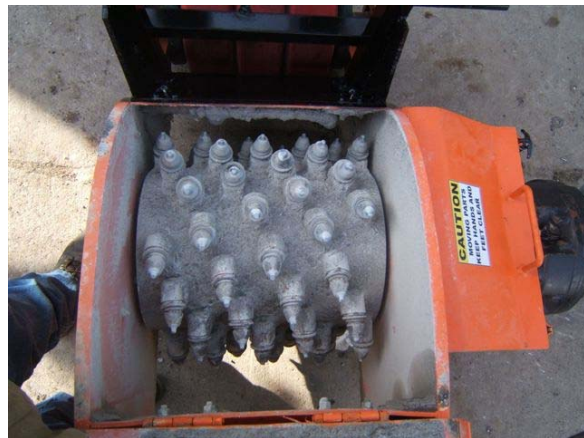
Figure 3-8. Milling equipment (photos courtesy Iowa Plains Signing, Inc.)

Work was suspended in early June to allow the contractor time to work on modifications to another piece of equipment that could complete the work that had been omitted on the inside of curves due to operational problems that will be described in the next section. The equipment shown in Figure 3-8 was adapted to allow milling along the low side of horizontal curves and to be performed more adequately, although the milling depth was still minimal and the alignment was less than ideal.

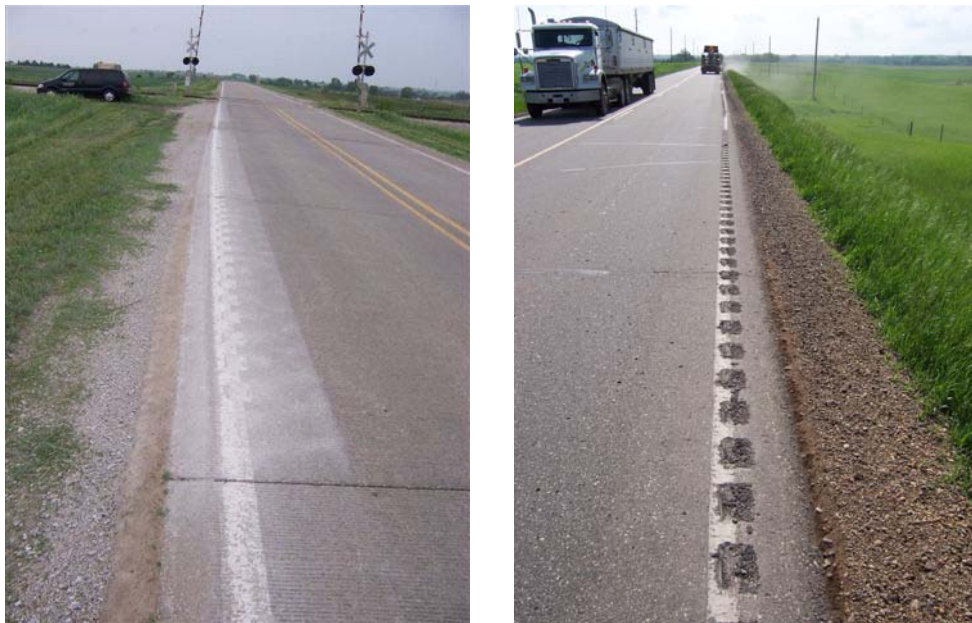
Figure 3-9. Examples of milling work

The contractor resumed milling work on October 16, 2008, and completed all contract work on November 3, 2008. Examples of that work are shown in Figure 3-9.

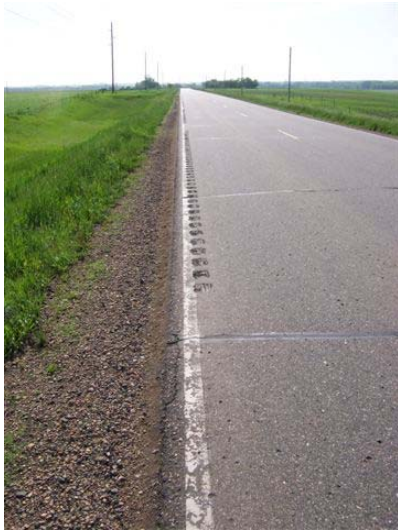
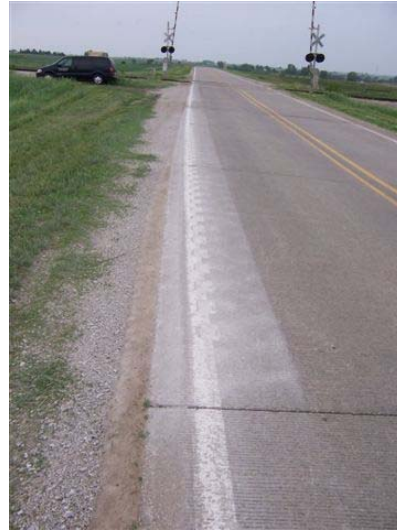
Figure 3-10. Milling in Sioux and Dallas Counties

Installation work was quite satisfactory in the tangent sections of roadway, but problems with machine stability were encountered when milling was attempted along the low side of super-elevated horizontal curves due to the high center of gravity of the milling machine. Milling machine instability, less than desirable milling depth, and difficulty in maintaining a satisfactory alignment through curves required omitting these sections until a modified machine was developed later in the season. In addition, it was necessary to add an air compressor to the process to remove millings from the pavement edge prior to application of pavement markings. Figure 3-10 shows sections on County Roads B-30 and P-53 after rumble stripes were cut into the pavement surface. Figure 3-11 shows the machine tipping.

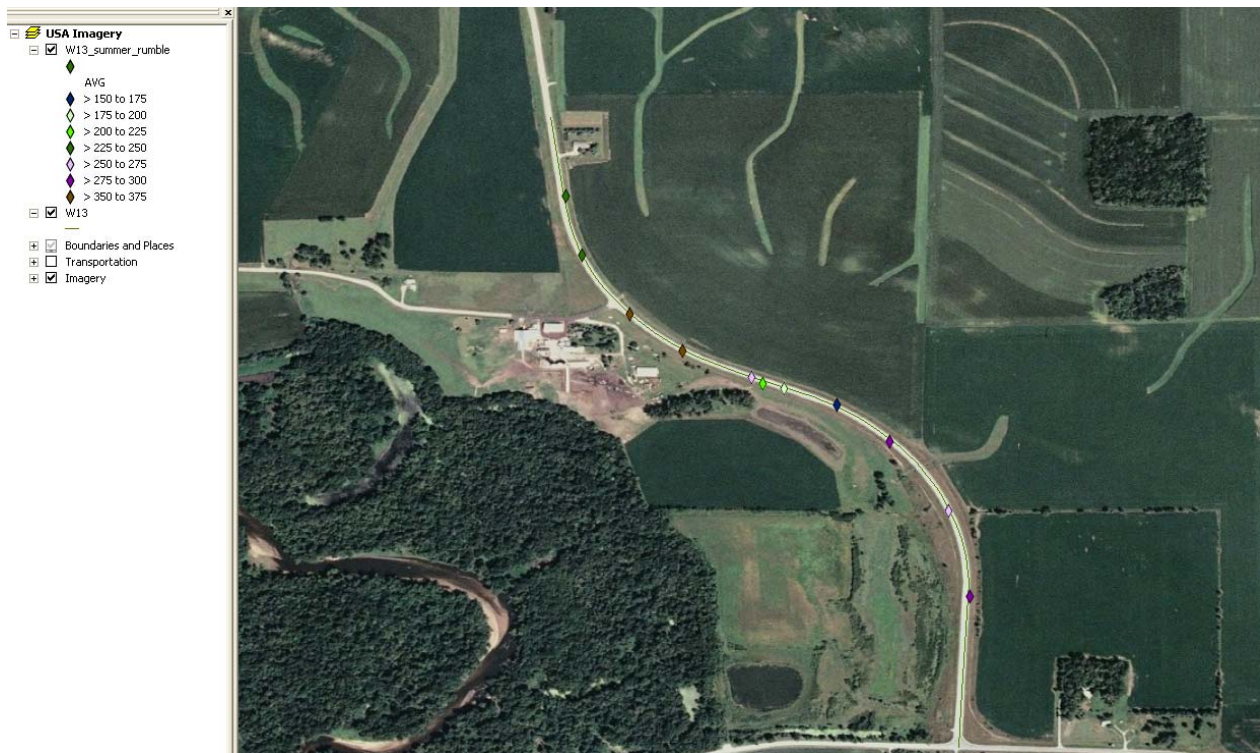
Figure 5-10. Summer readings for rumble stripes for test section W-13

Charts were also made that show individual readings at each site. Figures 5-7 to 5-9 show readings for the control “flat” areas on test section W-13 for summer 2008, fall 2008, and spring 2009, respectively. Figures 5-10 to 5-12 show readings for rumble stripe areas on test section W-13 for summer 2008, fall 2008, and spring 2009, respectively.
