# Road Safety Audit for Union County IA 25 from the WCL of Creston to North H-24 Intersection

**Final Report**  
**July 2008**

# **ROAD SAFETY AUDIT FOR UNION COUNTY IA 25 FROM THE WCL OF CRESTON TO NORTH H-24 INTERSECTION**

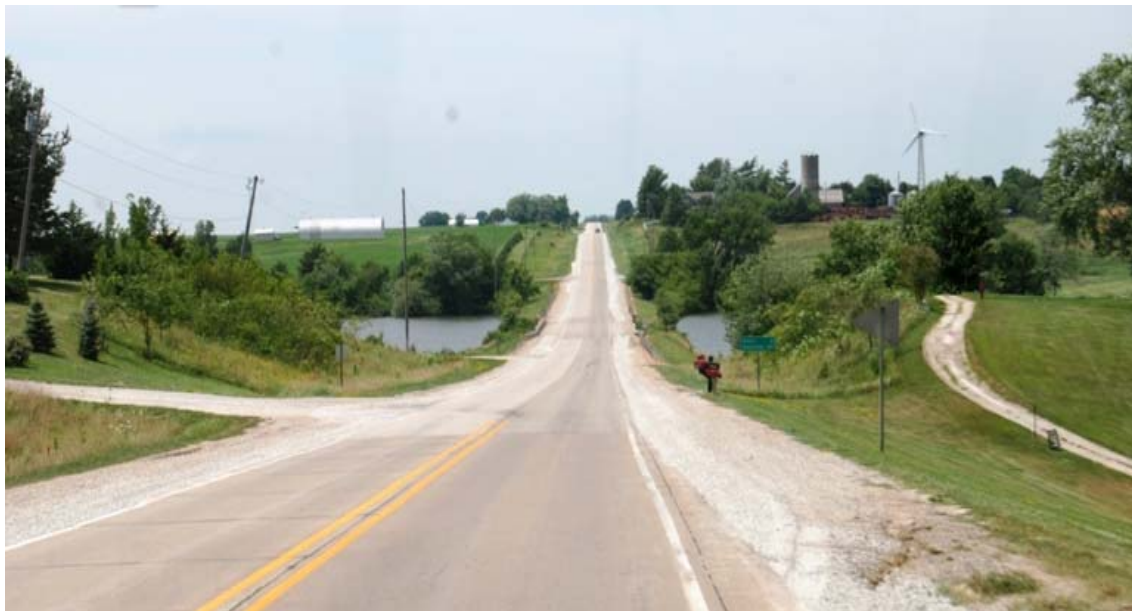
Pavement edge lines appeared quite worn west of Creston. Non-breakaway steel mailbox supports were noted in two locations with one mailbox protected with concrete-filled bollards.

**Figure A.2. IA 25 westbound just west of Creston City Limits**

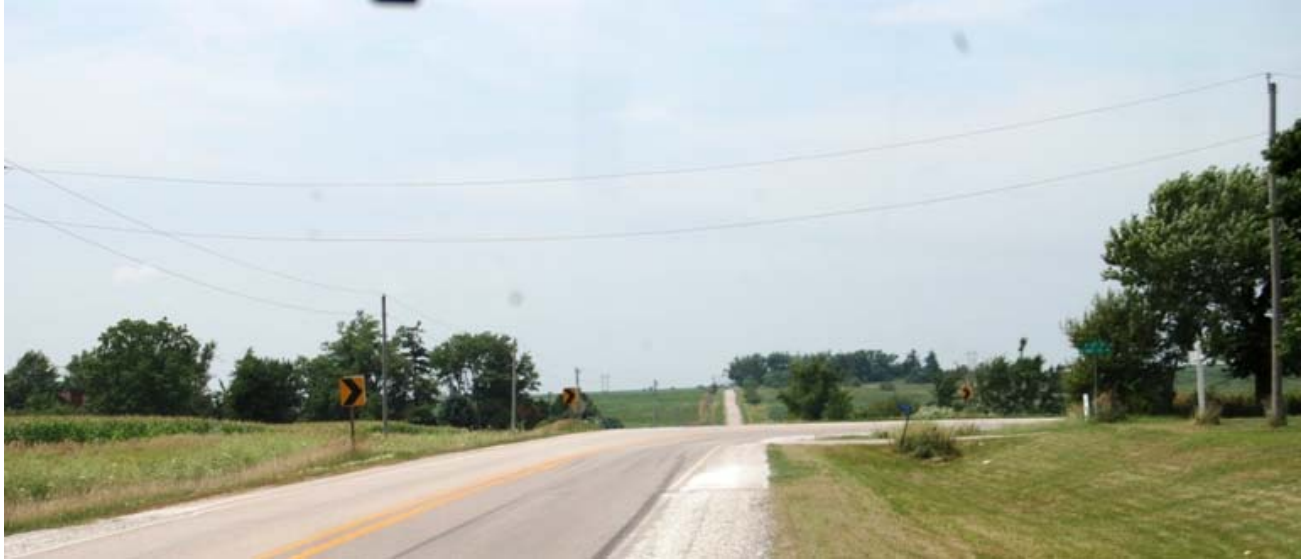
Standard curve warning signs with 45 mph advisory speed plaques are in place in advance of a curve west of Creston, and standard chevrons are in place through the super-elevated curve. Approximately 4 ft wide paved shoulders were placed through the curve as part of a 1996 pavement surface improvement project. However, no rumble strips were milled into the shoulders. Members of the audit team felt the addition of rumble strips would be beneficial.

**Figure A.3. Entering curve westbound**

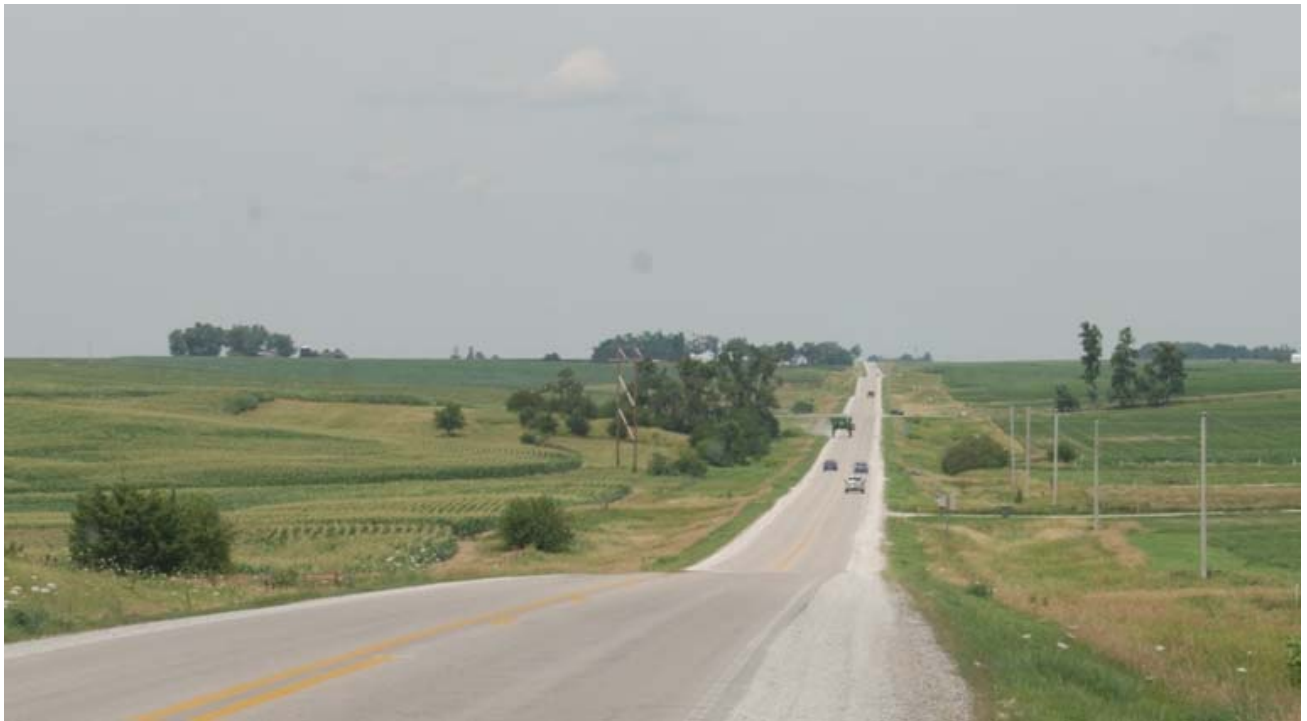
Northerly from the curve area, the granular shoulders appeared slightly narrower than along the previous section west of Creston, and several sections of steeper foreslopes were noted. In addition, two large, approximately 8 ft by 8 ft, reinforced box culverts were noted, both marked with triple amber delineators. Both culverts have ends immediately at the shoulder edge, and several feet of very steep foreslopes exist on either side of the culverts.

**Figure A.4. Northbound view just north of curve**

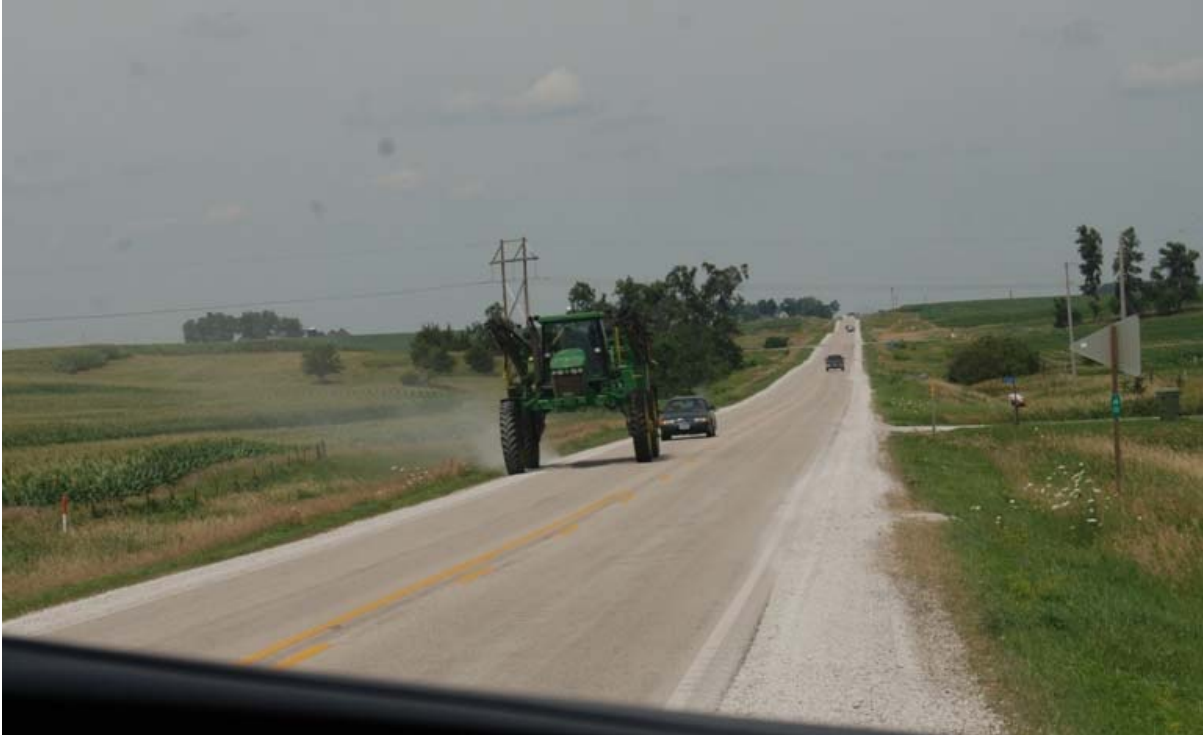
**Figure A.5. Agricultural equipment**

- Discuss replacement of heavy steel mailbox supports with the property owners.
- Several crashes, including one fatal, involved slow moving farm equipment. If that type of vehicle is a frequent road user, consider installation of Vehicular Traffic signs, W11-5 or W11-5a, possibly accompanied by Share the Road, W16-1, plaques.

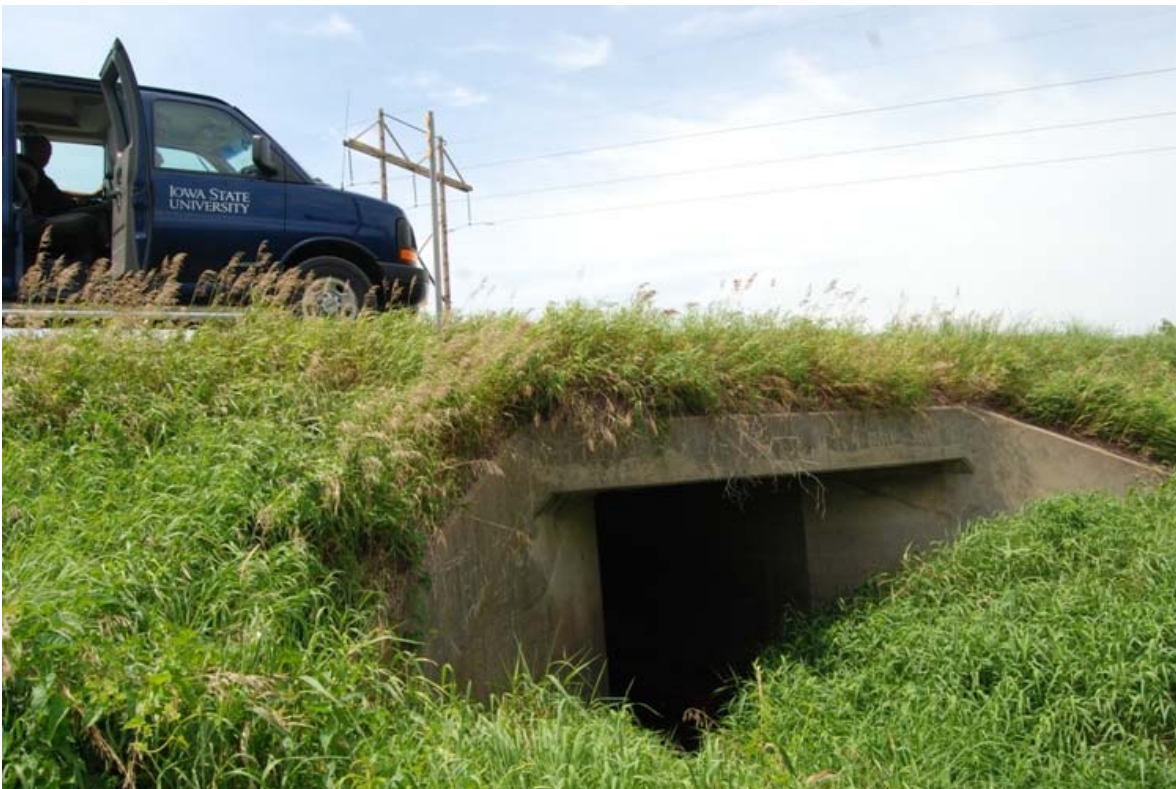
**Figure A.6. Large culvert under IA 25**

- Consider a future resurfacing, restoration, and rehabilitation (3R) project to widen the 22 ft pavement when surface conditions indicate a need for restoration. Include extension or shielding of large reinforced box culverts as part of the project.

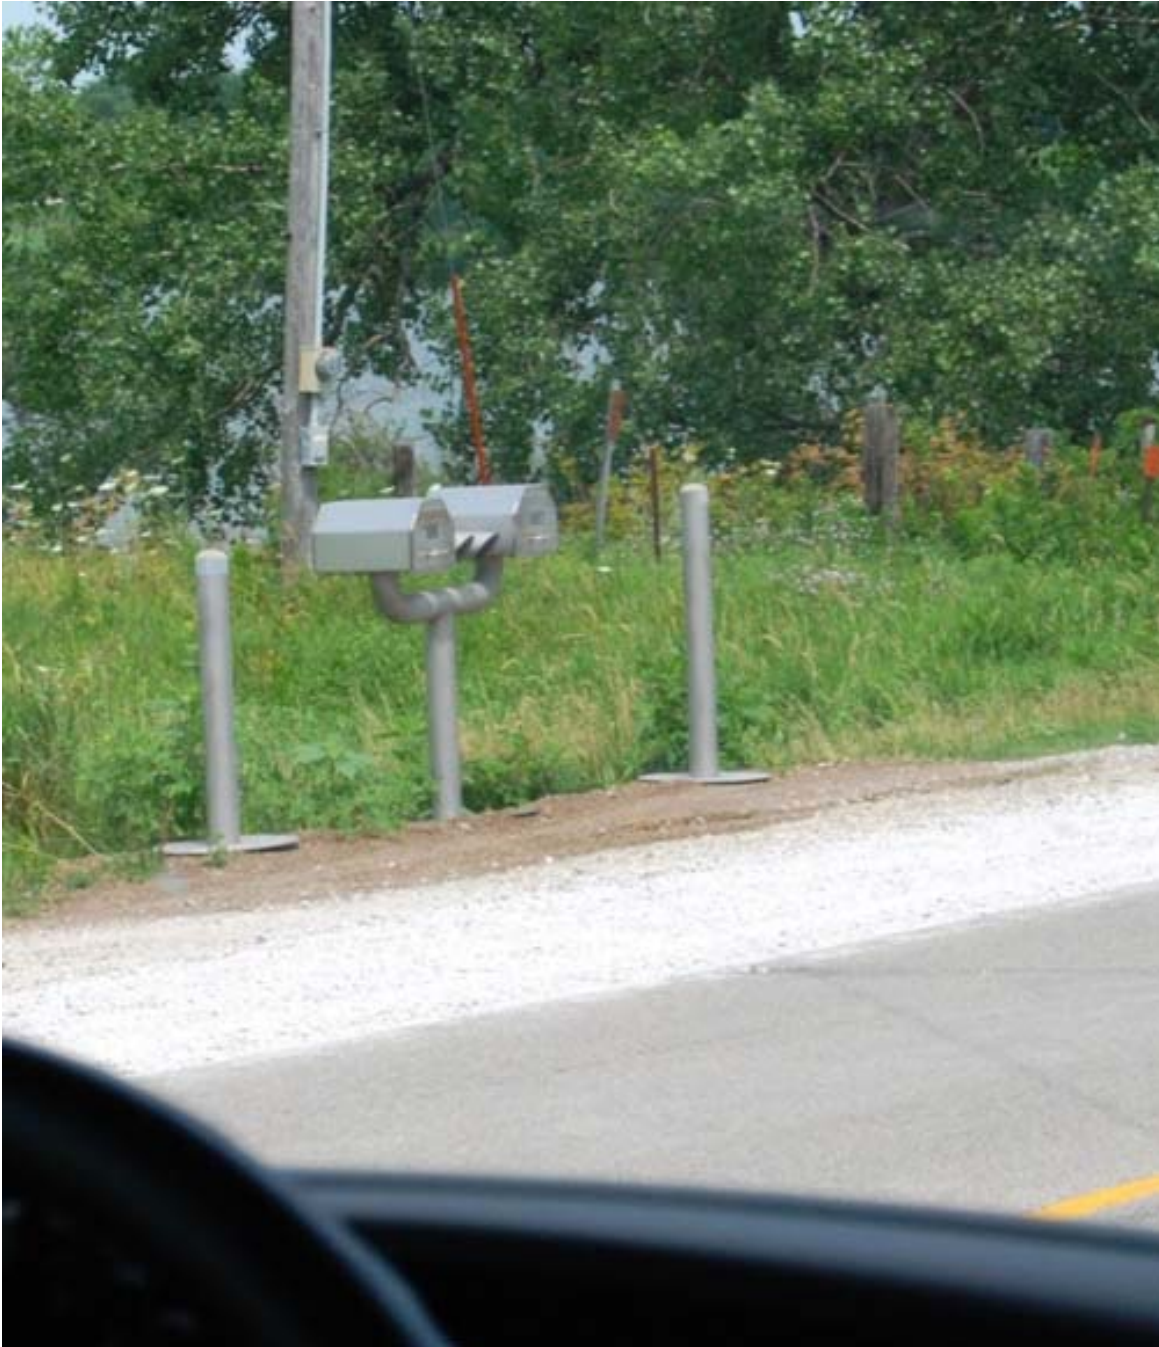
**Figure A.7. Mailbox support and guard posts**

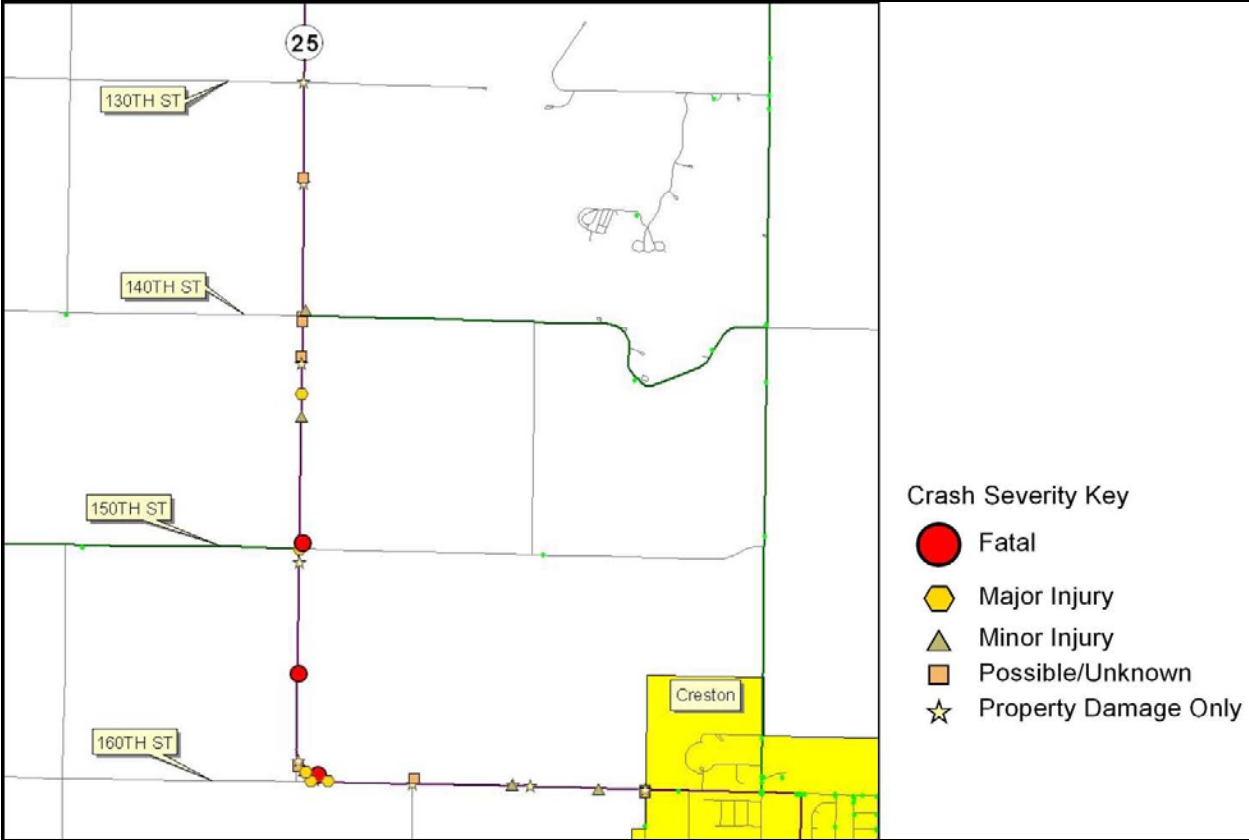
The serious crashes (fatal and major injury) occurred in a curve area or within one mile of that location. Other crash locations are scattered throughout the section. All three fatal crashes and two of the major injury crashes were head-on incidents. Other major injury crashes were attributable to broadside or non-collision causes. Non-collision, which generally involves run-off-road or animal crashes, were noted for 12 of the 31 total crashes in the corridor. Swerving/evasive action was noted as a major crash cause in eight crashes, and animal collisions occurred three times. Driving too fast for conditions was only noted for a single property damage crash.

Figure C.1. Crash severity locations

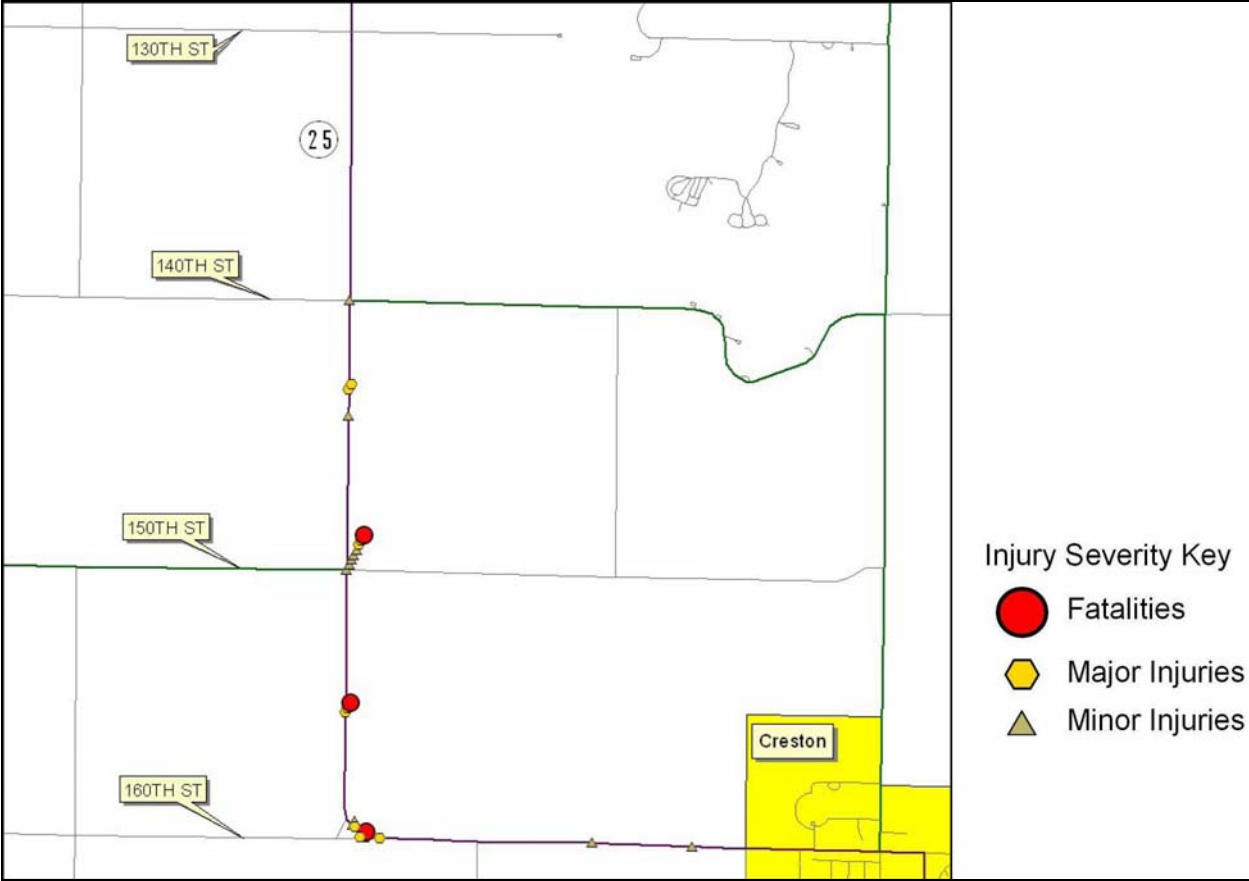
**Figure C.2. Injury severity locations**

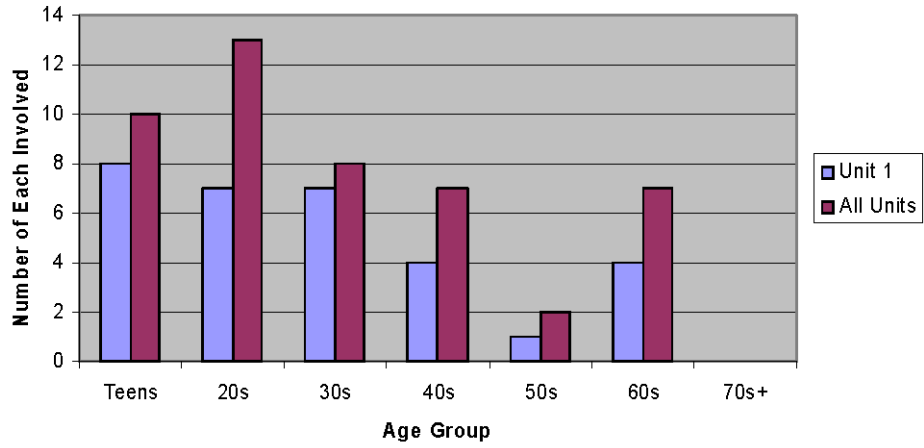
**Figure C.11. Crashes by driver age**

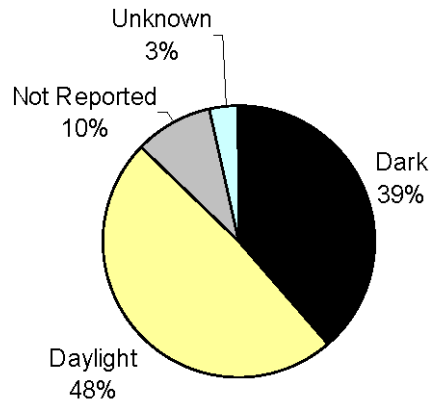
Approximately 48% of the crashes occurred in daylight conditions, and 39% in the dark.

**Figure C.12. Crashes by light conditions**

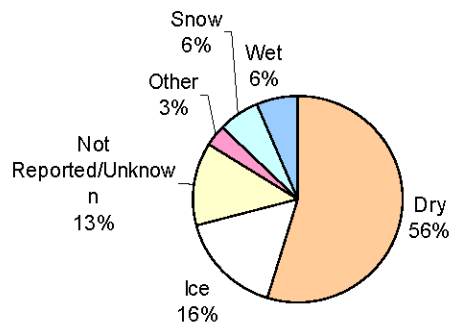
Roadway surface conditions were dry for 56% of the total crashes; wet surface, snow, and ice were noted for 28% of the crashes. Adverse weather conditions were noted in approximately

**Figure C.13. Crashes by surface conditions**
