Road Safety Audit for County Road H-46 from Redwood Avenue to the Southerly Corporate Limits of Fairfield in Jefferson County, Iowa

Final Report
January 2010

ROAD SAFETY AUDIT FOR COUNTY ROAD H-46 FROM REDWOOD AVENUE TO THE SOUTHERLY CORPORATE LIMITS OF FAIRFIELD IN JEFFERSON COUNTY, IOWA

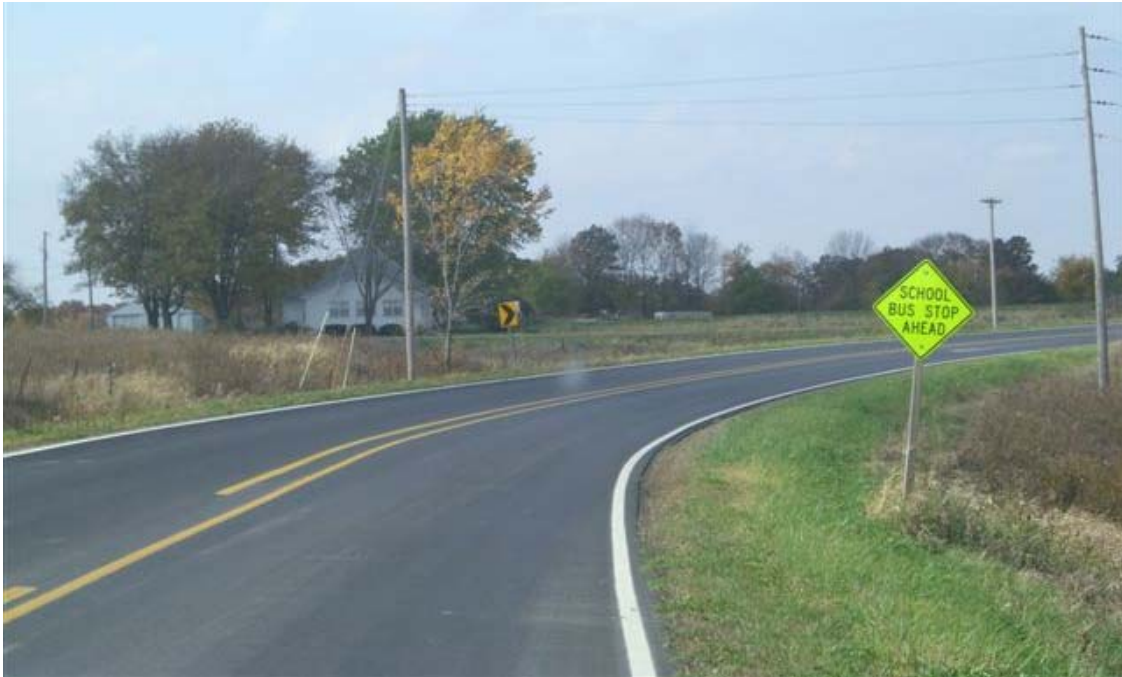
Palm Boulevard intersects H-46 from the south near a horizontal curve. One fatal crash, possibly weather related, was recorded in this area during the review period. Widely spaced, larger size chevron warning signs mounted on brackets are in place through this curve. For northbound traffic approaching this area, a curve warning sign with a 45 mph advisory speed is in place. A School Bus Stop Ahead warning sign is also located in advance of the curve.

Figure A.1. School bus warning sign and chevron along horizontal curve at Palm Boulevard intersection

The existing chevrons along the curve near the Palm Boulevard intersection would be more effective if these devices were repositioned to more closely comply with 2009 Edition of the *Manual on Uniform Traffic Control Devices* (MUTCD) guidelines. In addition, at least one more chevron should be added to enhance visibility of the curve for southbound drivers approaching the area from the north.

- Review the existing chevrons on the curve near Palm Boulevard for needed upgrades, such as adding of mounting brackets, re-spacing to match 2009 MUTCD guidelines, and possibly using fluorescent yellow, microprismatic sheeting. Consider similar sheeting for the curve warning signs at this location.
- Consider installing a hidden driveway warning sign easterly of Palm Boulevard for northbound traffic.
- Discuss with the affected property owner the removal of a large tree that hampers visibility at the Osage Avenue intersection.
- Study the feasibility of deer fencing along the right-of-way between Palm Boulevard and Queenscup Road, where there has been a high concentration of deer crashes.
- Monitor the pavement surface for friction quality.
- With a future resurfacing project, consider installing milled-in pavement markings for better longevity and performance.

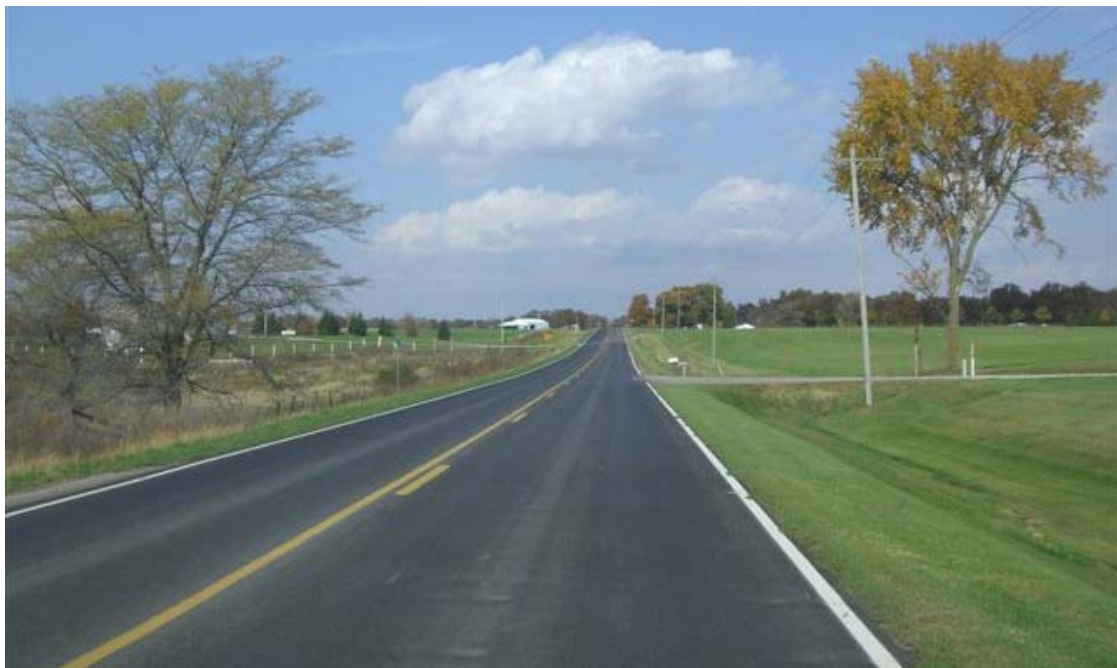
The pavement markings on the newly applied Gilsonite surface treatment were quite visible, with good retroreflection. In addition, the markings beyond the Gilsonite section also appeared very satisfactory.

Figure A.2. Pavement markings on County Road H-46

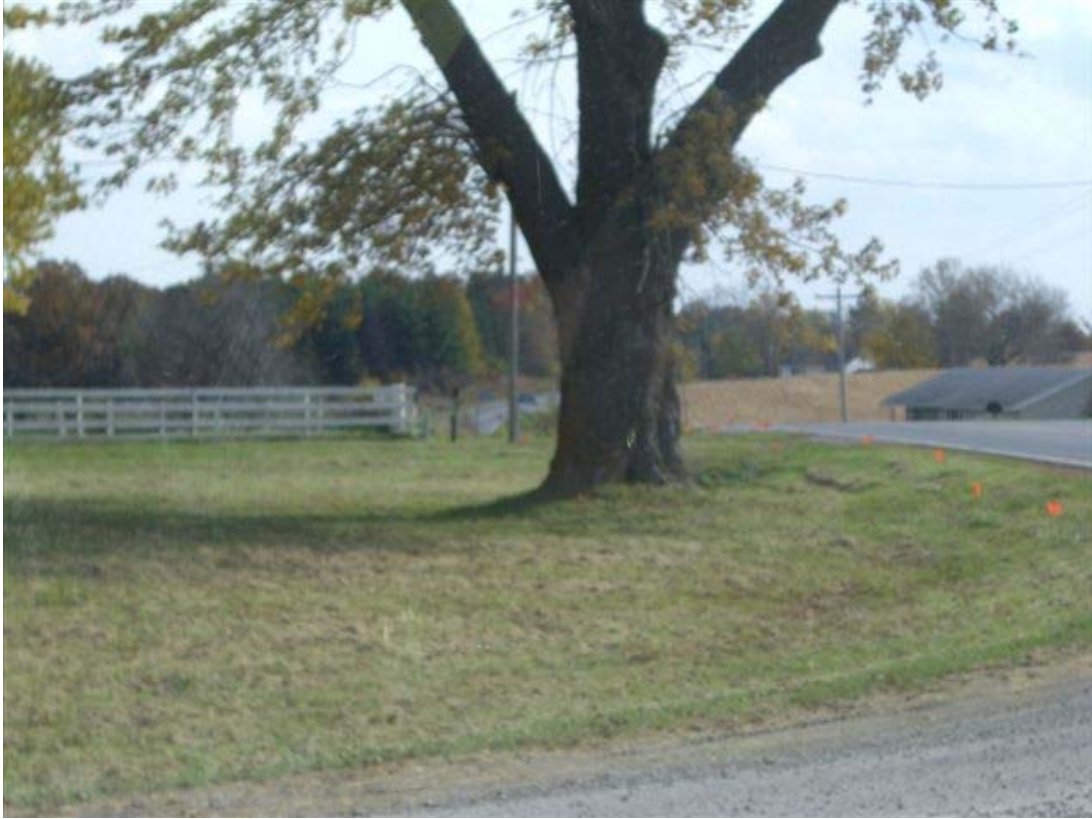
Figure A.3. Large tree obstructing view from side road at Sage Avenue intersection

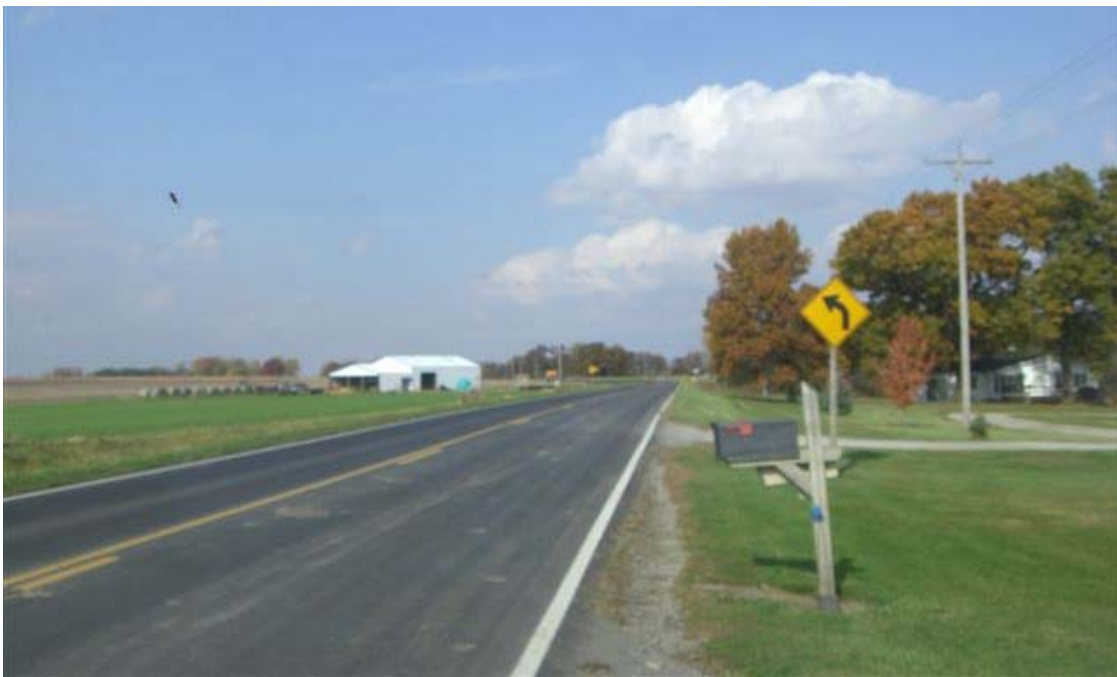
Figure A.4. Curve sign and mail box

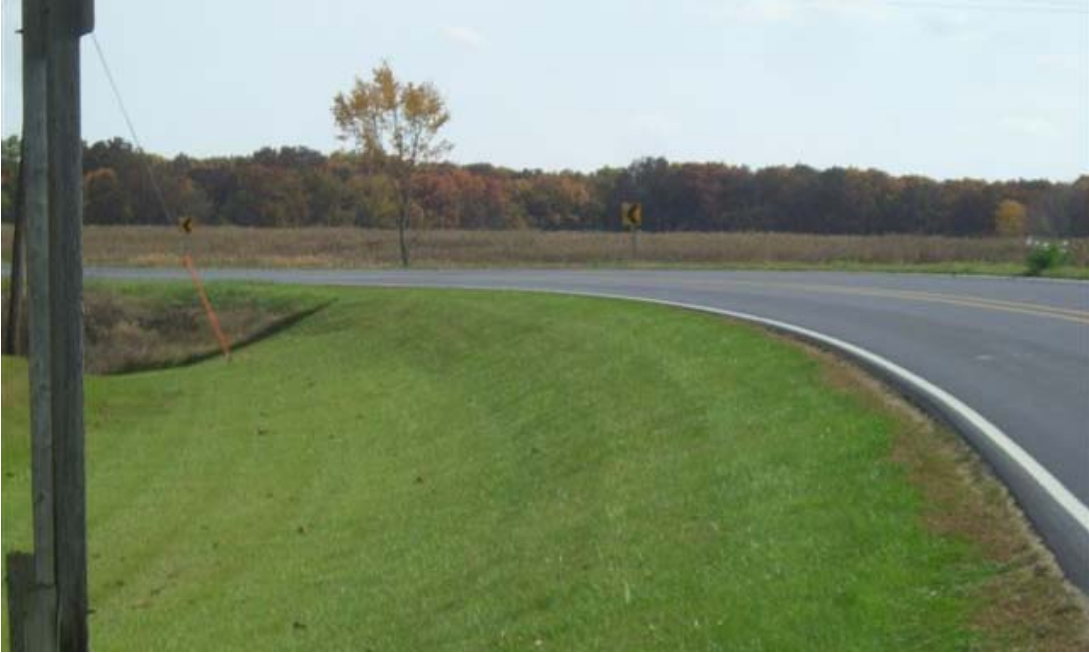
Figure A.5. Chevron installation along horizontal curve

Only one curve in the reviewed section has been delineated beyond standard pavement markings. Enhanced guidance along several curves with higher degrees of radius would be effective, perhaps using single white delineators spaced according to 2009 MUTCD guidelines or using devices similar to the Carsonite product to provide flexible supports.

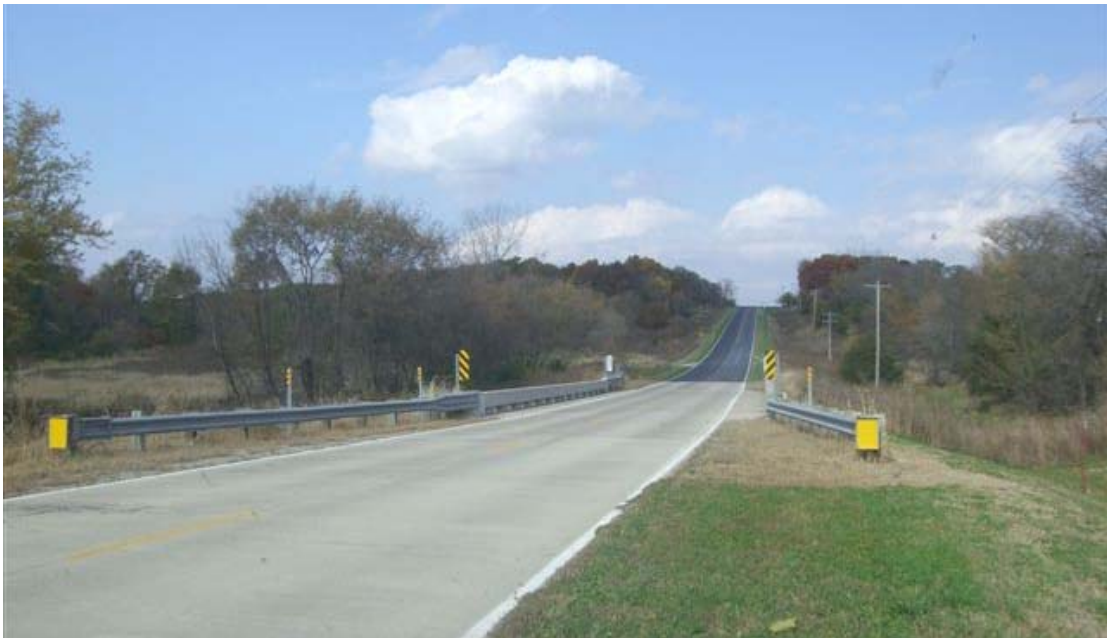
Southeasterly from Pine Avenue, a newer bridge with a current guard rail exists. Vertical panels marking the bridge ends are in good condition. Beyond the bridge, H-46 features a long vertical rise with numerous private entrances and roads. One private road serves seven to eight residences. Advance sight distance to this private road connection for northbound drivers is hampered by the vertical geometry of H-46.

Figure A.6. Guardrail and delineation at newer bridge

Visibility of the bridge and guardrail southerly from Pine Avenue could be improved by replacing the vertical panel object markers and delineators. Additional delineation along the face of the guardrail would also be very effective.

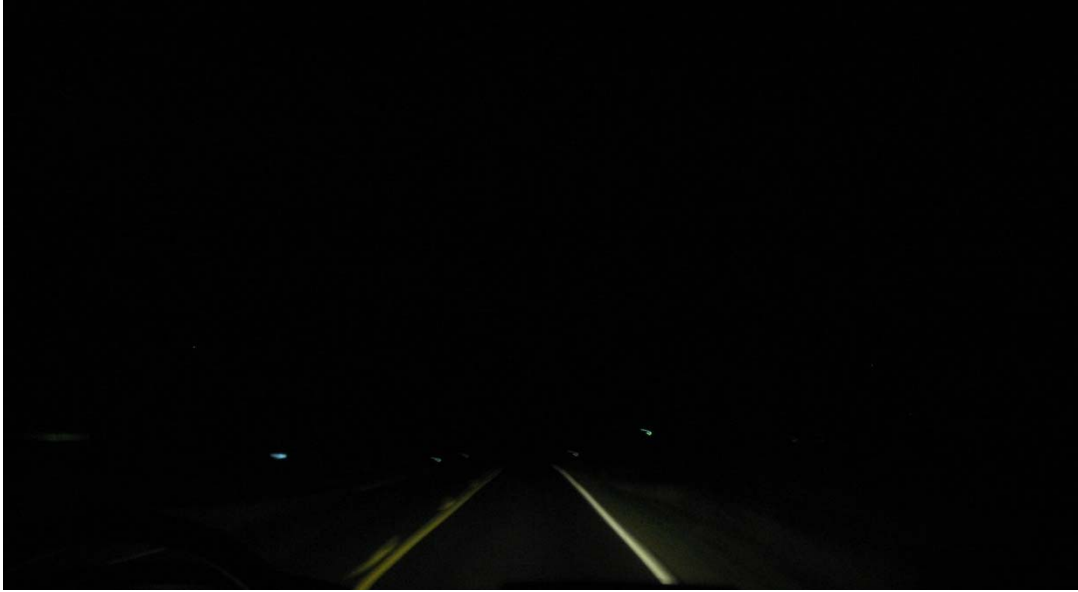
Figure A.7. Nighttime view of pavement markings

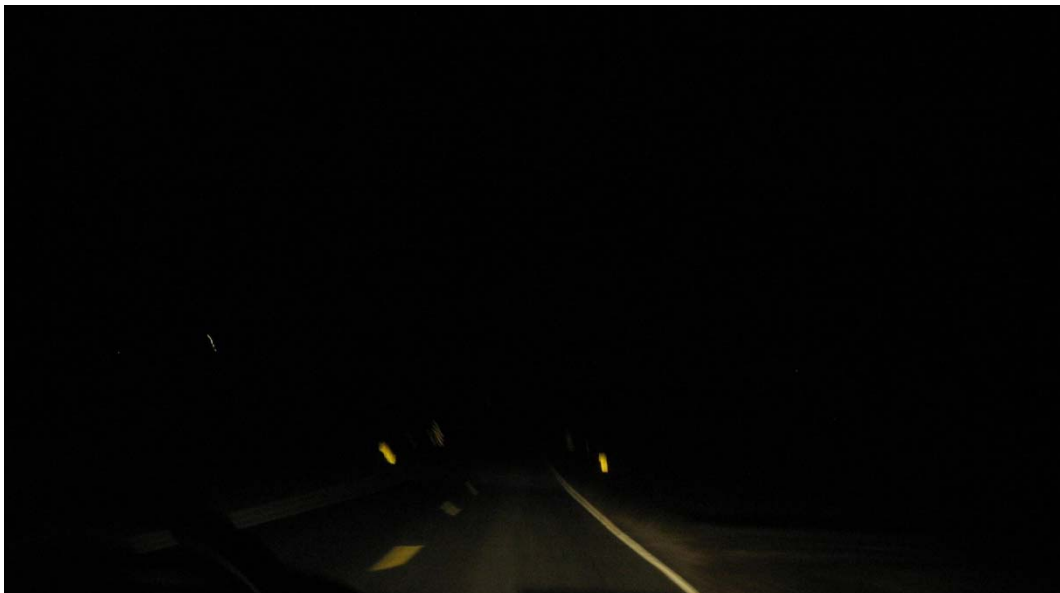
The relatively new bridge over the US 34 bypass did not appear to feature delineation in the guardrail. Nighttime visibility of this structure could be improved with guardrail reflectors and perhaps newer vertical panel object markers.

Figure A.8. Nighttime view of pavement markings and guardrail delineation at bridge

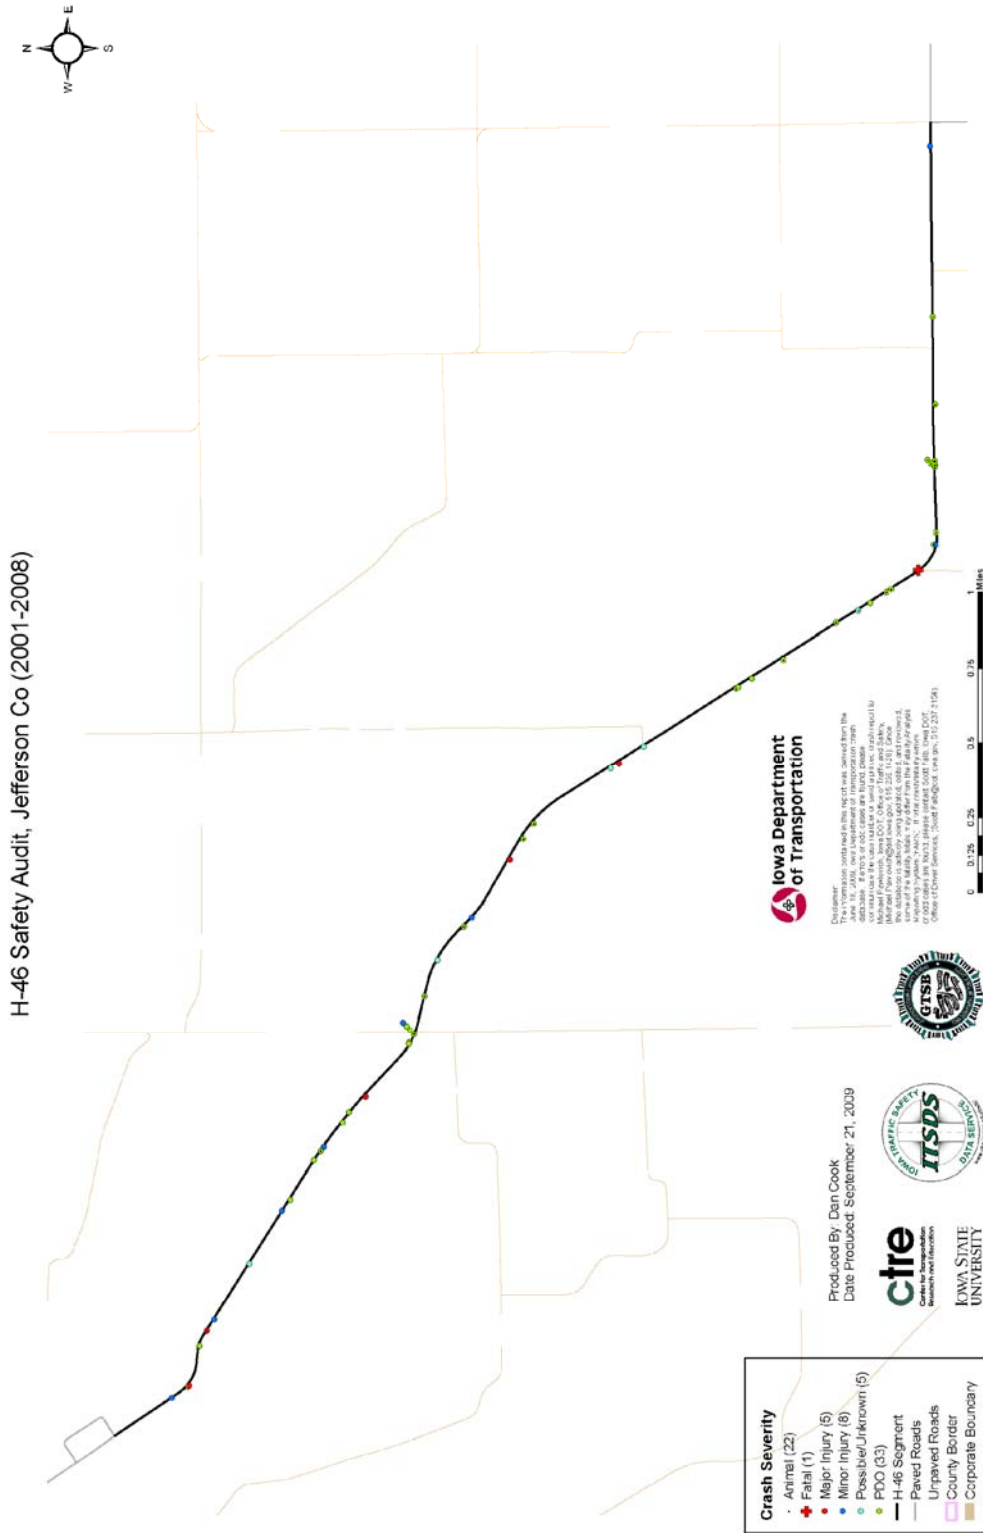
Figure B.1. Crash map for 2001 to 2008
